RE: 2015 SURFACE IMPOUNDMENT ANNUAL INSPECTION REPORT, COLSTRIP STEAM ELECTRIC STATION, COLSTRIP, MONTANA

**2015 SURFACE IMPOUNDMENT
ANNUAL INSPECTION REPORT
COLSTRIP STEAM ELECTRIC STATION
COLSTRIP, MONTANA**

2015 Initial
 Annual Inspection Report
 Colstrip Steam Electric Station
 Colstrip, Montana

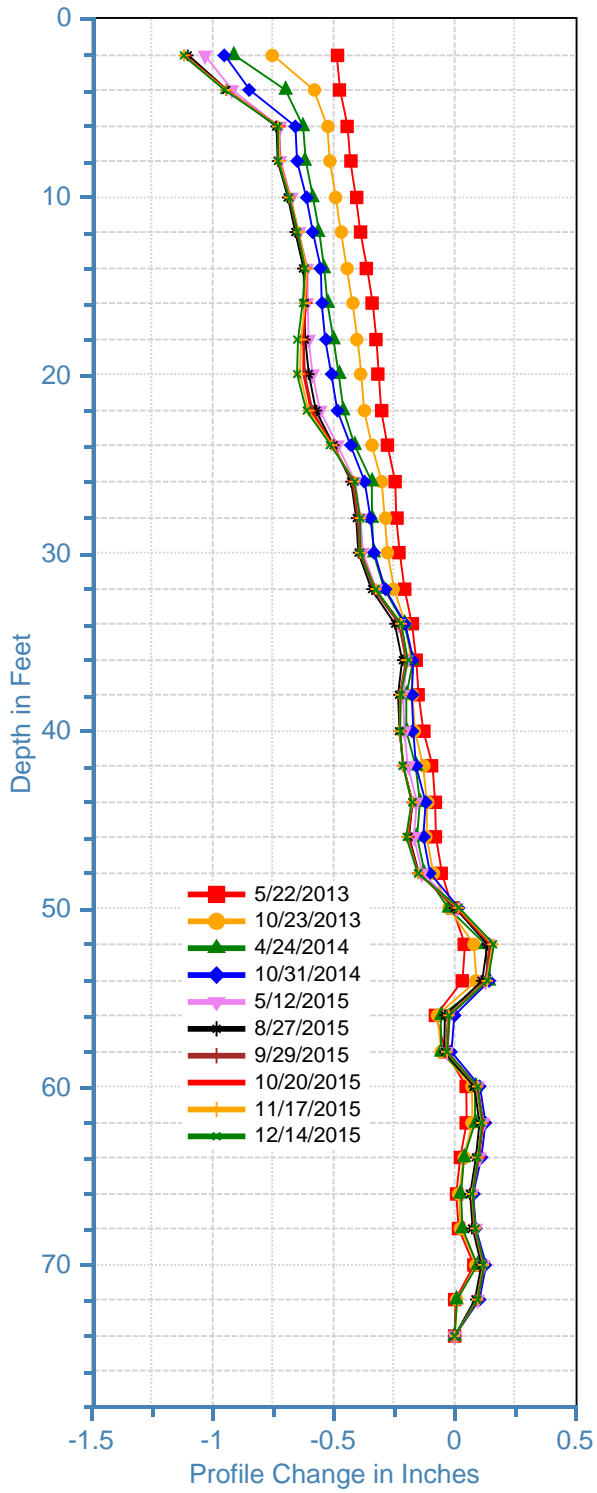
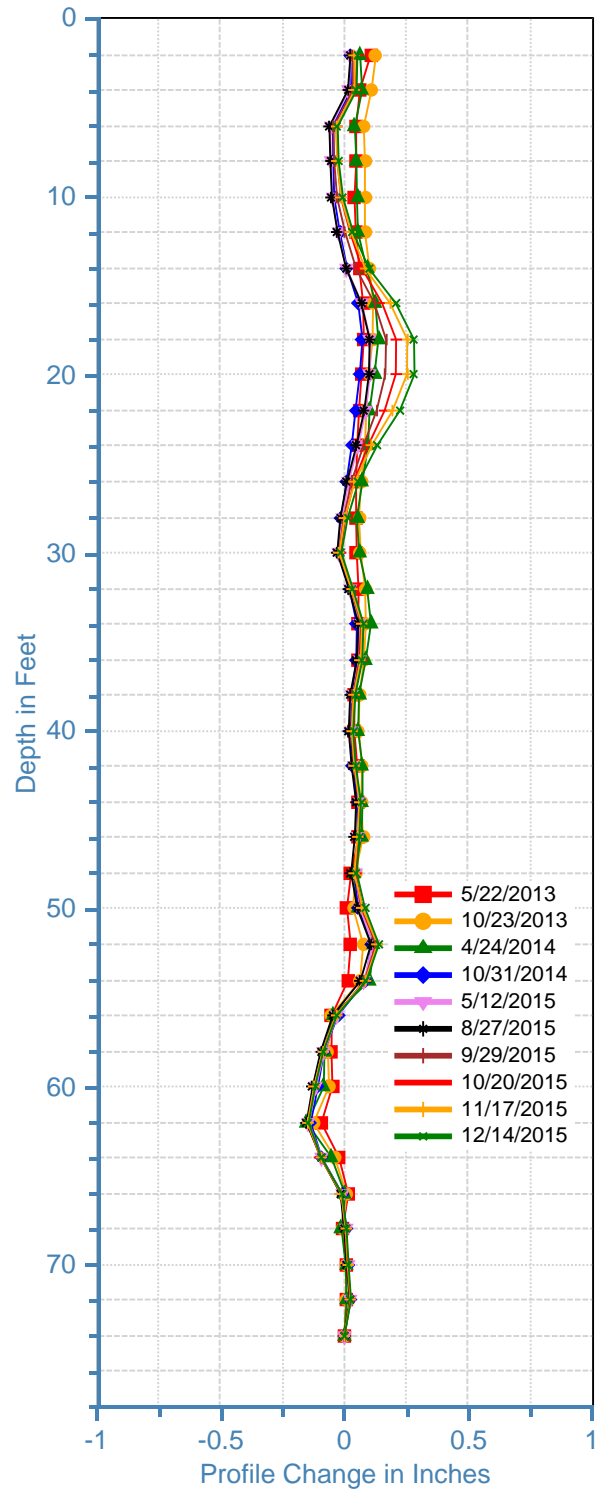
Location: Units 3 & 4 EHP
Instrument: SD-12-15INC

Movement is on the order of 0.25-in since the baseline survey in October 2012. This is not a cause for concern because: 1) the majority of the movement is parallel to the embankment, 2) the movement is very small and spread over about 8 to 10 vertical feet rather than in a discrete zone (as would be expected from shearing), and 3) no surface expression exists to indicate movement of the embankment.

Two additional inclinometers (SD-15-17INC and SD-15-19INC) were installed in 2015 to bracket SD-12-15INC and assess whether the small detected movements are indicative of a larger problem. At this time, measurements of the new inclinometers appear to verify movement observed in SD-12-15INC is not wide spread. SD-15-17INC may be detecting settlement-related movement in the “B” axis direction in the clinker foundation at a depth between 34 and 40 feet. This likely indicates the saturated clinker underlying the embankment inboard of the cutoff wall is still undergoing minor settlement from the weight of recent fill (see Section 4.2.3). Although this movement needs to be monitored in the future, its direction and appearance do not appear to indicate instability. SD-15-19INC was installed in September 2015 and did not appear to show movement when measured in November and December.

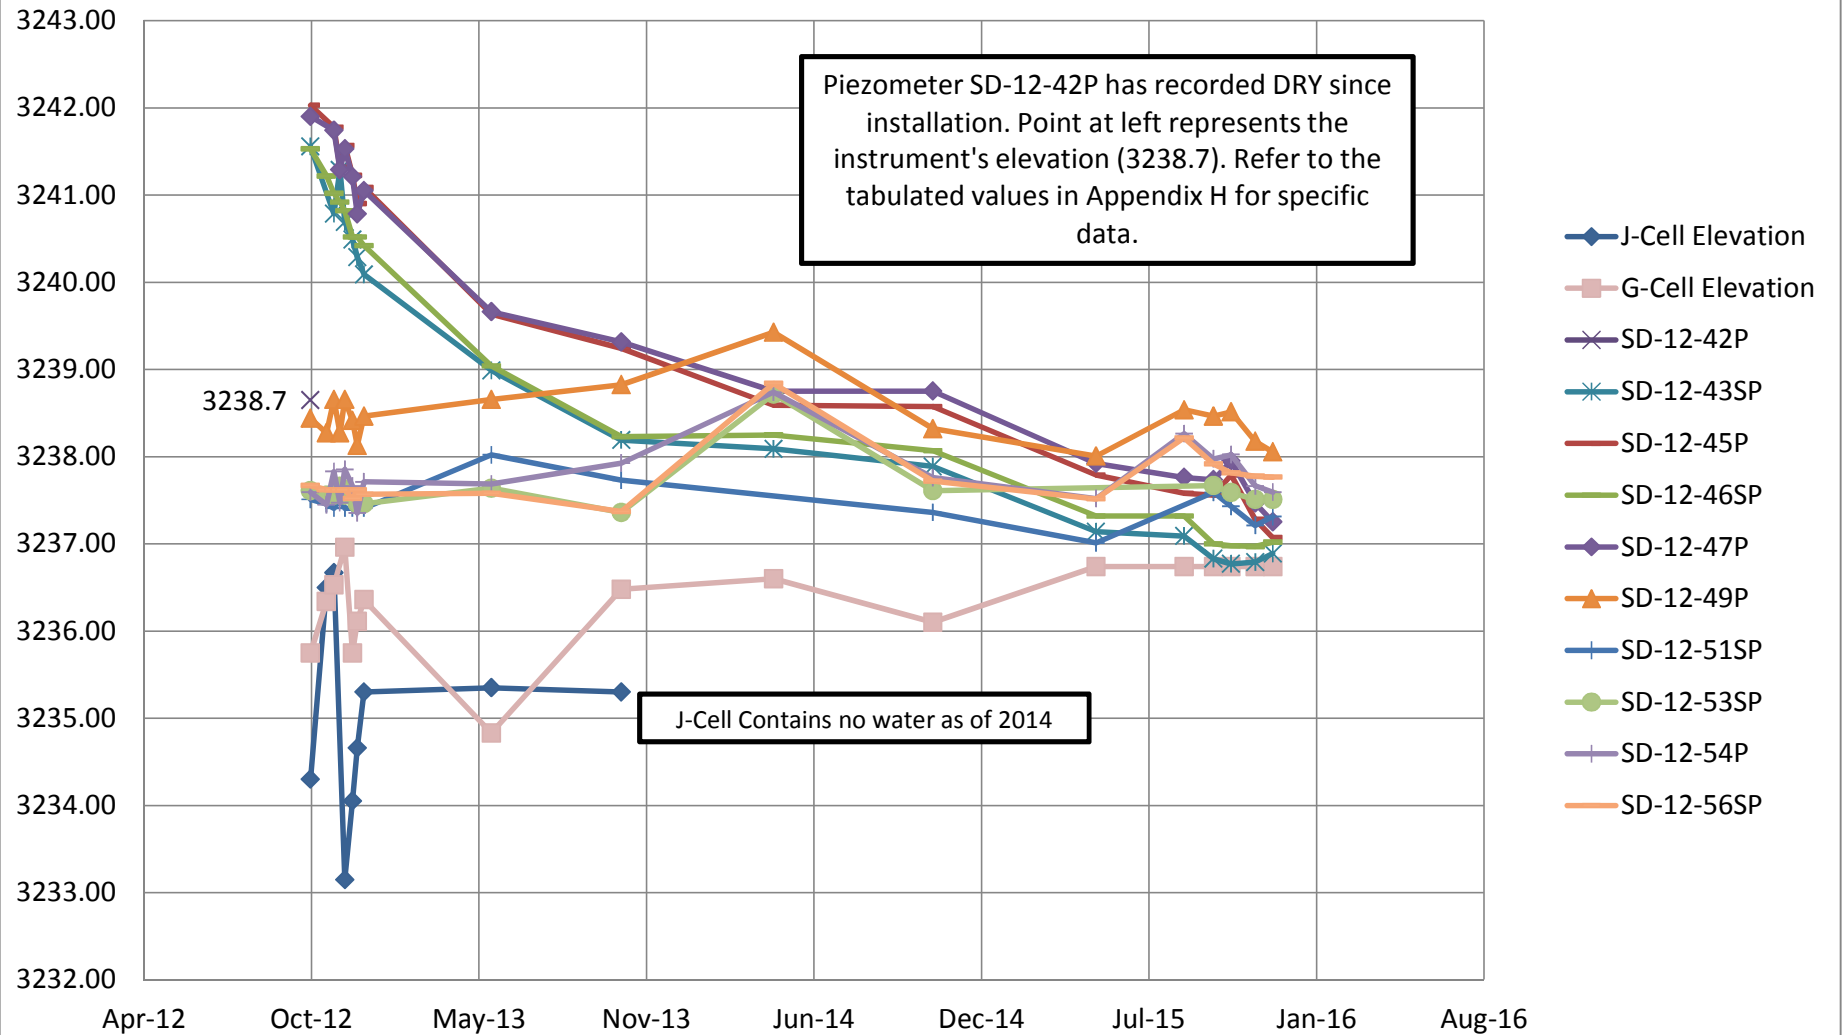
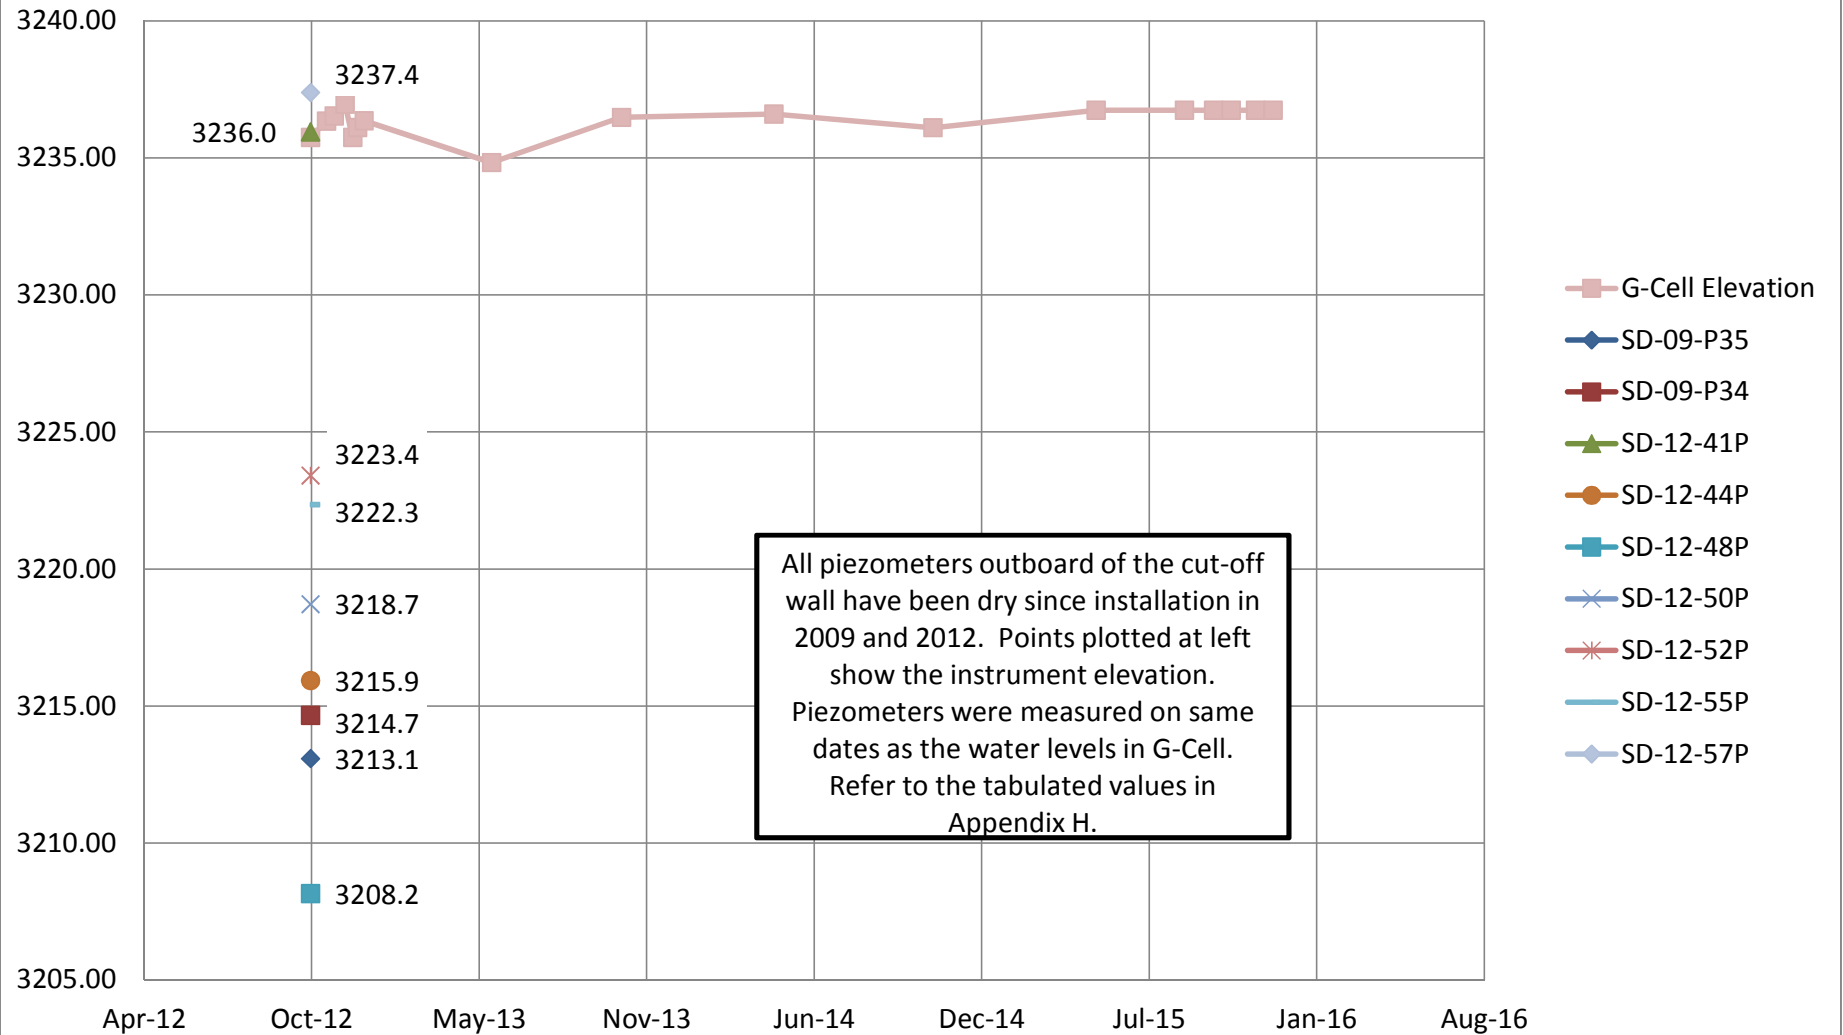
Of the 19 VW and standpipe piezometers within the Saddle Dam, 9 are located outboard (i.e., downstream) of the cutoff wall. Each of these piezometers has reported dry conditions since their installation in 2009 and 2012. The 10 piezometers inboard (i.e., upstream) of the cutoff wall fluctuate in response to water levels in adjacent unlined cells in the 3&4EHP, particularly C-Cell, which is considered the hydraulic driver of the facility. Plots of individual wells outboard of the cutoff wall are presented in addition to a summary plot. In general, Saddle Dam piezometers are reporting some of the lowest water surface elevations since their installation. During 2015, water levels in some of piezometers rose during the summer and fall before falling in the early winter, indicating influence by seasonal precipitation.

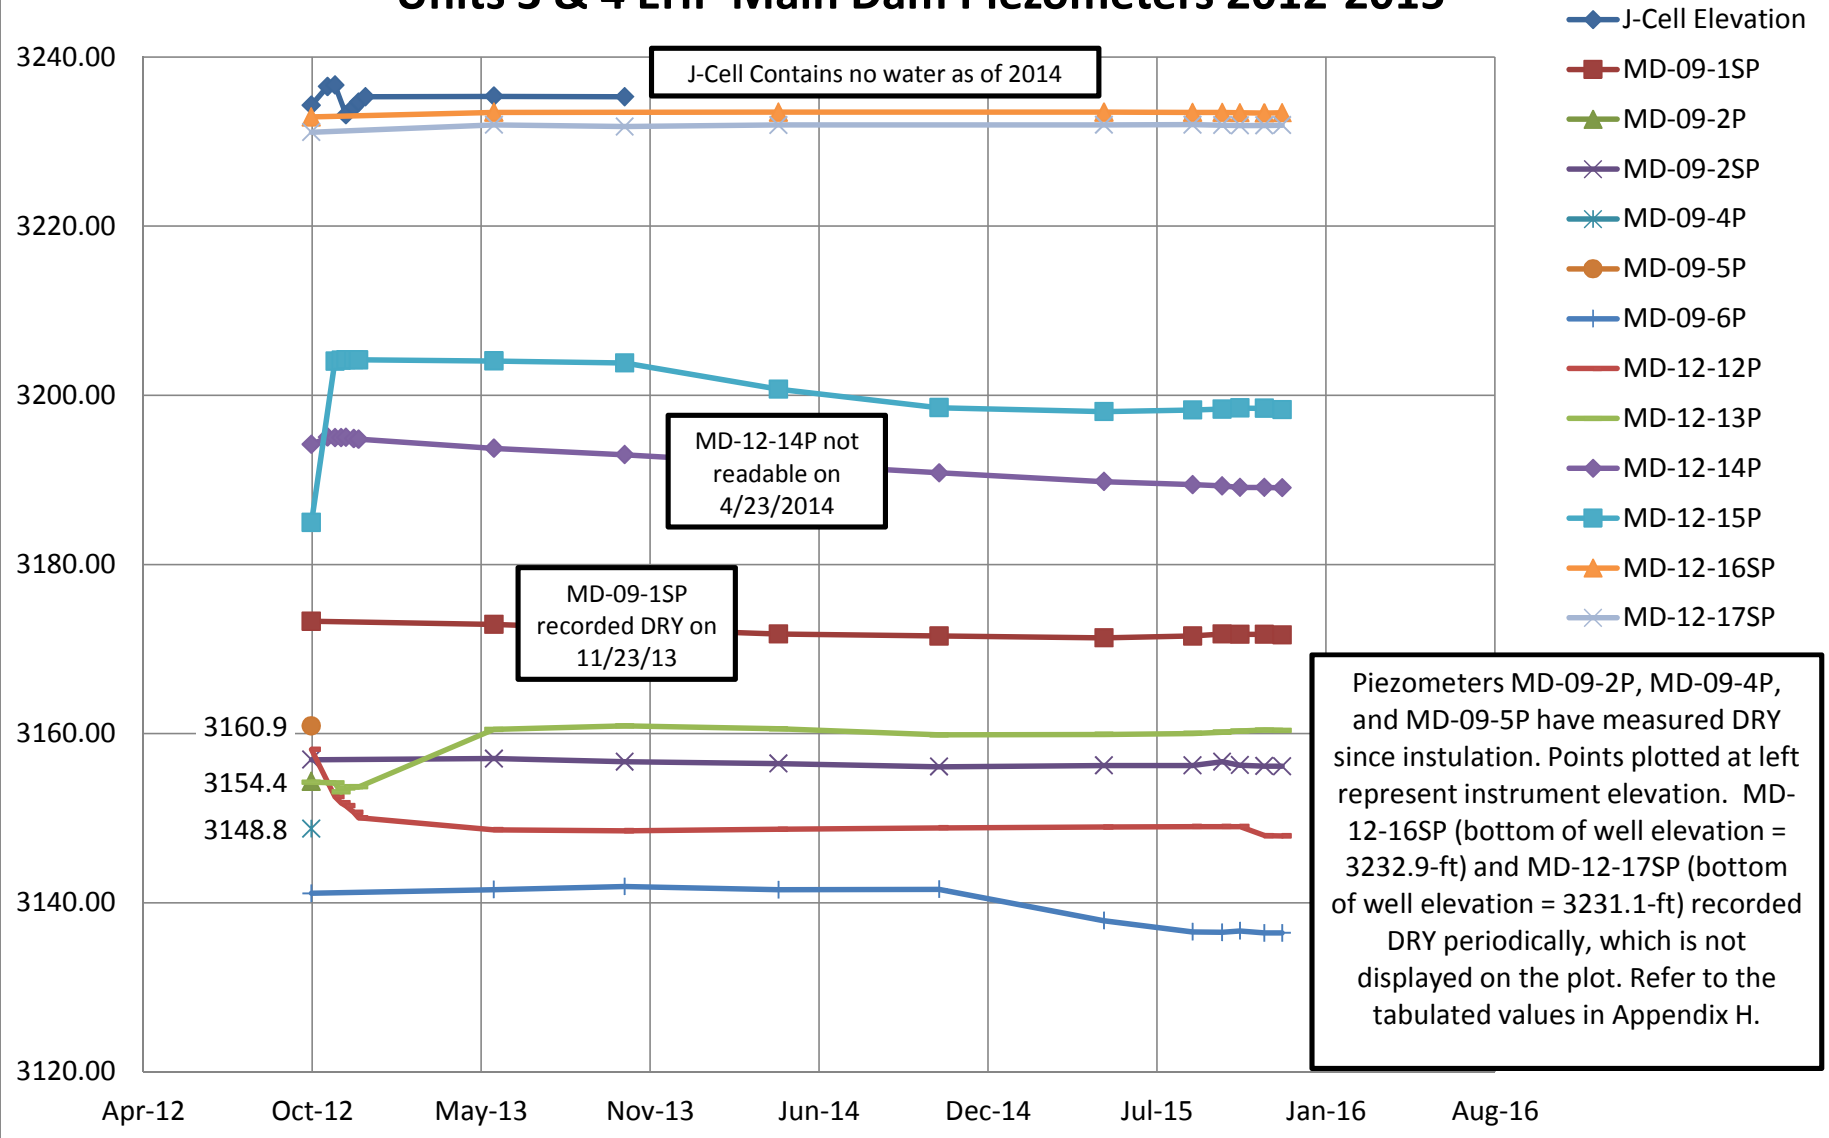
Units 3 & 4 EHP Main Dam Piezometers 2012-2015

A total of 12 VW and standpipe piezometers in the Main Dam embankment and abutments were measured during the 2015 monitoring effort. Two piezometers (MD-09-2P and MD-09-4P) are located within the shell material outboard of the chimney drain, and one piezometer (MD-09-5P) is located in the foundation material beyond the toe of the embankment. All of these have reported dry conditions since their installation in 2009. Of the nine piezometers reporting water, very little change occurred in 2015 compared to historic values, indicating the internal structure of the zoned-earth embankment is functioning properly.

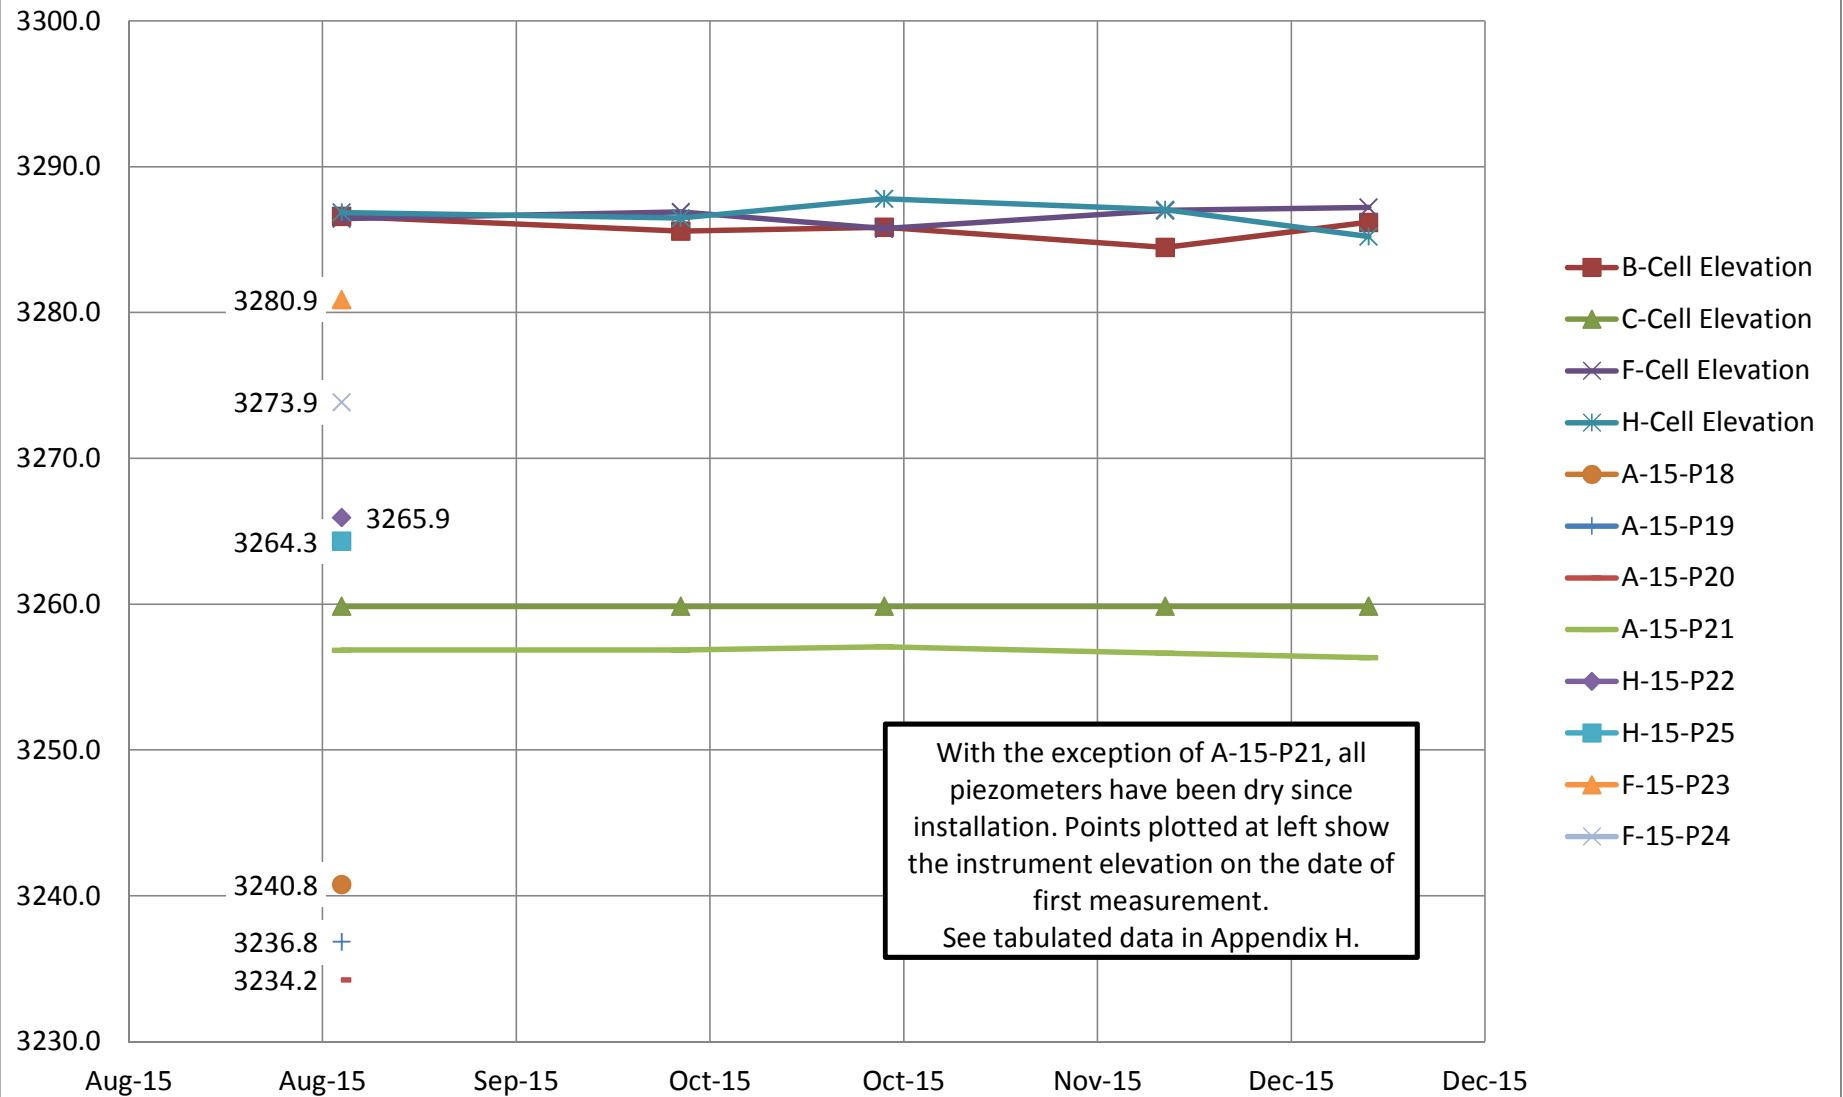
Units 3 & 4 EHP Additional Piezometers

Four new piezometers were installed within the embankment outboard of A-Cell. With the exception of A-15-21P, all have reported dry conditions. Water surface elevations recorded in A-15-21P, which is located inboard of the concrete cutoff wall, are approximately 3256-ft, as would be expected, because the seepage is likely reporting from C-Cell through permeable clinker bedrock. The seepage is apparently contained by the cutoff wall. It is unexpected that a similar water surface elevation has not appeared in A-15-19P. Although 19P was installed inboard of the cutoff wall location shown on the map of the EHP, it is possible that A-15-19P is actually outboard of the cutoff wall or installed within fine-grained bedrock that isolates it from the source of water observed in A-15-21P.

With the exception of A-15-P21, all piezometers have been dry since installation. Points plotted at left show the instrument elevation on the date of first measurement. See tabulated data in Appendix H.
