January 15, 2016

390/265831

**Subject: 2015 Annual (Initial) USEPA CCR Surface Impoundment Inspection Report
Montour Ash Basin No. 1**

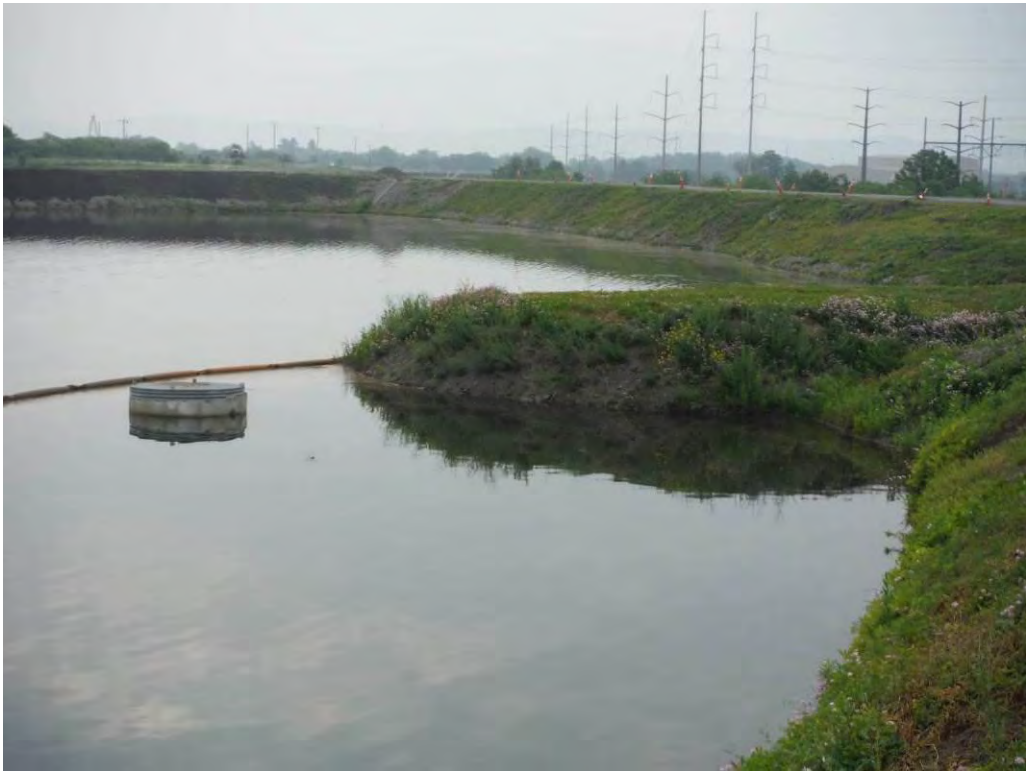
Photo 2 – Upstream slope of Sub-basin C looking southeast, showing outlet riser and riprap slope stabilization.

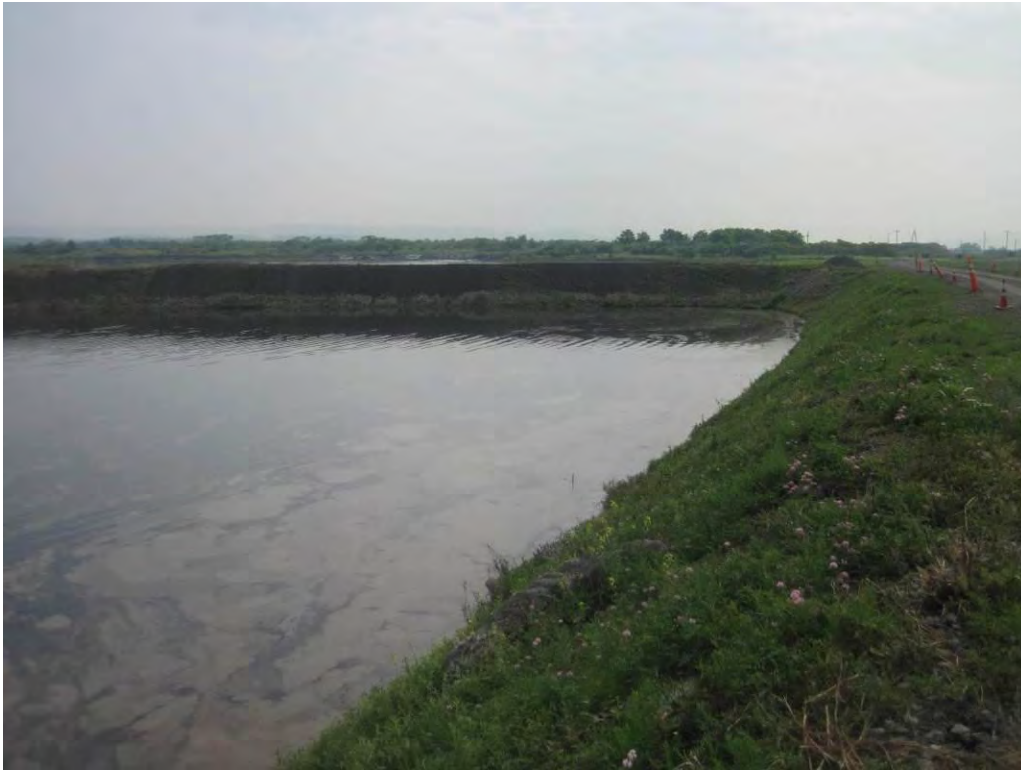
Photo 3 – Upstream slope of Sub-basin C looking southeast. The 12-inch CMP at the waterline was half submerged during the 2015 inspection. There was no current or other evidence of flow entering the pipe. The purpose of the pipe and the alignment of the pipe within the embankment is unknown.

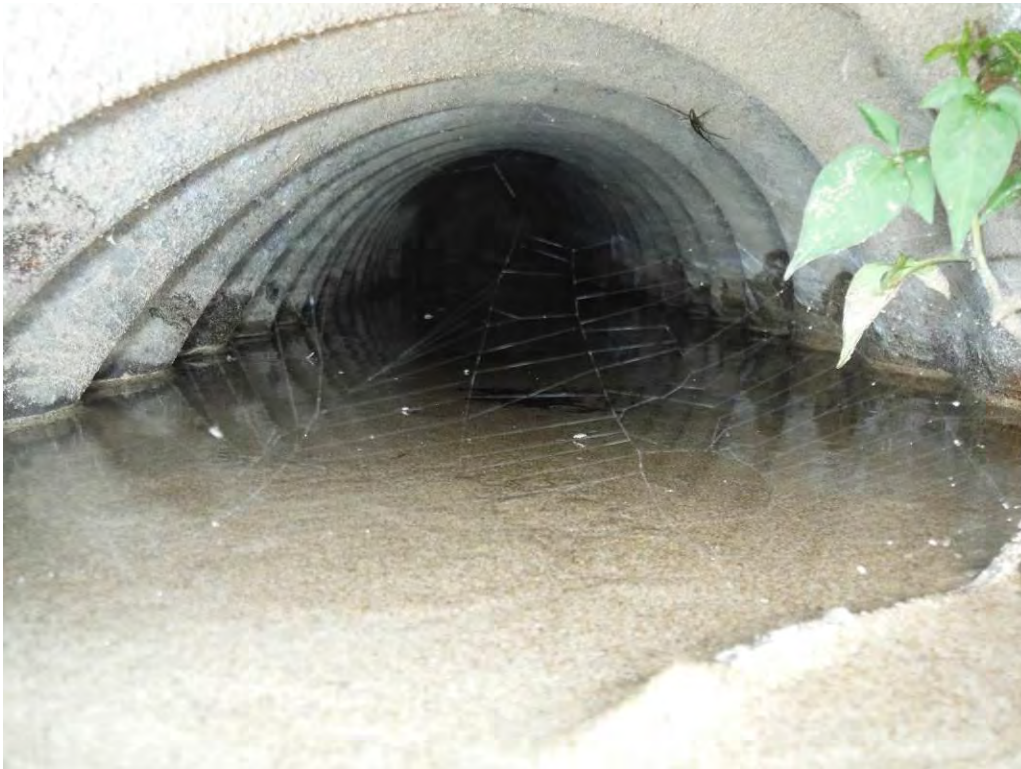
Photo 4 – View of the interior of the 12-inch CMP at the waterline at upstream slope of Sub-basin C, showing pipe partially submerged. A photo of the pipe interior taken in 2014 showed the pipe partially clogged.

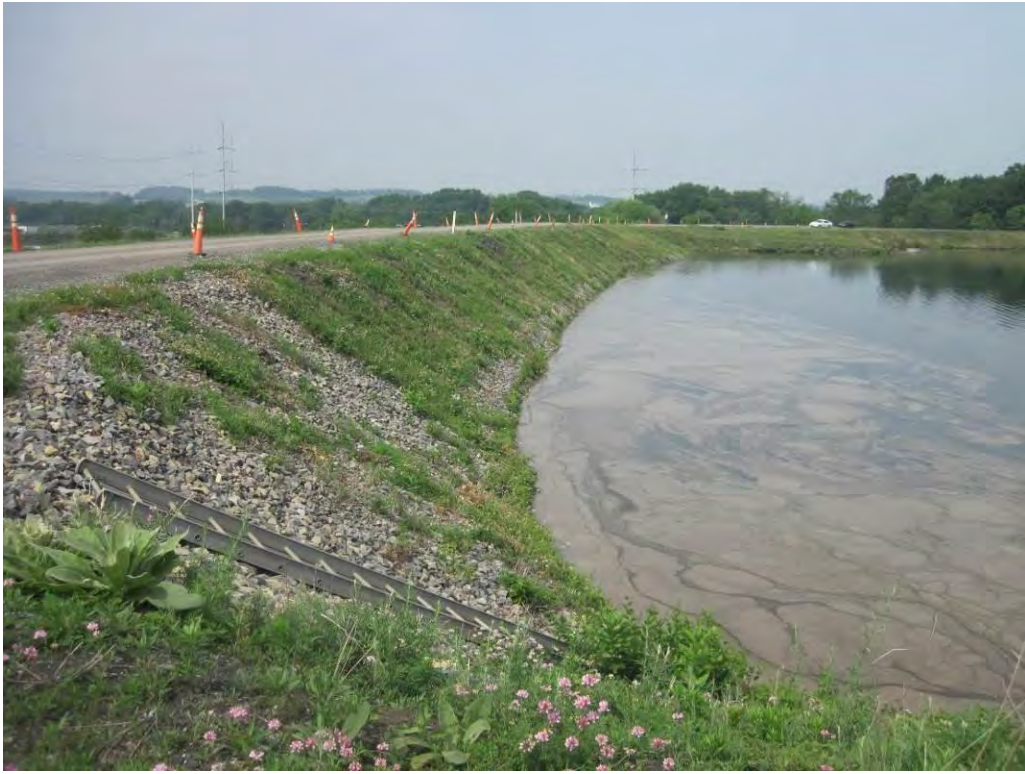
Photo 5 – Upstream slope of Sub-basin C looking northwest, showing riprap slope stabilization.

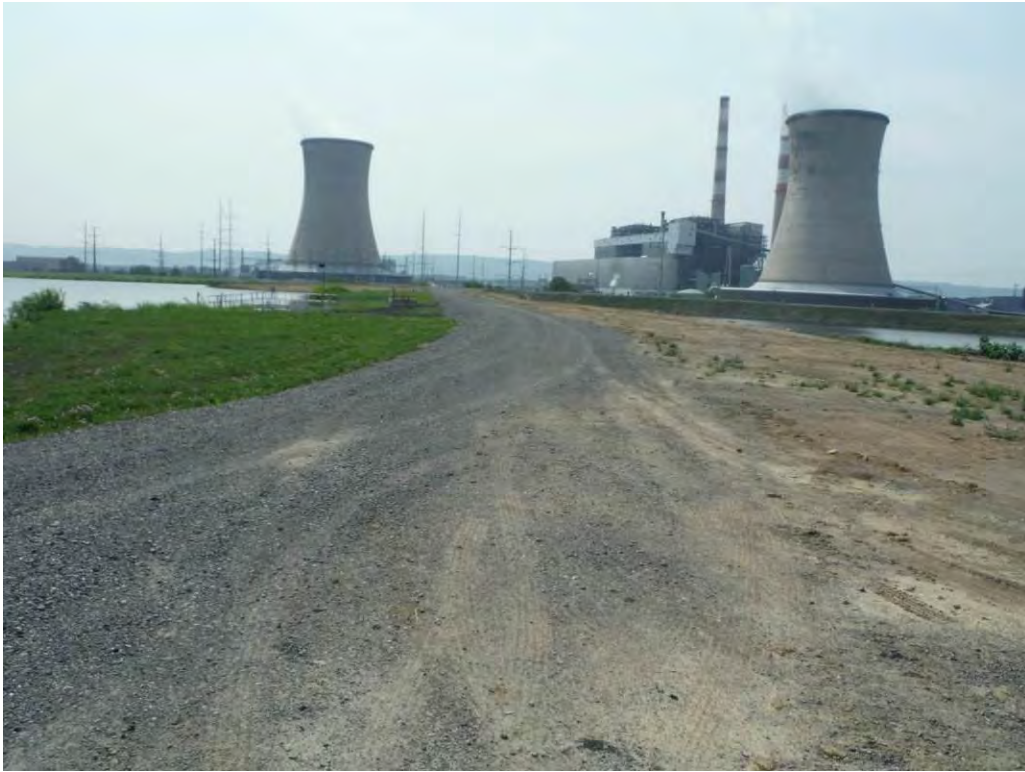
Photo 6 – Splitter dike between Sub-basin B and C, showing the vegetated bottom ash bench against the inside slope of Sub-basin B, effectively widening the embankment.

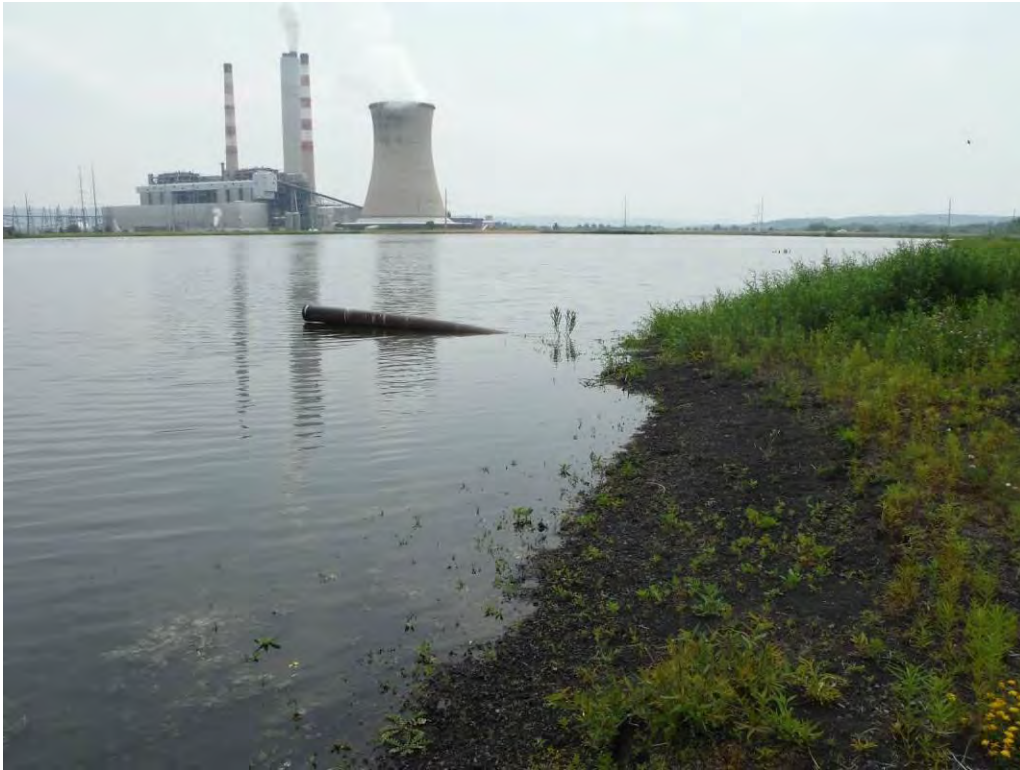
Photo 7 – Upstream slope of Sub-basin B showing the 12-inch HDPE extending into the basin in the background. This pipe is believed to be a discontinued ash deposition line, and the orientation and means of closure of the buried part are not known.

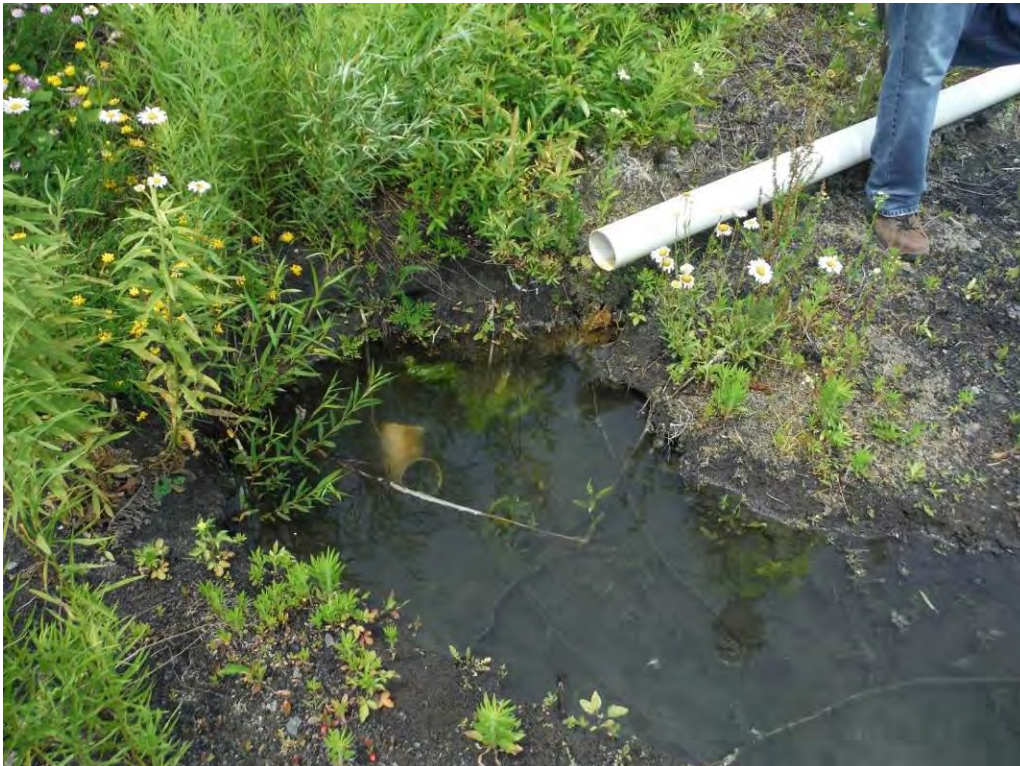
Dewatering Pump 4, at the east end of the north embankment, connects to an above-ground, soil-supported, partially buried, temporary, 700-foot-long, 4-inch-diameter PVC pipe running along the inside of the basin that discharges into Sub-basin B, seen in Photo 8. This pipe has been used to extend the discharge point of the pump line to free water since the basin is progressively being filled. No provisions for thermal expansion or contraction were observed and the 90 degree bend at the pipe discharge was unrestrained and unsupported, causing the 90 degree bend to separate from the pipe, resulting in a small erosion pocket adjacent to the crest. Talen reported that after the 2015 inspection, this pipe was shortened to discharge directly into the perimeter swale which eliminates the 90-degree bend and additional pipe length.

Photo 8 – PVC elbow disconnected from the 4-inch PVC discharge pipe from dewatering well 4, located on the upstream slope of Sub-basin B. Talen reported that a modified swale now conveys this discharge.

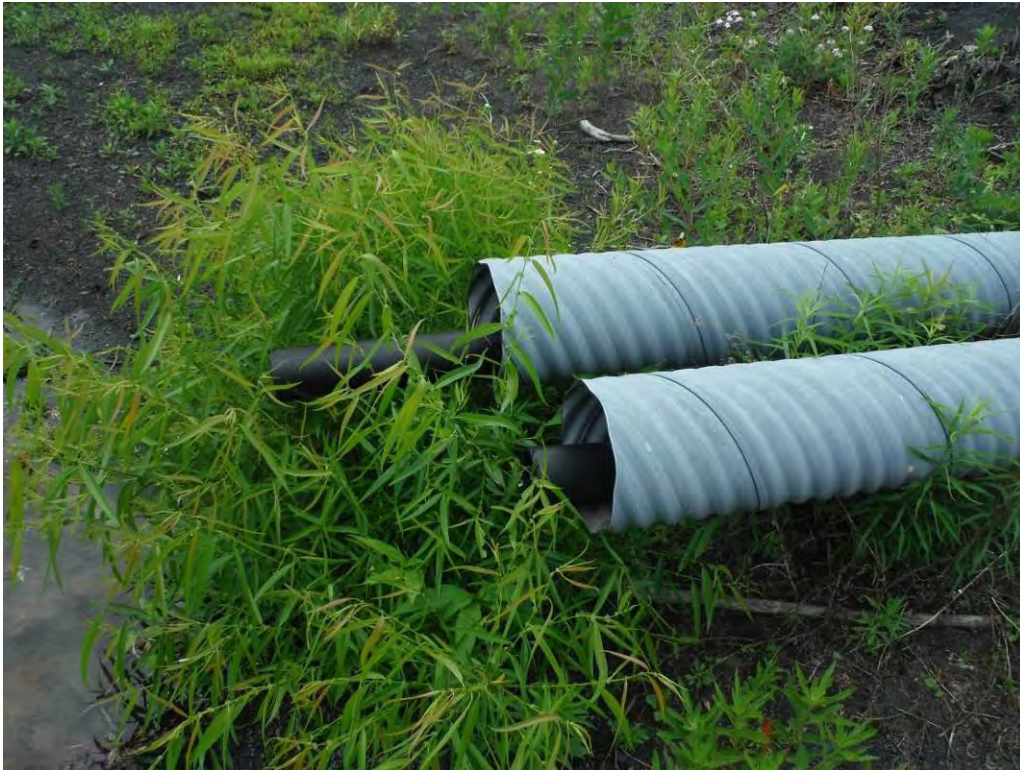
deposition was observed at the discharges although the wells do not discharge to a chamber where deposition can be readily observed, as seen in Photo 9. Thick brush was observed around each of the well discharge points, making it difficult to view the discharges clearly. The brush should be cleared.

Photo 9 - Middle dewatering well discharge area. No significant deposition was observed.

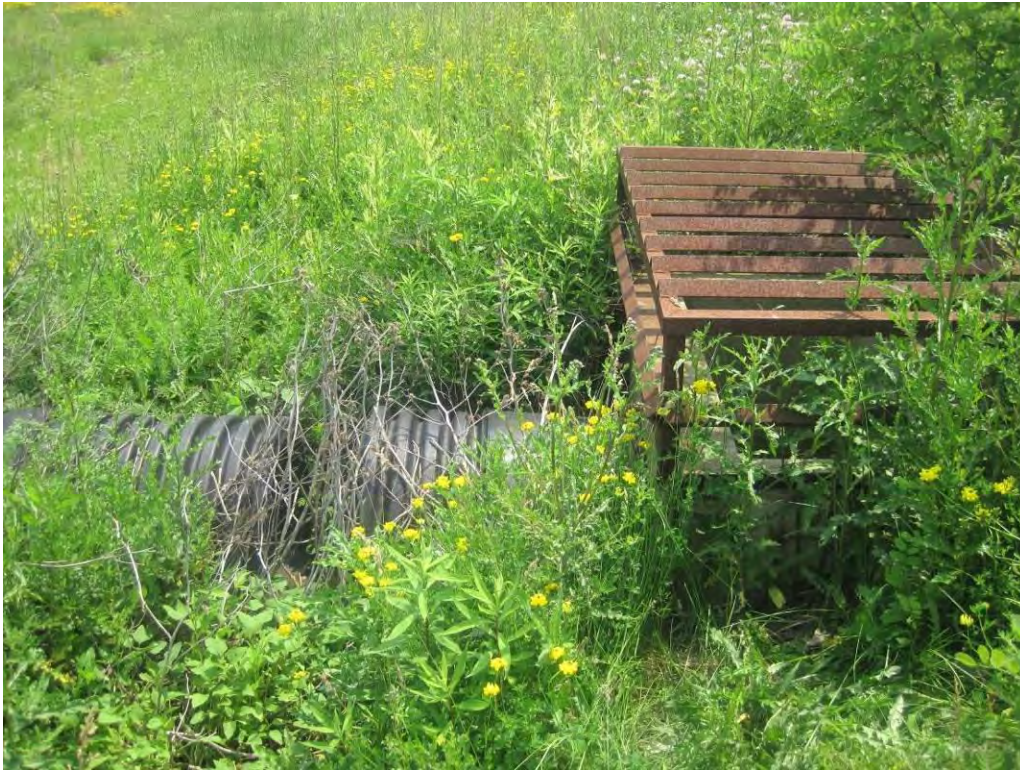
Photo 10 - Cut out in the catch basin drainage pipe in Sub-basin A that has the potential to fill with mud or debris. Talen noted that the pipes were capped subsequent to the inspection.

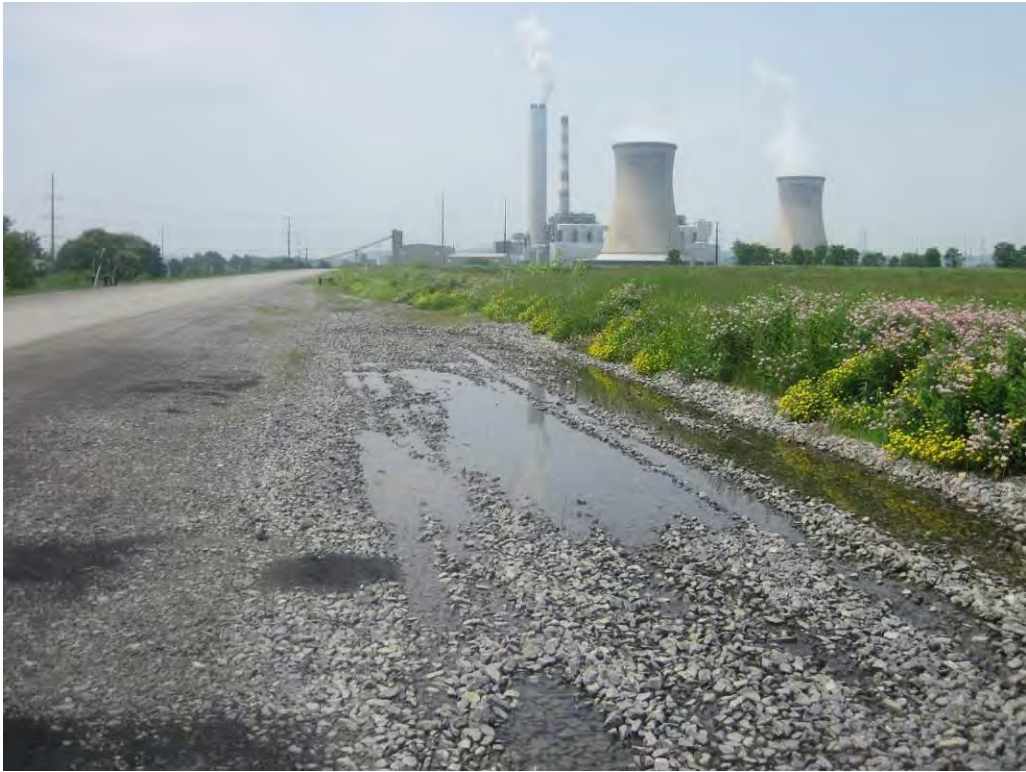
Photo 12 – The closed portion of Sub-basin A at the southeast corner of the ash basin. Note some minor surface runoff ponds along the Sub-basin A dike on the crest road. The crest access road has been regraded to slope toward Sub-basin A, and a drainage swale has been constructed in Sub-basin A dike to drain runoff from the crest access road.

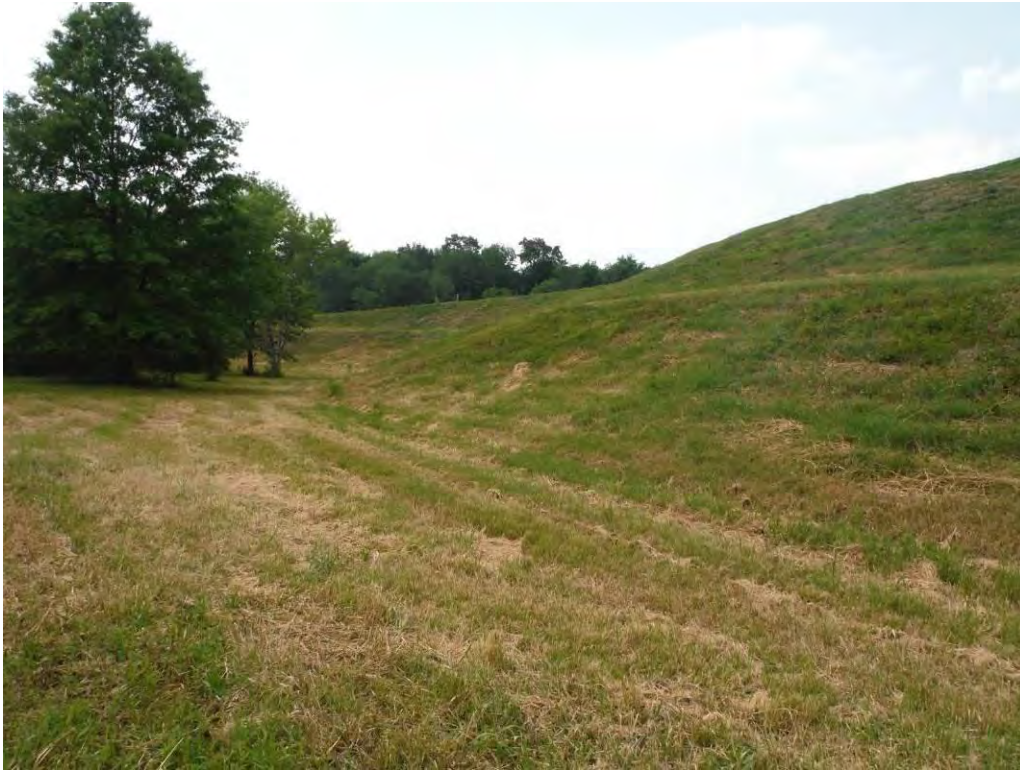
Photo 13 – North end of southwest embankment and access ramp. Wet areas observed in previous inspections along toe were observed dry or damp in 2015.

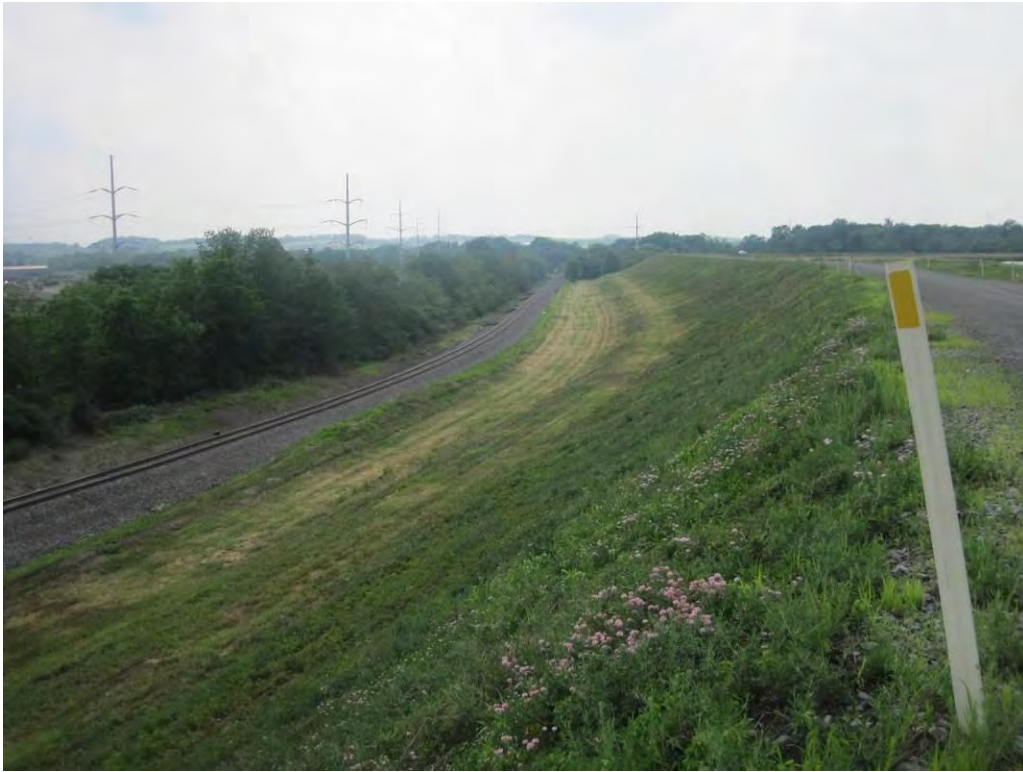
Photo 17 – Downstream slope of the southwest embankment, looking northwest from pipe bridge. Standing water had been observed previously along the stabilization berm where the tracks are, although this area was comparatively dry in 2015.

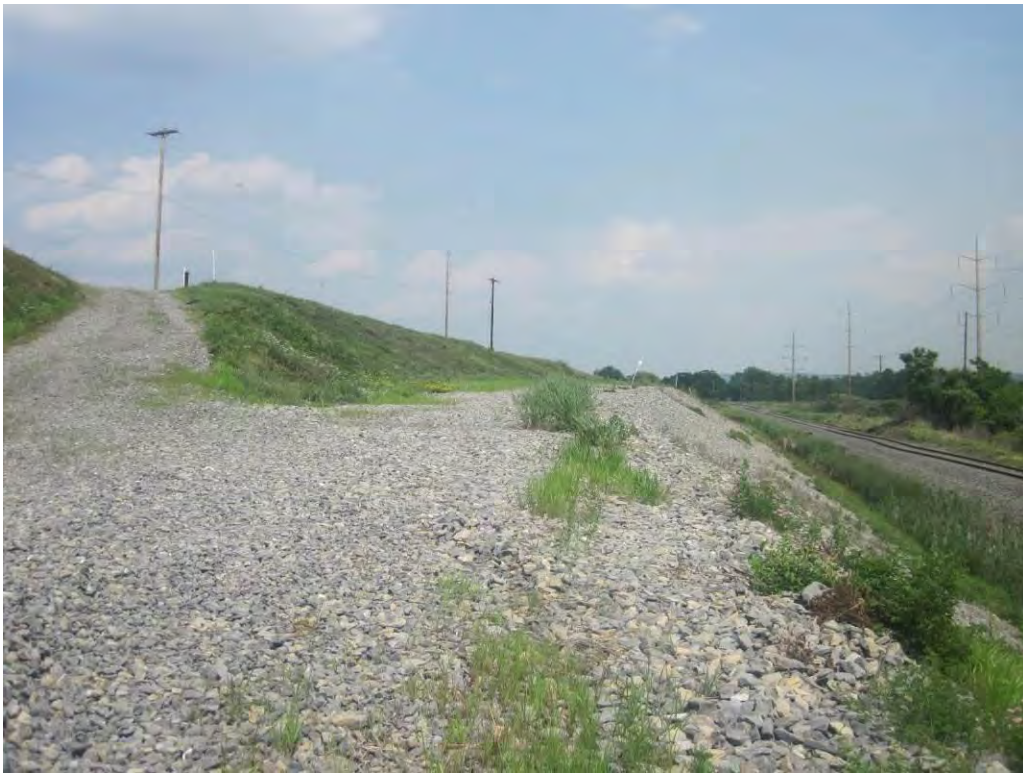
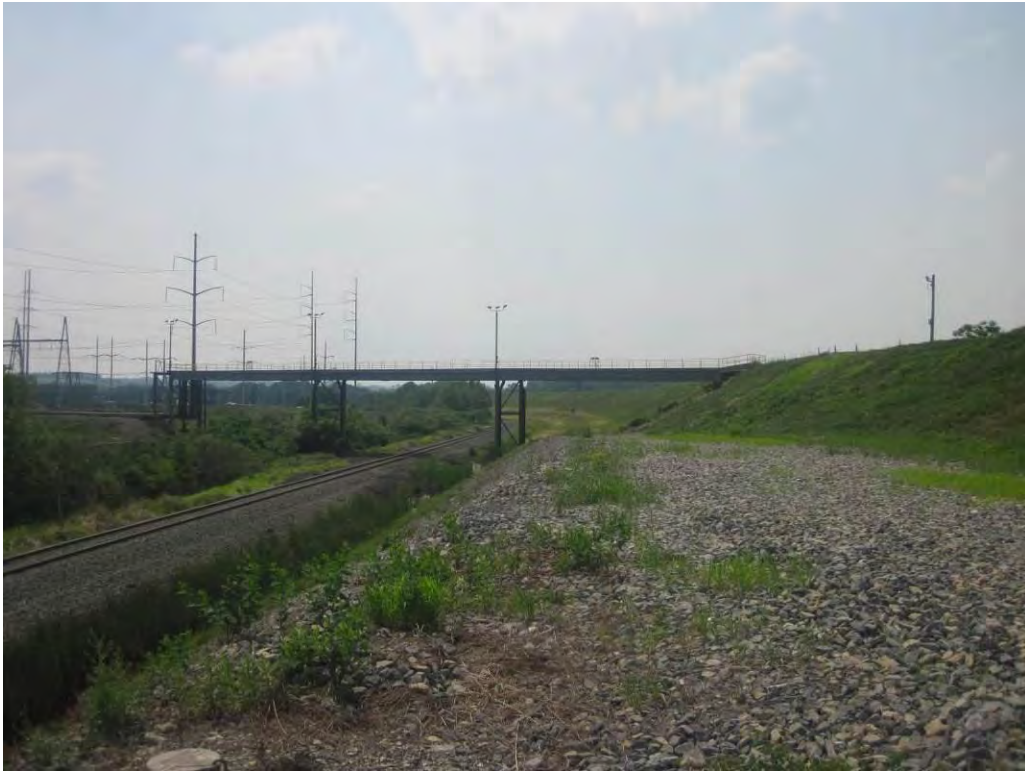
Low thorn trees covering the southwest embankment stabilization berm that were noted in previous reports had been cleared, and the slope was covered with stone. There was no evidence of the slope crack observed previously at the brink of the berm, although the stone

slope protection could have obscured cracking. The stabilization berm can be seen in Photos 18 and 19. Heavy vegetation along the toe south of the stabilization berm, approximately 20 to 35 feet wide, obscured observations during the inspection.

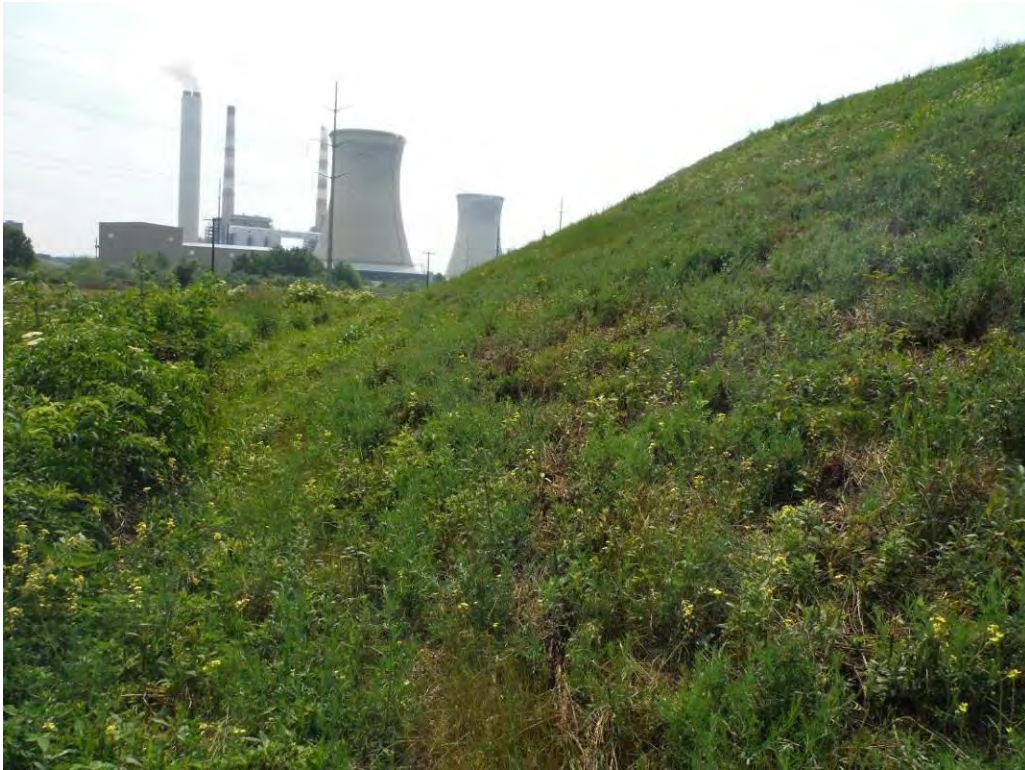
The south embankment was in good condition and can be seen in Photo 22. Wet soils were observed along much of the toe, and a wetland area at the toe extended from the southwest corner of the basin to near the east end of the south embankment. A wet area previously observed to be about 150 feet long had become overgrown as seen in Photo 20, and couldn't be viewed closely.

Photo 20 – Downstream slope of the southwest embankment, looking northwest from the southwest corner of Sub-basin A.–Note the vegetation overgrowing the embankment toe.

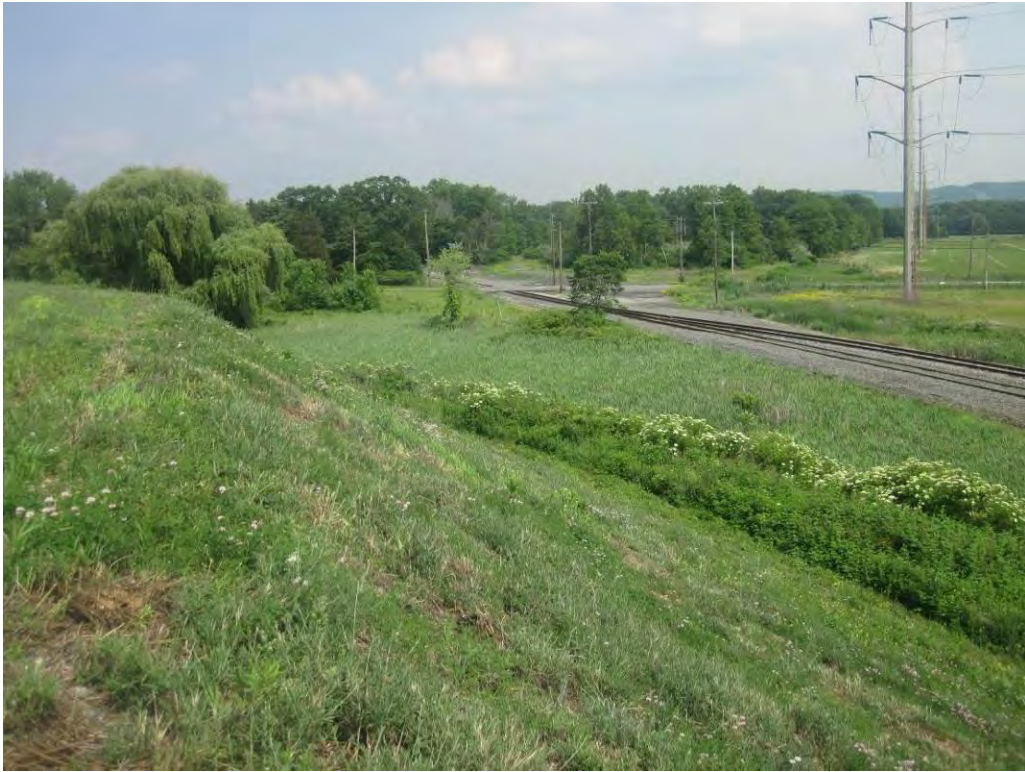
A depression at the west end of the south embankment was reported in 2008 and was observed again during the 2010, 2011, 2012, and 2013 inspections. The depression was not visible in 2014 and 2015 due to overgrown vegetation, as seen in Photos 20 and 21. The dimensions of the depression were previously estimated as approximately 3 feet in depth and 5 feet in diameter. A second depression, first reported in 2011, measuring about 5 feet in diameter and 18 inches deep and located about 100 yards to the east, at the toe, was not observed in 2013, 2014, or 2015 due to thick vegetation.

Photo 21 – Southwest corner of the basin, looking southeast. A depression noted in previous reports at southwest corner of the basin, measuring 5 feet wide by 3 feet deep, was not visible due to overgrown vegetation.

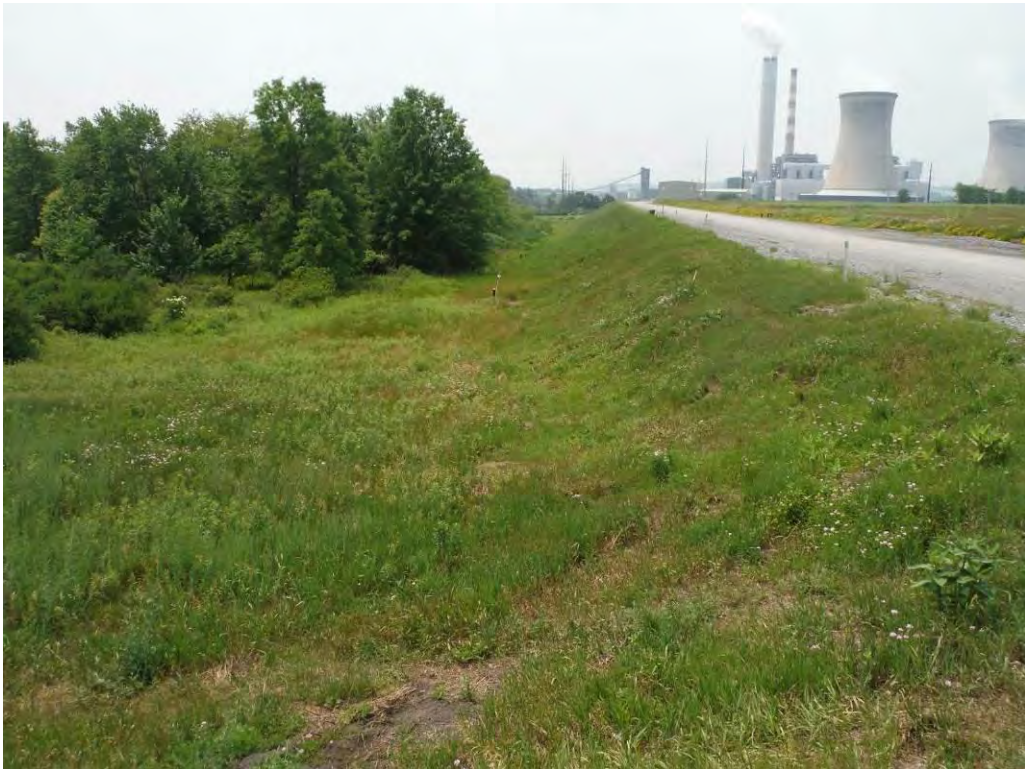
Photo 22 – The south downstream slope of Sub-basin A, looking west.

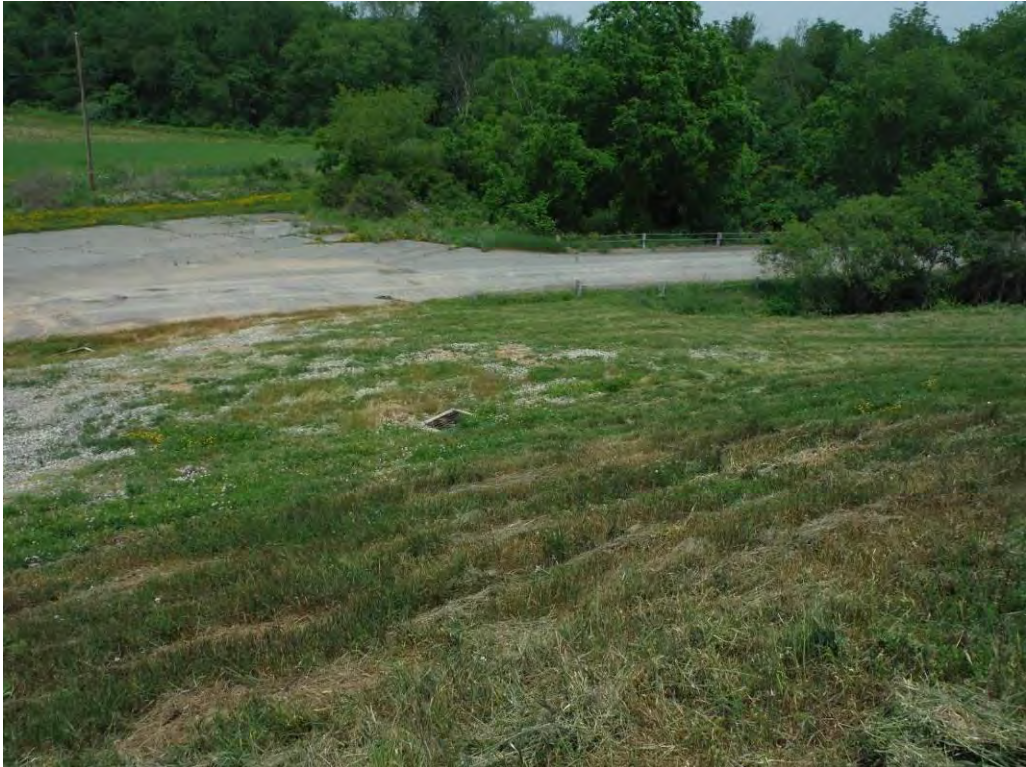
The north embankment was in good condition. The north embankment can be seen in Photos 24 through 29. A gravel stabilization berm is located at the east end of the embankment and extends intermittently to the west end. The vegetation was well trimmed, with the exception of a narrow band at the northeast corner of the embankment, seen in Photo 28. Vegetation in this area should be cut. The wet area in the gravel berm at the east end of the north embankment, initially reported in 2008, was observed in 2013 but not observed in 2014 or 2015. The wet area was previously reported to be about 50 feet long and was located about 50 feet northwest of Well 4. A stormwater runoff drainage system was installed several years ago in the northeast corner of the basin. This system includes a catch basin within Sub-basin B with a drain line extending across the crest of the north embankment, down the downstream slope, and across the toe access road to a discharge structure. Talen reported that the stormwater pipe has since capped at the upstream end. There are two catch basins to the east of Dewatering Well 4 on the downstream slope of the north embankment. Groundwater was observed to be flowing into both catch basins from pipe penetrations that had not been properly sealed. The groundwater inflow into the catch basin is unfiltered and has the potential to wash fine soil into the catch basins, as evidenced by a small depression in the ground surface over the leaking penetration of the catch basin, adjacent to the toe access road that may be the result of piping and subsidence. Although it is unlikely that a significant amount of

Photo 24 – Alignment of the drain line at the east end of the north embankment. The two lower catch basins can be seen. Both catch basins had seepage entering the basin from improperly sealed penetrations, with surface subsidence above.

soil could wash in quickly, the pipe penetration into the lower catch basin should be sealed. Talen also noted that they had reviewed drawings, construction records, and pipe inspection videos, and it appeared that the east drain line that feeds into the catch basin for Dewatering Well 4 was cut when the stormwater drain piping was installed. The dewatering system drain line was rerouted under the stormwater drain line.

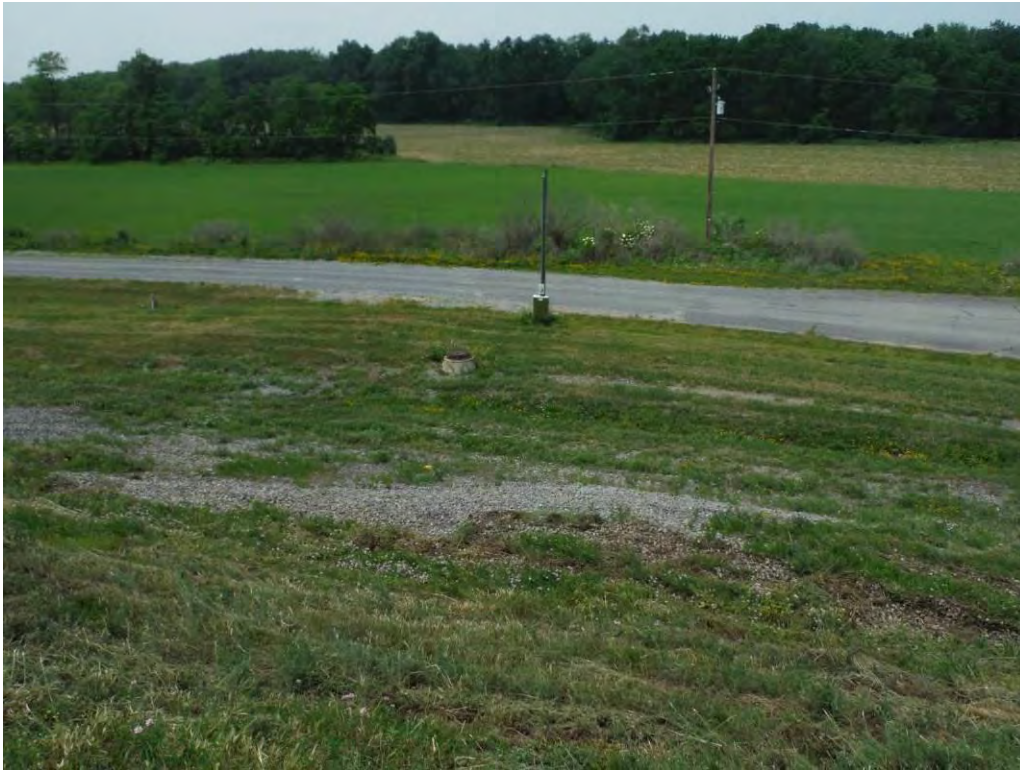
Photo 25 – East end of north embankment, showing gravel stabilization berm and the manhole that houses dewatering well 4. Wet areas have previously been observed here, and were damp during the 2015 inspection.

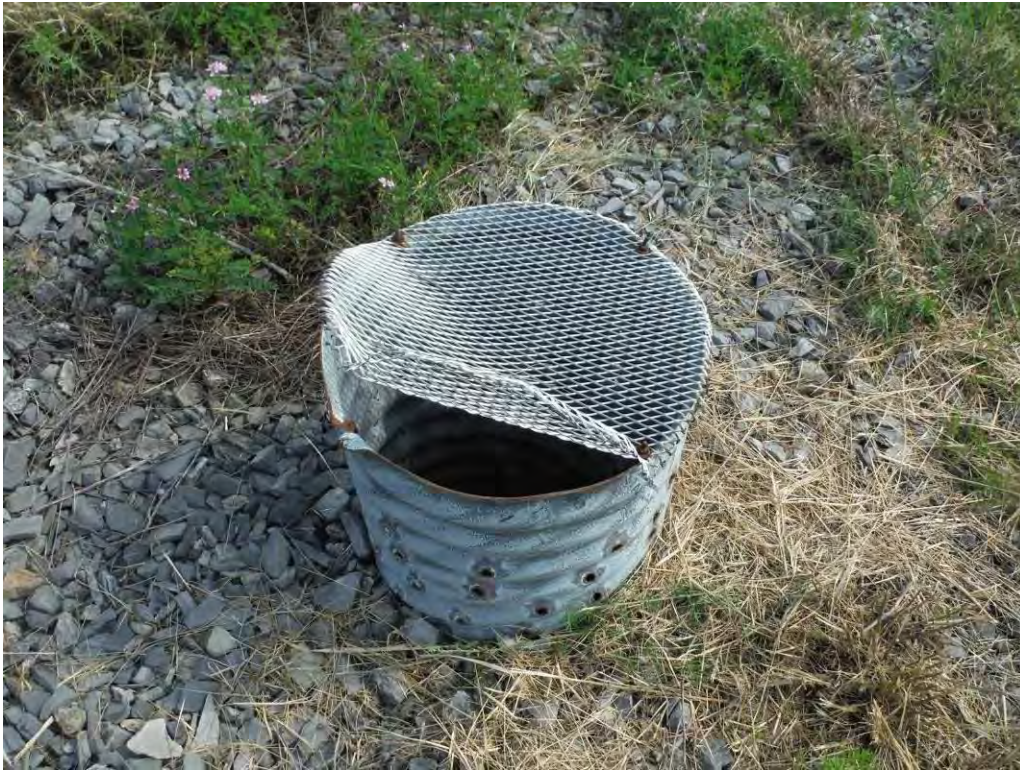
The ditch adjacent to Well 1 was drier than previous years, as seen in Photo 29. In past years the ditch was full of water indicating that the pump is either not working or is not completely effective in draining the embankment toe. Talen reported that this pump had been repaired in 2013 and the ditch was dry during the 2013 inspection. The surface of the north embankment gravel stabilization berm is irregular, as reported previously, although there is no evidence that this is the result of foundation subsidence as suggested in a previous report, or slope instability. None of the four permanent dewatering well pumps were observed to be pumping during this inspection, though water could be heard trickling into the wells at Pump Nos. 1, 2, 3, and 4, indicating they had been in operation recently. The outlets of Dewatering Wells 1 and 3 were overgrown and should be cleared. The discharge for Dewatering Well 2 is cantilevered a significant distance. Support should be added to prevent the line from breaking as a result of snow or ice loading. The elbow on the discharge for Dewatering Well 4 has become detached and should be repaired. The catch basin screen on Dewatering Well 4 has been partially pried off and should be reattached.

Photo 29 – The ditch near the west end of the north embankment, adjacent to dewatering Well No. 1. Note the damaged screen on the top. The ditch was drier than previous years.

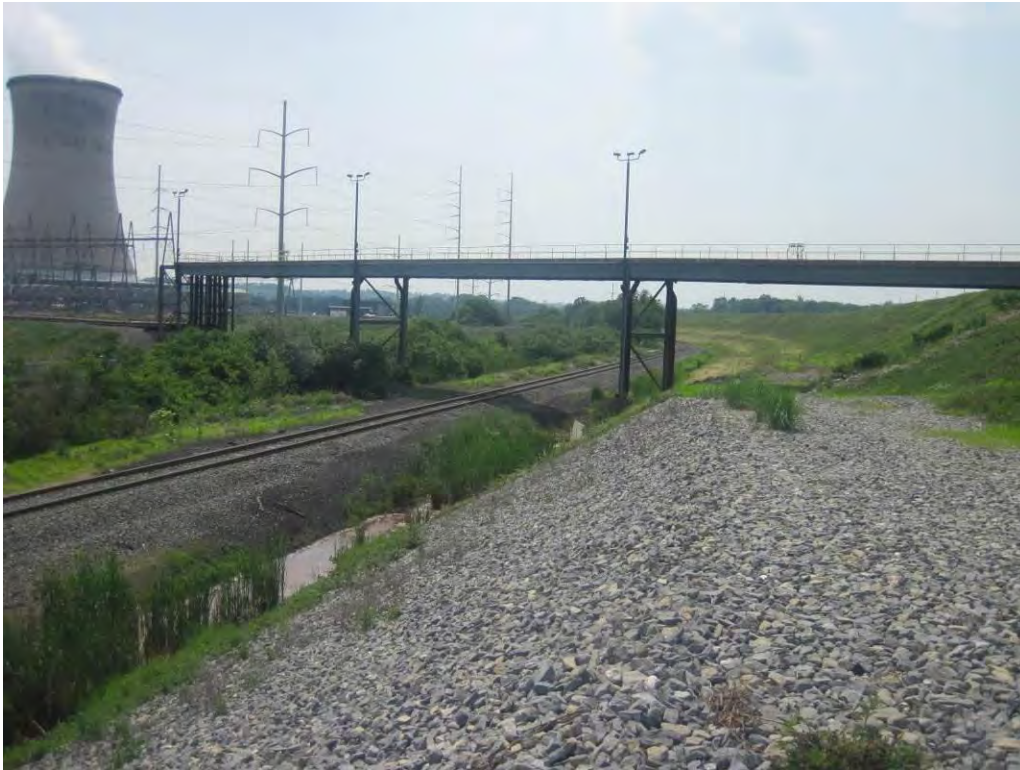
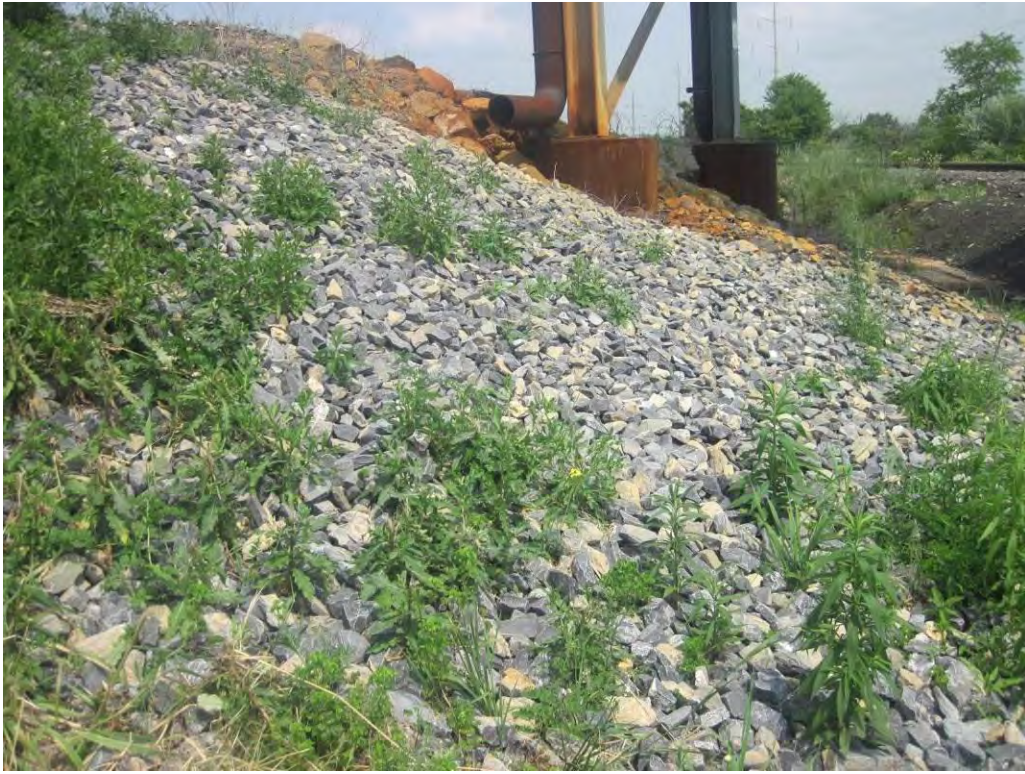
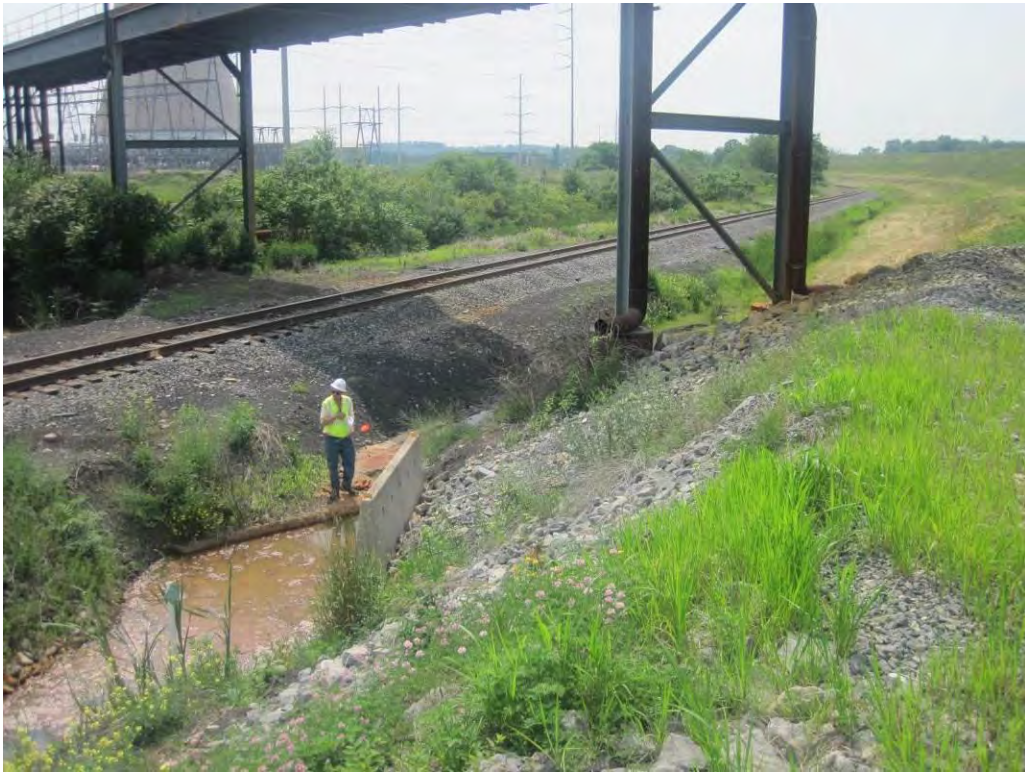
The pipe bridge appeared to be in good condition with no signs of movement. The pipe bridge and supports can be seen in Photos 30 through 32. The grout pad supporting the southeast corner of the bridge had deteriorated and should be repaired. The grout pad at the northeast corner was also deteriorated, but the grout pad was not as thick, and the deterioration was not as severe, and it did not appear that repairs of this grout pad were necessary immediately. The 4-foot-diameter, 2-foot-deep scour hole slightly to the north of the bridge that was observed and likely the cause of a recent leak in one of the pipes in 2014 had been repaired. There was no evidence of additional scour in that area.

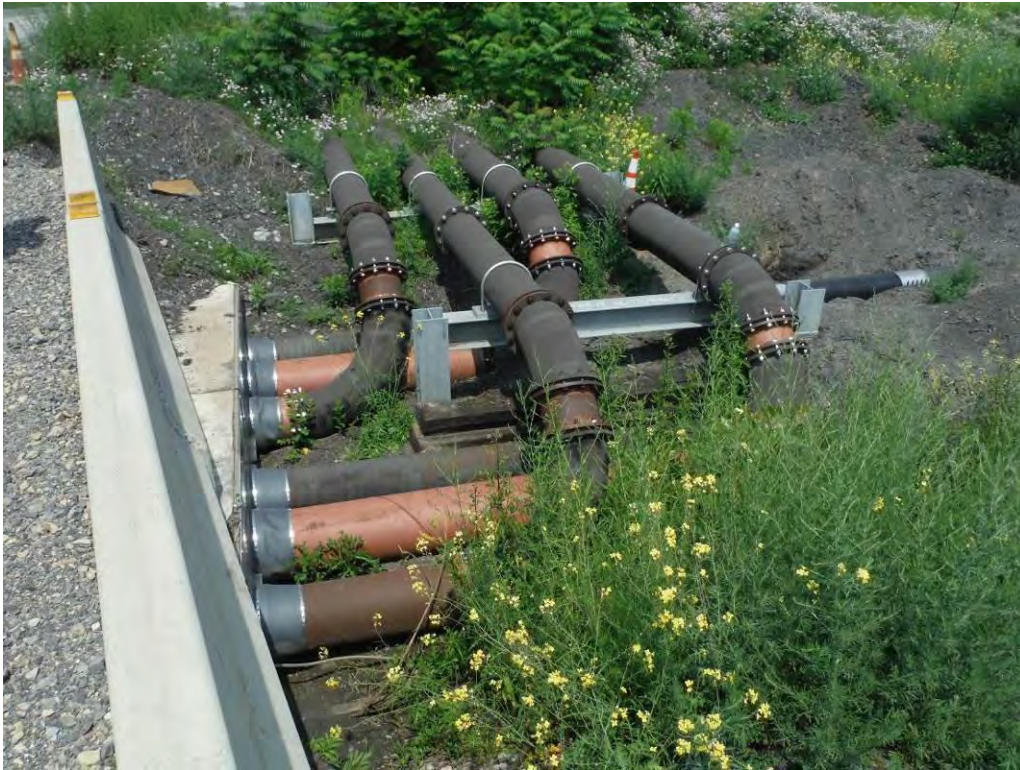
The ash discharge piping was previously supported on stacks of timbers where it left the bridge and turned 90 degrees towards the ash processing area. Talen replaced the unstable cribwork supporting the ash discharge piping, as seen in Photo 33. The new pipe supports are constructed of structural steel.

Photo 33 – Cribbing at discharge pipe bend near bridge abutment, which was modified in 2014.

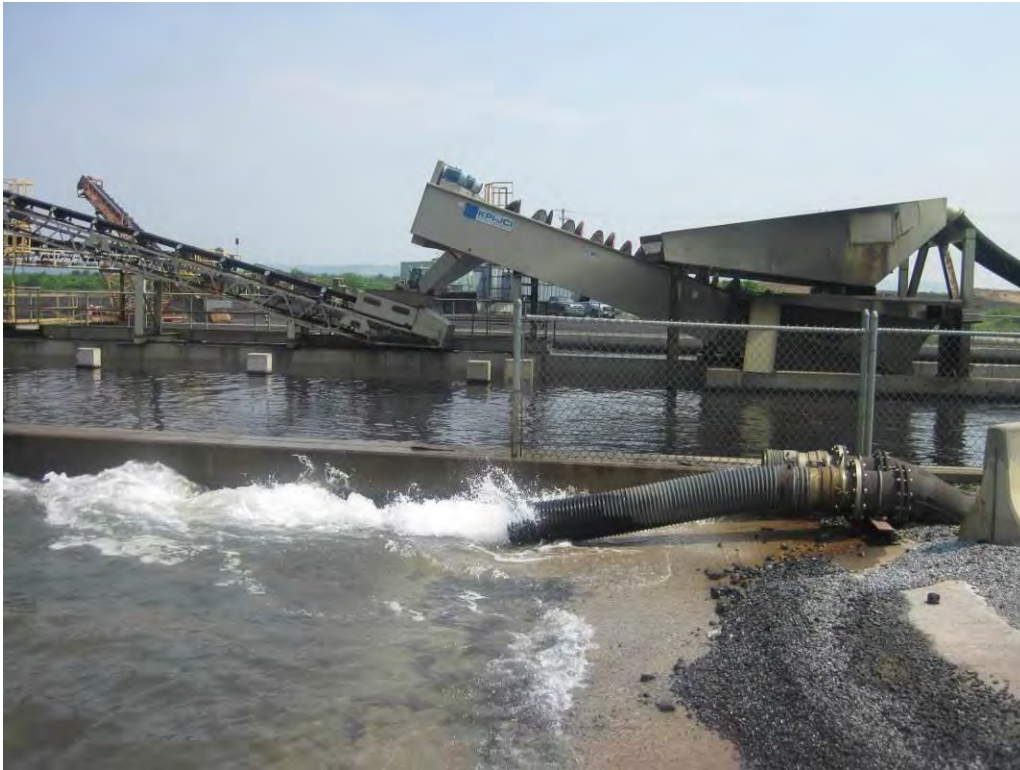
The slurry ash-settling trough can be seen in Photo 34. The slurry handling facilities generally appear well constructed and well managed. The settling troughs are located in an area of Sub-basin B elevated approximately 7 feet above the top of the embankment. Overtopping of the sub-basins as a result of the basins filling with ash, a breach forming around the discharge hose, or a discharge hose coming loose could result in overtopping of the embankment. The sluice pipeline runs along the embankment between the utility bridge and the discharge structure and has the potential to cause significant erosion were it to break. These concerns warrant additional attention when monitoring this area, including observing during periodic inspections the amount of ash fill in the basins, the condition of the discharge hose and contact area, and the condition of the sluice pipeline running along the embankment.

Photo 34 – Ash discharge area, showing the settling basins.
