January 15, 2016

390/265831

**Subject: 2015 Annual (Initial) USEPA CCR Surface Impoundment Inspection Report
Montour Ash Basin No. 1**

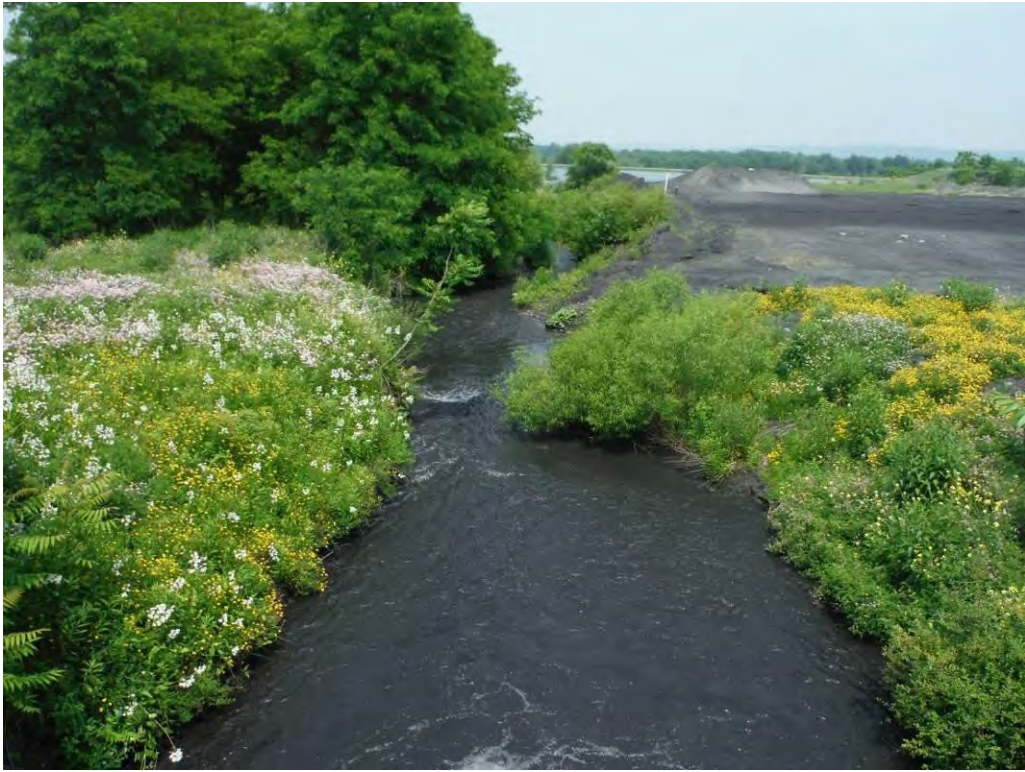
The side slopes of the discharge channels extending from the ash reclamation area to Sub-basin B are steep and potentially unstable, as seen in Photo 35. A failure of the channel slopes could restrict the channel. Although it seems likely that the discharge would be able to re-route itself to Sub-basin B without an issue in the event of a partial collapse of the channel walls, this area should be monitored and the channel stabilized as needed.

Photo 35 – Discharge channel from the ash slicing area to Sub-basin B. Note the narrow channel and steep side slopes.

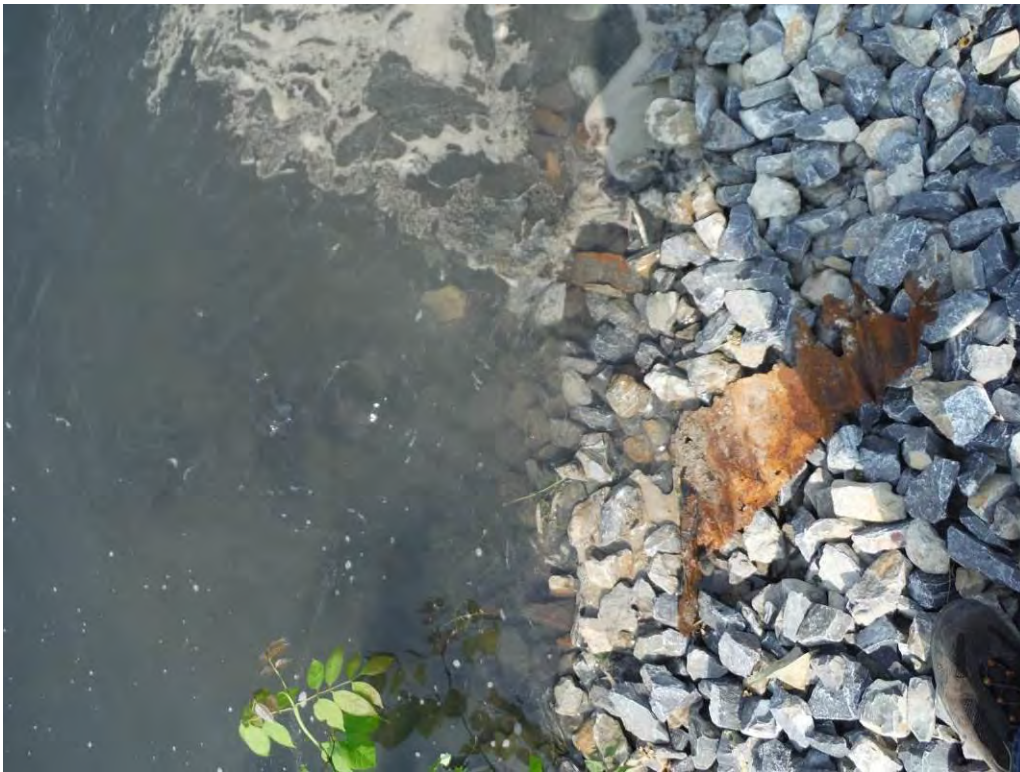
Photo 38 – Abandoned, corroded CMPs in the splitter dike. –Boil observed at outlet of one abandoned pipe.

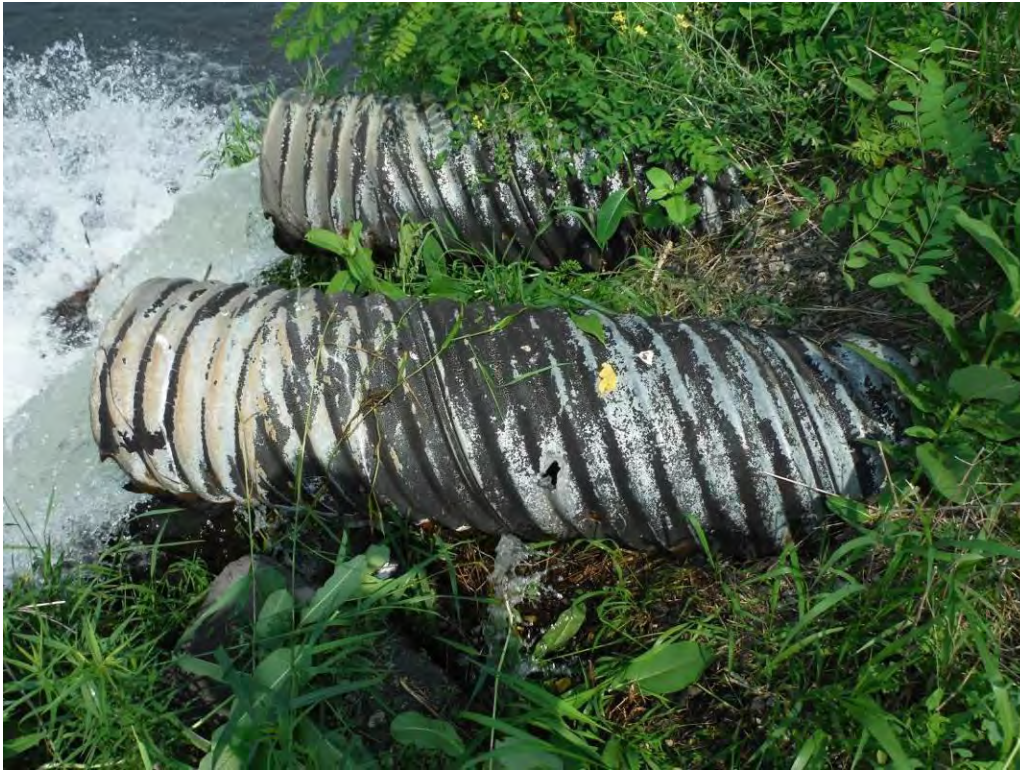
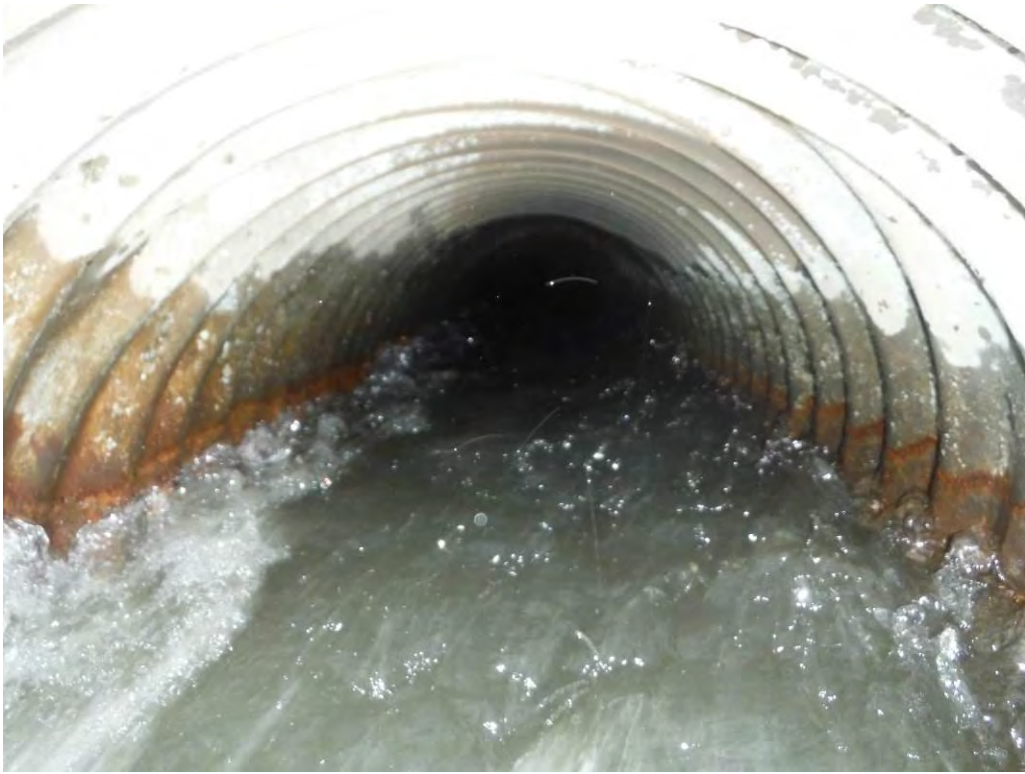
The splitter dike between Sub-basins B and C was in good condition and Talen recently raised the crest and placed new riprap on the steep downstream slope. The dike is broad, so that a shallow failure of the steep downstream slope will not affect the stability of the dike, and, in any event, Sub-basin C should be able to contain any inflow resulting from a failure. It is possible that a slope failure could damage the discharge piping; therefore, continued remote monitoring of the Sub-basin B water level for abnormal increases is important. The downstream face of the dike is shown in Photo 36. The upstream end of the 24-inch CMP inlet to the discharge structure in the splitter dike between Sub-basins B and C was replaced with HDPE pipe in 2014. A debris float was installed surrounding the intake pipe, and the intake was free of debris as seen in Photo 37. Talen installed a trash rack at the upstream end of the intake subsequent to the 2015 inspection, as seen in Photo 37a of Appendix A. The deck of the intake structure had been previously jacked up by over-extension of the gate stem and was no longer plumb after lowering the gate stem. Several of the CMP discharge pipes at the downstream slope of the splitter dike were observed to be corroded and abandoned. These CMP discharge pipes, previously observed with under-seepage, were no longer flowing and it appeared that the upstream ends had been sealed. However, a boil was observed at the downstream end of one of the abandoned pipes, as seen in Photo 38. This boil should be monitored. The origin of these pipes is not clearly documented. There is little differential head acting on the splitter dike, and any discharge, were it to occur, would be contained by the exterior dike around Sub-basin C. If monitoring shows excessive flow or signs of internal erosion, the abandoned pipes should be excavated and removed. The two active 18-inch CMP discharge pipes of the splitter dike discharge structure exhibited signs of corrosion at the downstream end, as seen in Photos 39 and 40. Discharge was observed flowing from

punctures at the ends and sides of the discharge pipes, though the observed punctures have no impact on the reliability of the piping. Access to the downstream end of these pipes should be provided by clearing vegetation and adding a landing at the pipe outlet to more readily allow visual observation of the pipe condition.

Photo 39 – Active splitter dike discharge pipes exhibited signs of corrosion.

Photo 40 – Splitter dike discharge pipes exhibited signs of corrosion, view of the pipe interior from downstream end.
