Dam Failure Analysis and 2016 Initial Hazard Potential Classification

Brunner Island Ash Basin No. 6

Prepared for:
Brunner Island, LLC

September 29, 2016

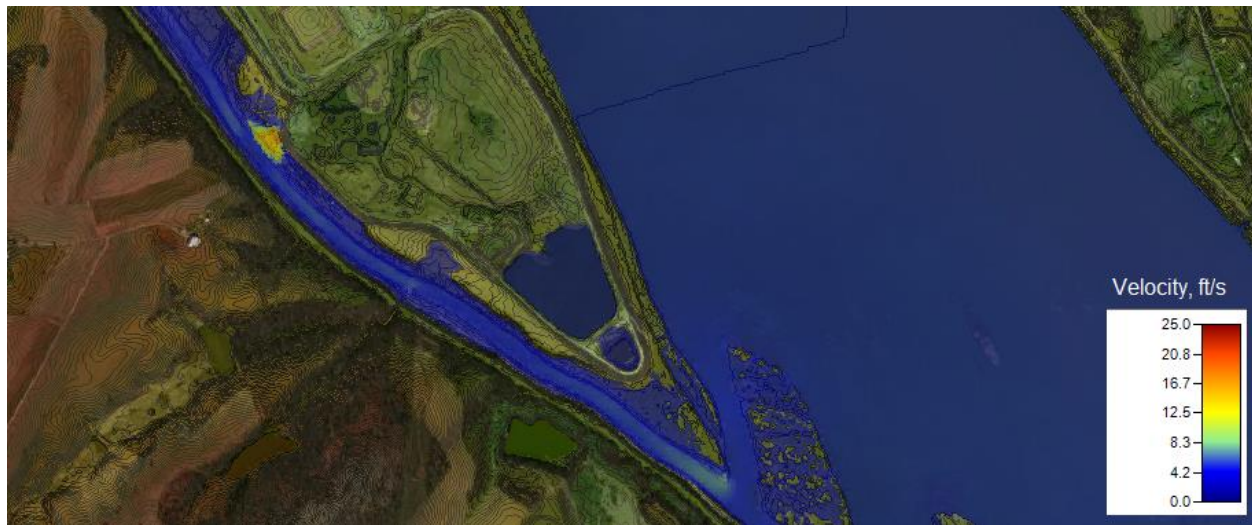
Figure 3.3-1 HEC-RAS 2D Dam Failure Simulation – Northwest Sunny Day Breach Scenario

The dam failure simulations for the Sunny Day condition resulted in a localized increase in water surface elevation in the Susquehanna River main stem and bifurcation channel immediately surrounding the Project location. The incremental increase in water surface did not travel downstream of the Project or result in a backwater impact up the bifurcation channel past the project extent. Figure 3.3-1 and Figure 3.3-2 show the Sunny Day breach peak velocity at the northwest and northeast breach locations.

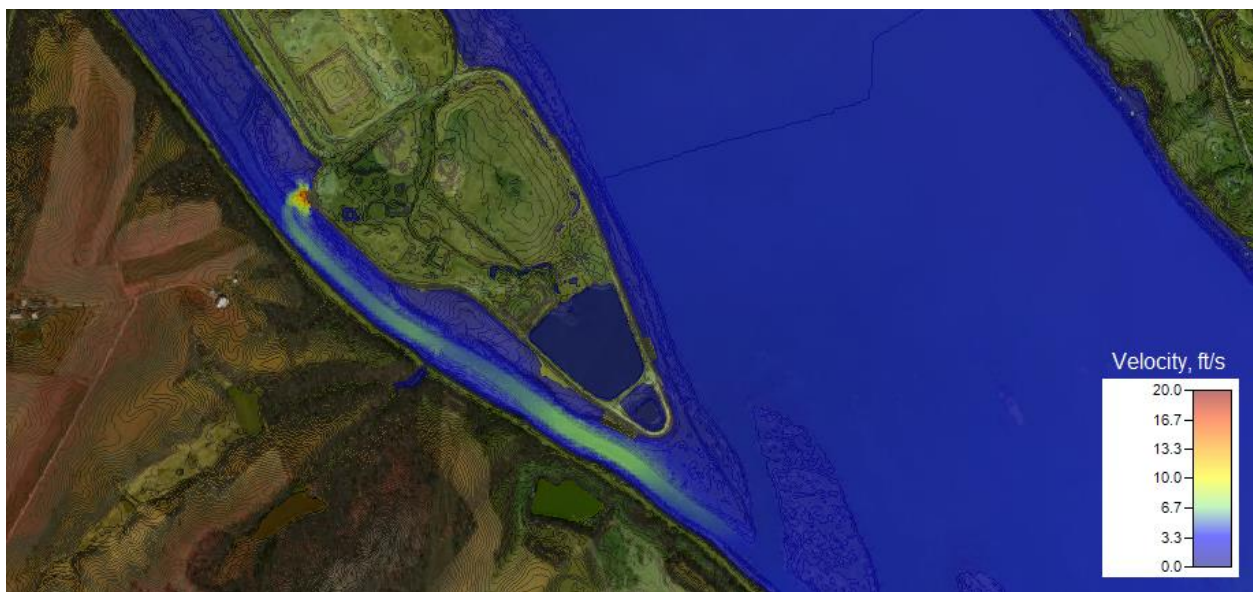
Figure 3.3-3 HEC-RAS 2D Dam Failure Simulation – Northwest IDF Breach Scenario

The dam failure simulations for the IDF condition resulted in increased velocity and increased water surface elevation of less than two feet immediately surrounding the breach location of each simulation, but did not result in an increase in peak water surface elevation in the Susquehanna River main stem of more than a tenth of a foot as the river was already elevated to the 100-year water surface elevation and the IDF breach flood wave was quickly dissipated. Figure 3.3-3 and Figure 3.3-4 show the IDF breach peak velocity at the northwest and northeast breach locations.

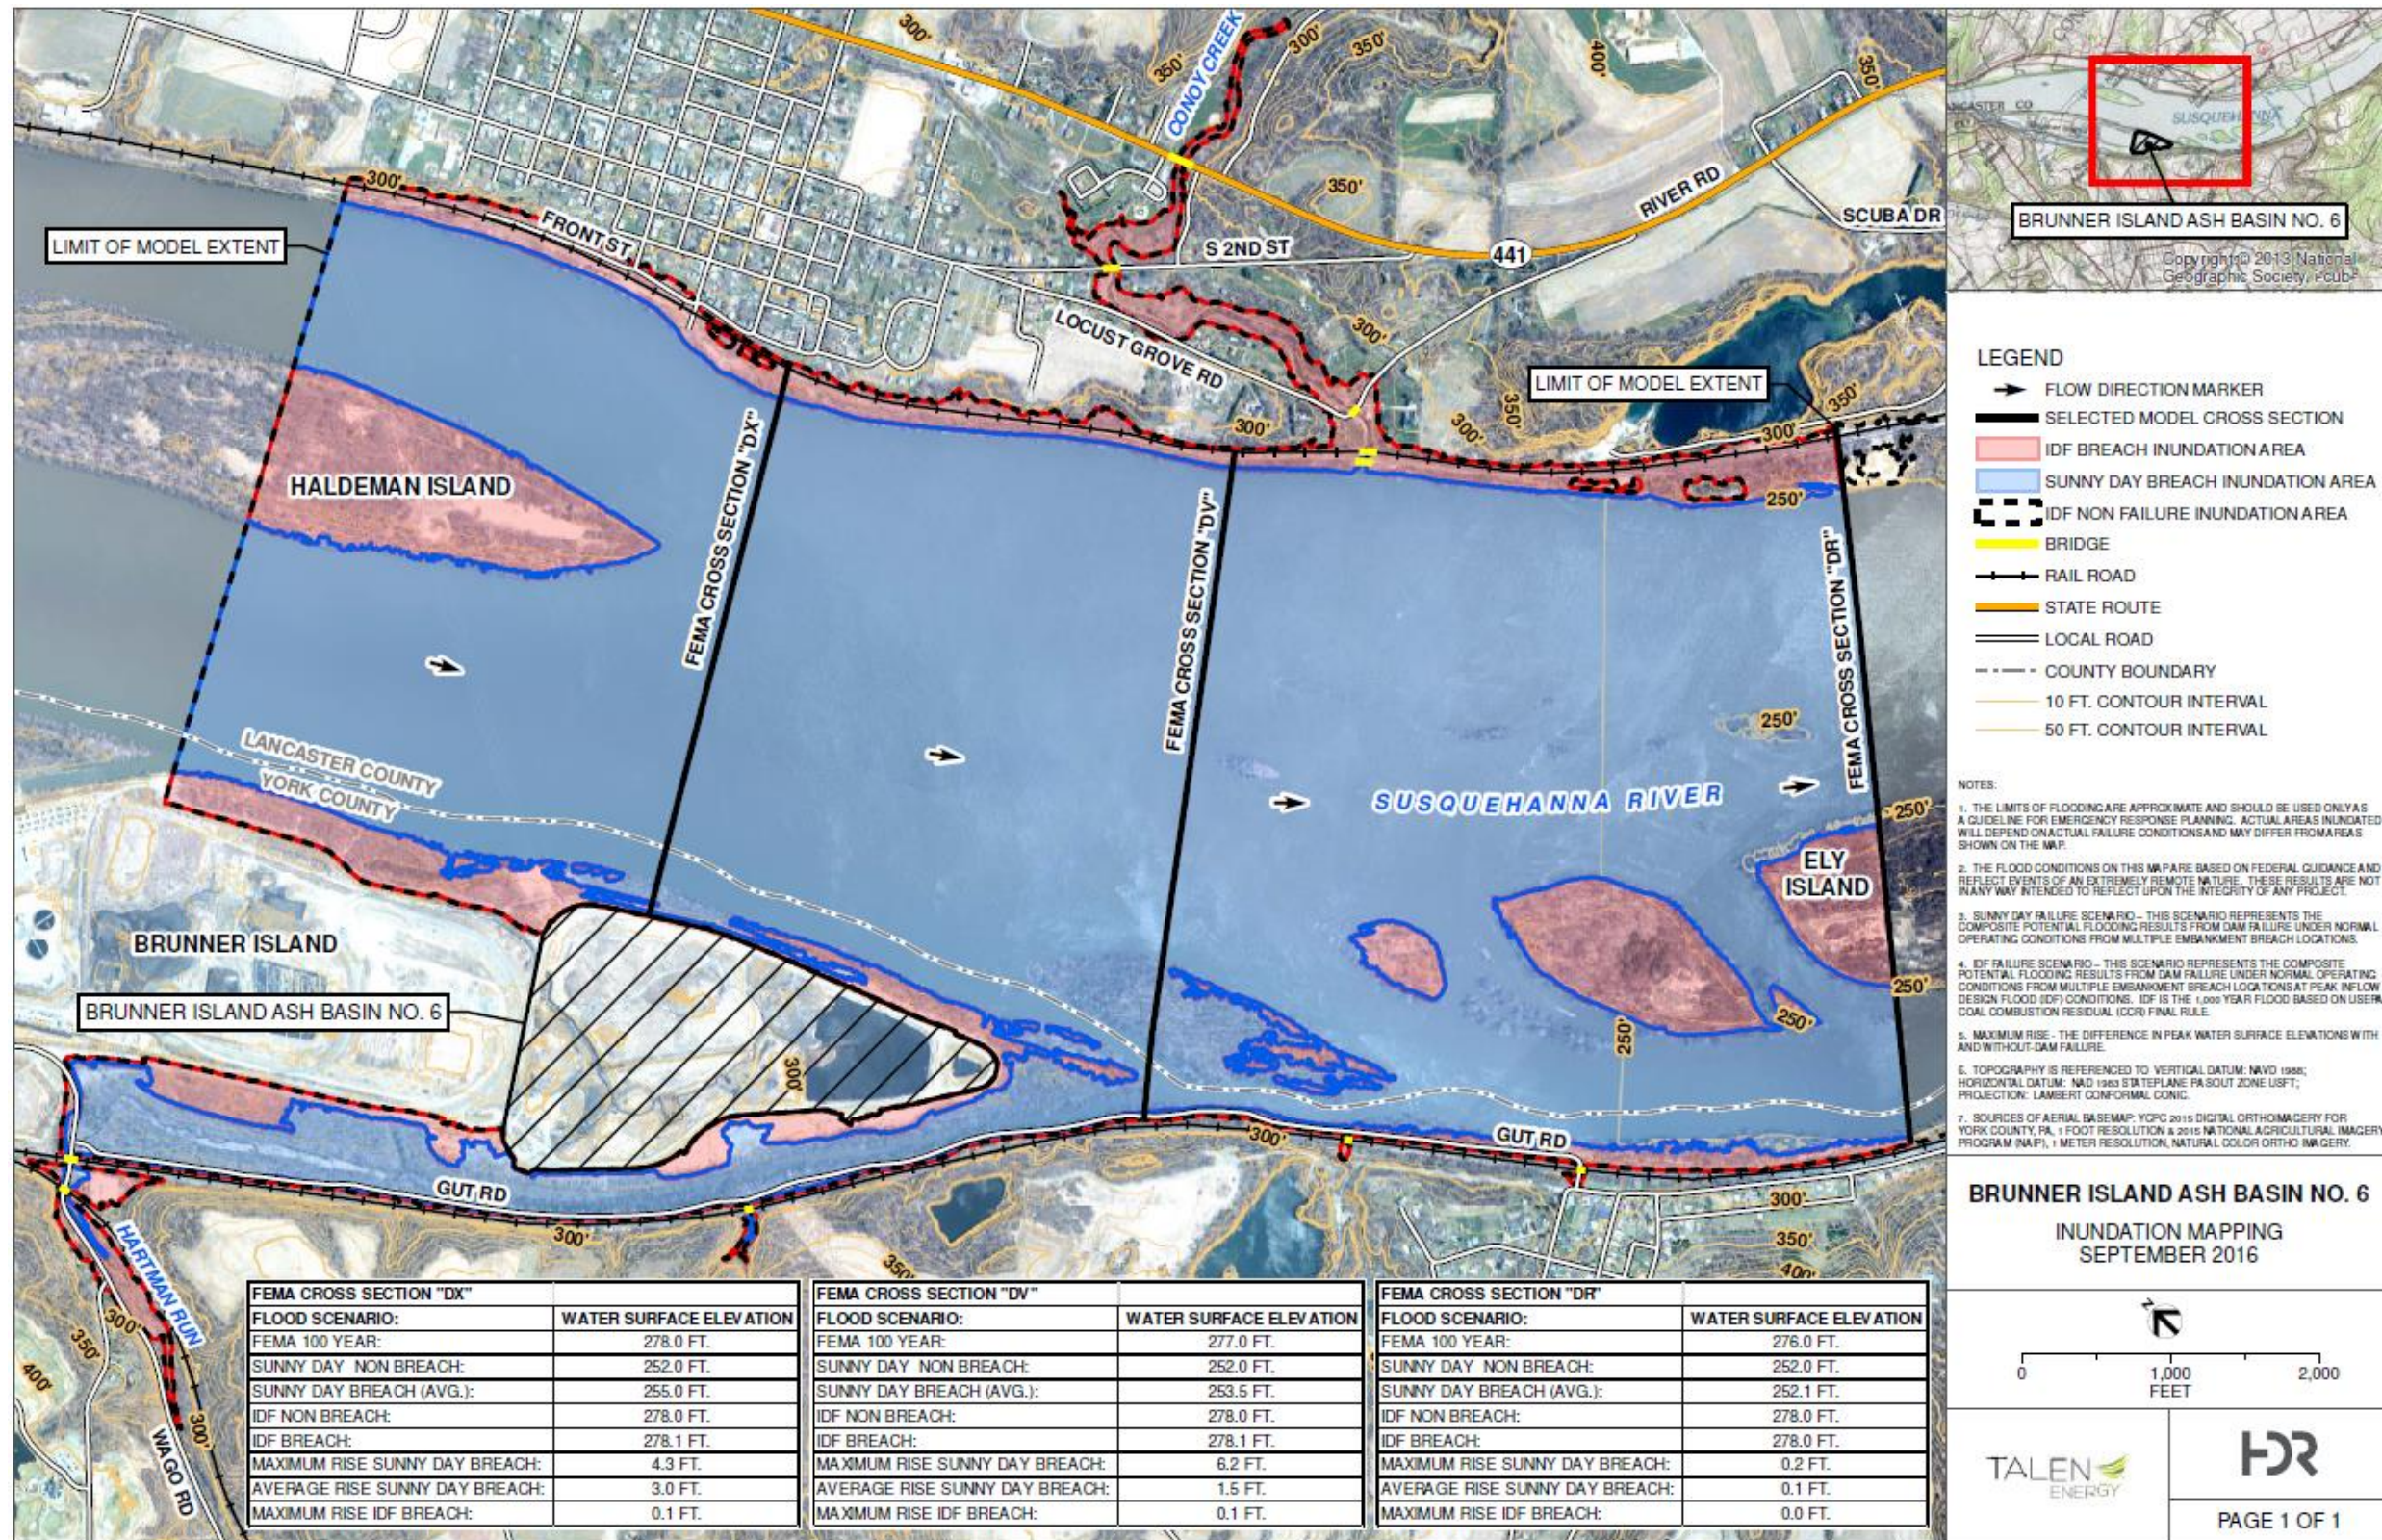
Figure 3.3-5 Inundation Mapping Resulting from Dam Failure Analysis

The key objective of inundation mapping is to depict and delineate the extent of potential flooding as a result of the selected hydraulic conditions. Incremental flooding, defined as the rise in water surface elevation from the base (normal) condition to the maximum stage that is associated with the failure of a hydraulic structure, identifies the areas downstream of the hydraulic structure that may result in potential population at risk. Figure 3.3-55 shows the water surface inundation extent for the Sunny Day and IDF conditions under both normal inundation and breach scenario inundation. The Sunny Day inundation extent is the same for both normal and postulated breach scenarios, staying within the river bank. The IDF inundation extent is also the same for both normal and postulated breach scenarios. Under the IDF inundation the river is already inundated to the 100-year flood limits, and the postulated IDF breach does not inundate further inland than the 100-year flood limits. There is no increase to the inundation area under both the Sunny Day and IDF conditions resulting from a postulated breach of the Ash Basin No. 6.

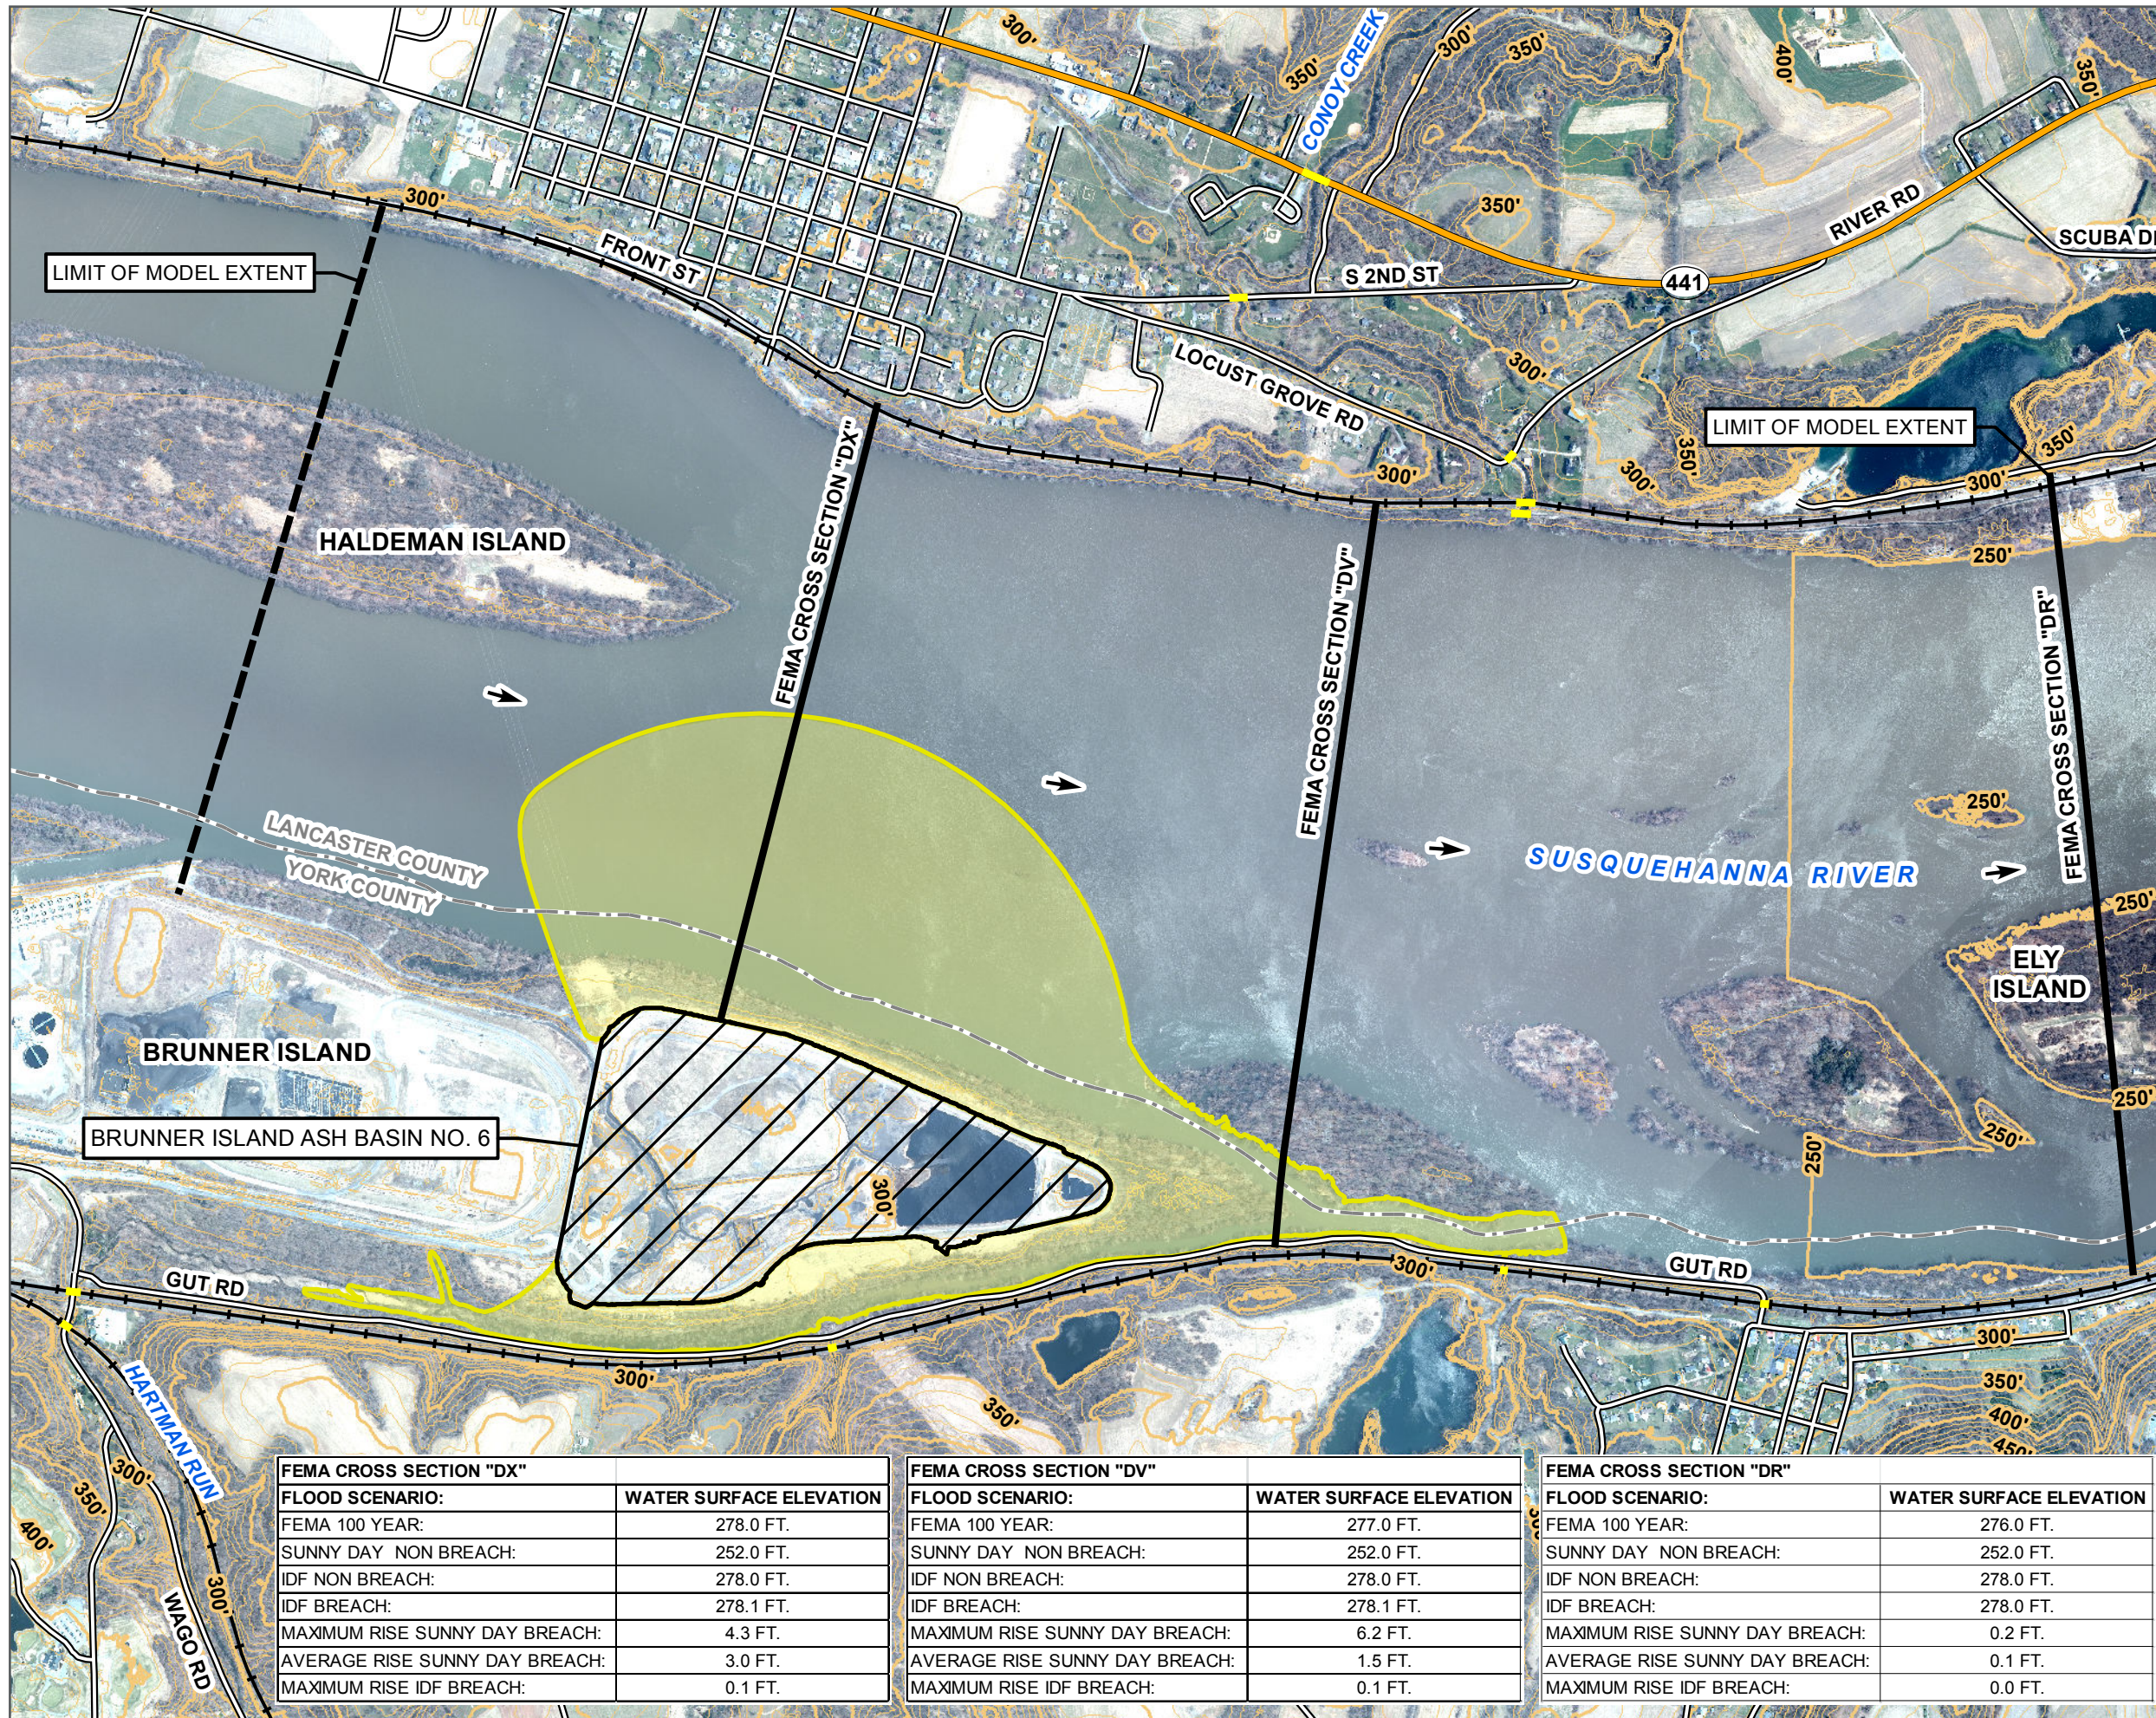
BRUNNER ISLAND ASH BASIN NO. 6
HAZARD INUNDATION MAPPING
SEPTEMBER 2016

The downstream limits of potential hazard impact, as determined by an incremental rise in water surface elevation greater than two feet between the normal and the postulated breach condition for the Sunny Day scenario, terminates immediately downstream of Ash Basin No. 6 where the bifurcation creek and the main stem of the Susquehanna River converge.

The downstream limits of potential hazard impact for the IDF scenario terminates immediately surrounding the Ash Basin No. 6 perimeter dike breach. The model results do not show a significant downstream potential hazard impact under the IDF conditions, as the Susquehanna River is assumed to be at the 100-year flood water surface elevation and the breach volume dissipates to the river.

This analysis indicates that there are no occupied structures or regularly occupied areas within the hazard inundation zone; therefore, there is no probable loss of human life indicated as a result of a failure of the Ash Basin No. 6 perimeter dike. A failure of the ash basin could result in significant economic loss as a result of damage to the basin and interference with plant operations, environmental damage as a result of inflow of ash to the Susquehanna River, or disruption of lifeline facilities as a result of erosion damage to the adjacent transmission line towers or natural gas supply line to the Brunner Island Steam Electric Station. Ash Basin No. 6 is, therefore, classified as having a significant hazard potential in accordance with the requirements of the CCR Final Rule. The IDF corresponding to the 1,000-year flood, as initially assumed for this analysis, is appropriate. The inundation map prepared for this study can be used to support the future development of an EAP, in accordance with the USEPA Final Rule.
