INITIAL STRUCTURAL STABILITY ASSESSMENT REPORT

ASH BASIN NO. 1

**MONTOUR STEAM ELECTRIC STATION
DERRY TOWNSHIP, MONTOUR COUNTY, PENNSYLVANIA**

October 13, 2016

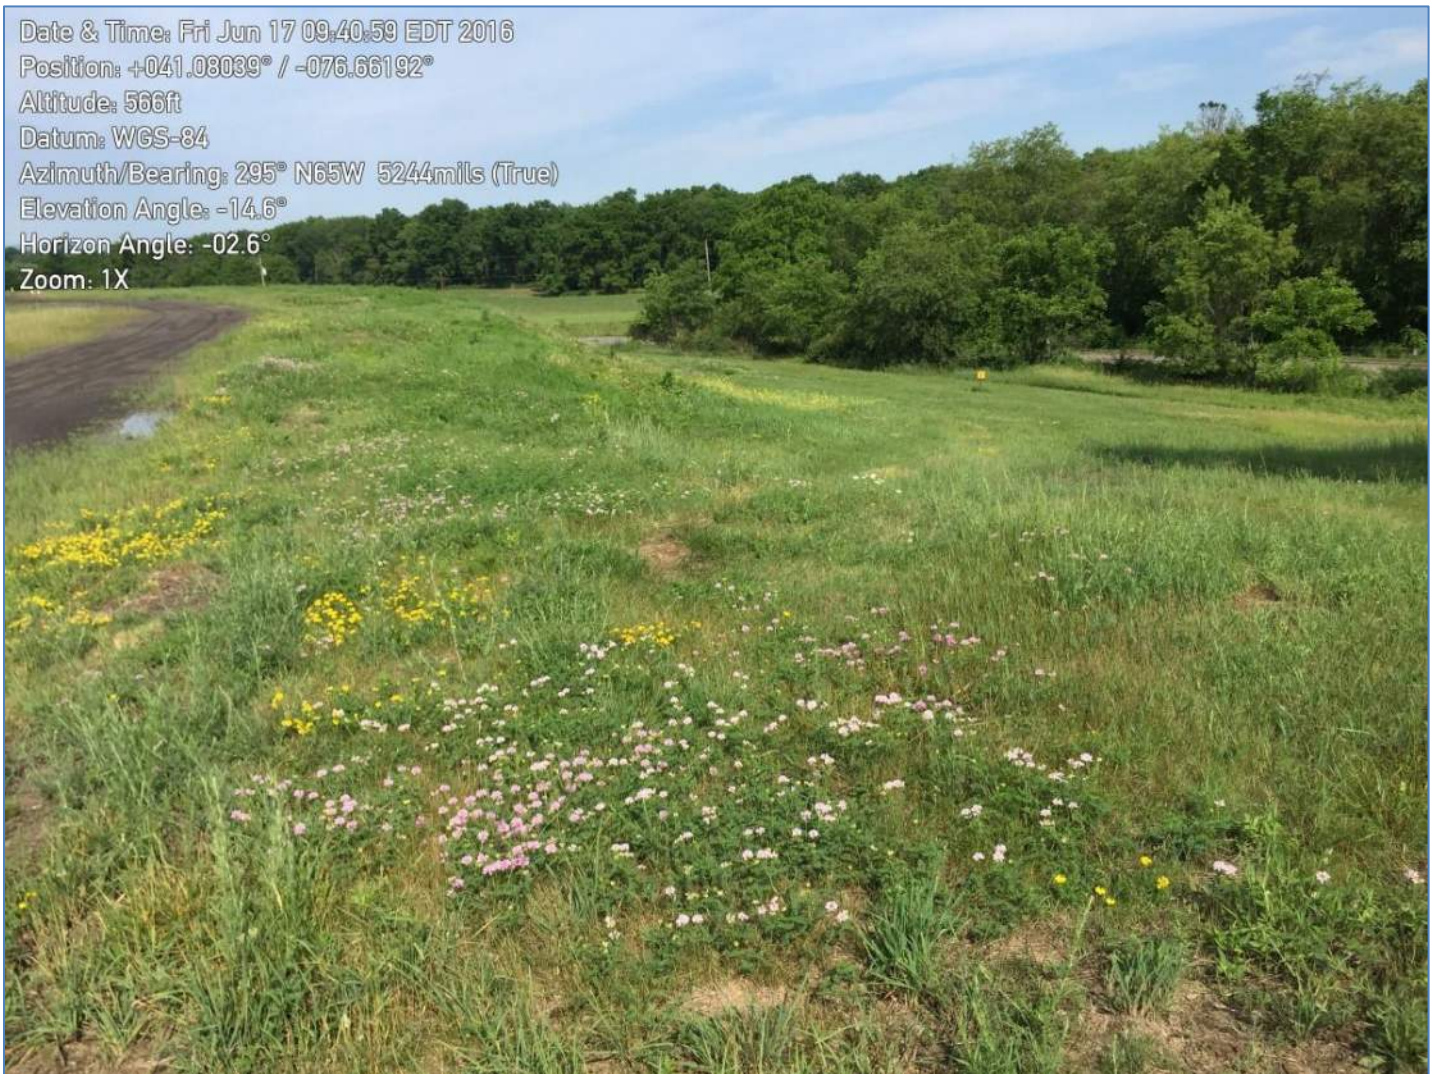
Photograph 1 – Northern Abutment

According to Section 3.5 of the Basin 1 History of Construction Report, the Basin 1 perimeter dike was primarily founded on bedrock consisting of weathered shale. The perimeter dike ties into natural existing grade at the northern and southeastern corners of the basin. According to the History of Construction Report, the abutment material at these locations consists of residual soils overlying weathered shale. A view of these northern and southeastern dike corners are shown in Photographs 1 and 2 in Appendix B.

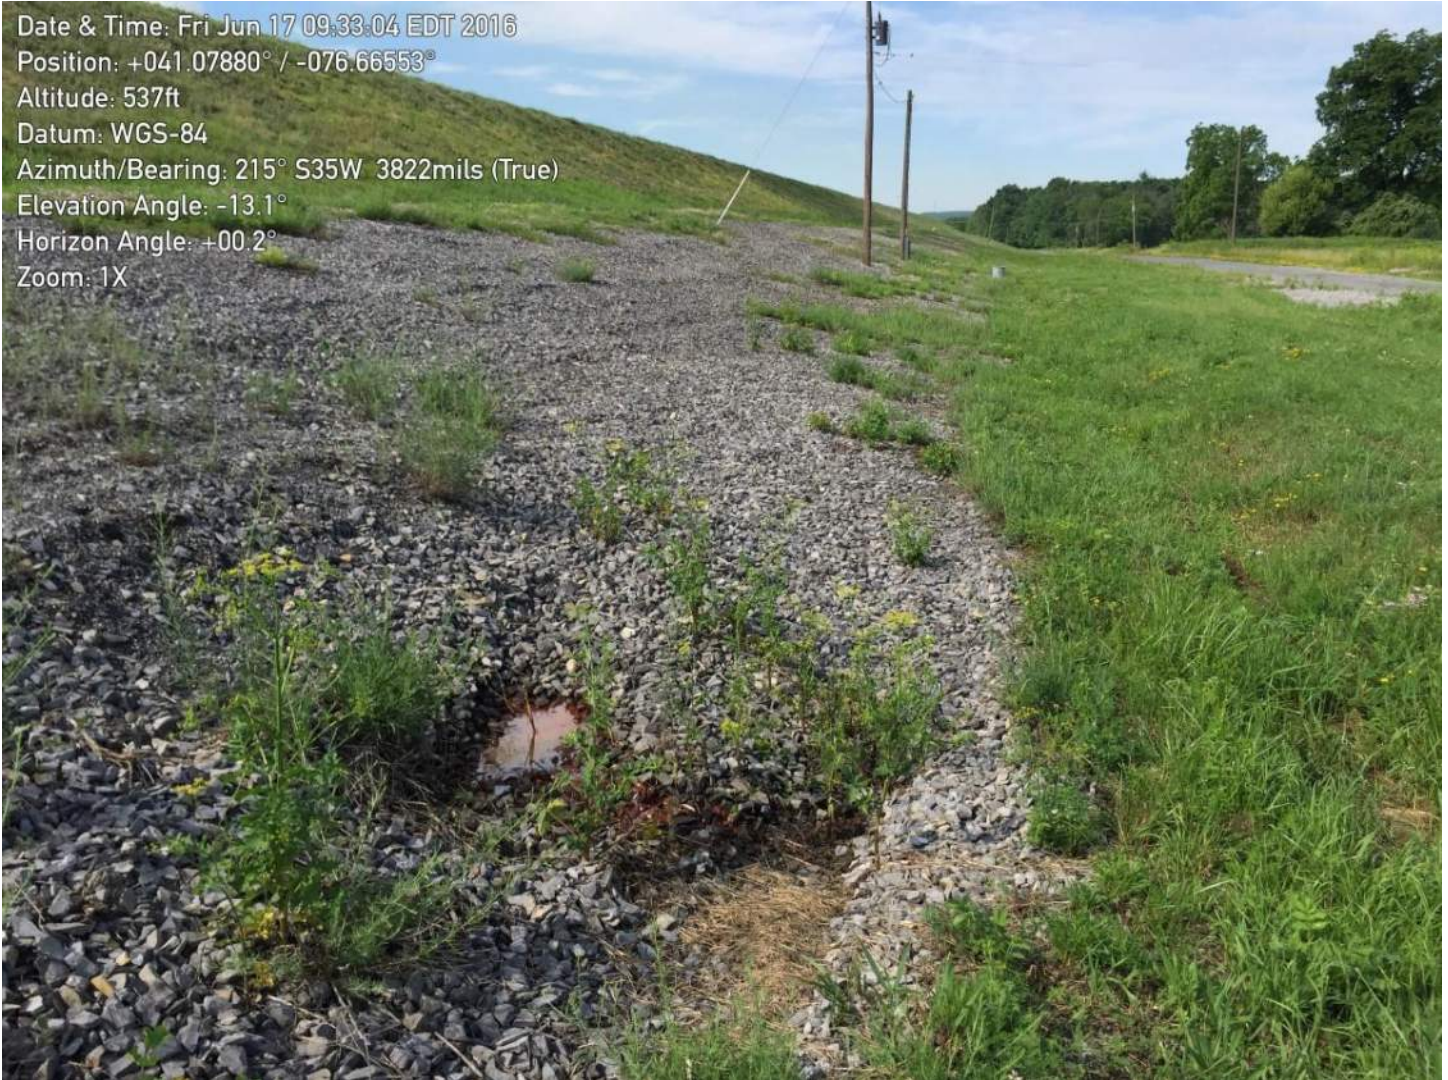
During CEC's site visit, a seep at the toe of the northern dike slope, just upstream of the seepage collection system, was observed. The seep was observed to be flowing and the seepage water appeared to be clear. Iron oxidation was observed on the riprap at the seep. This seep can be seen in Photograph 3 in Appendix B. Talen is currently investigating the cause of this seep so that the issue can be addressed.

Photograph 3 – Seep at Toe of Northern Dike Slope (looking west)

Item 19 – One seep was observed at the approximate location shown on the attached figure. Clear water was observed flowing. Iron oxidation was observed.

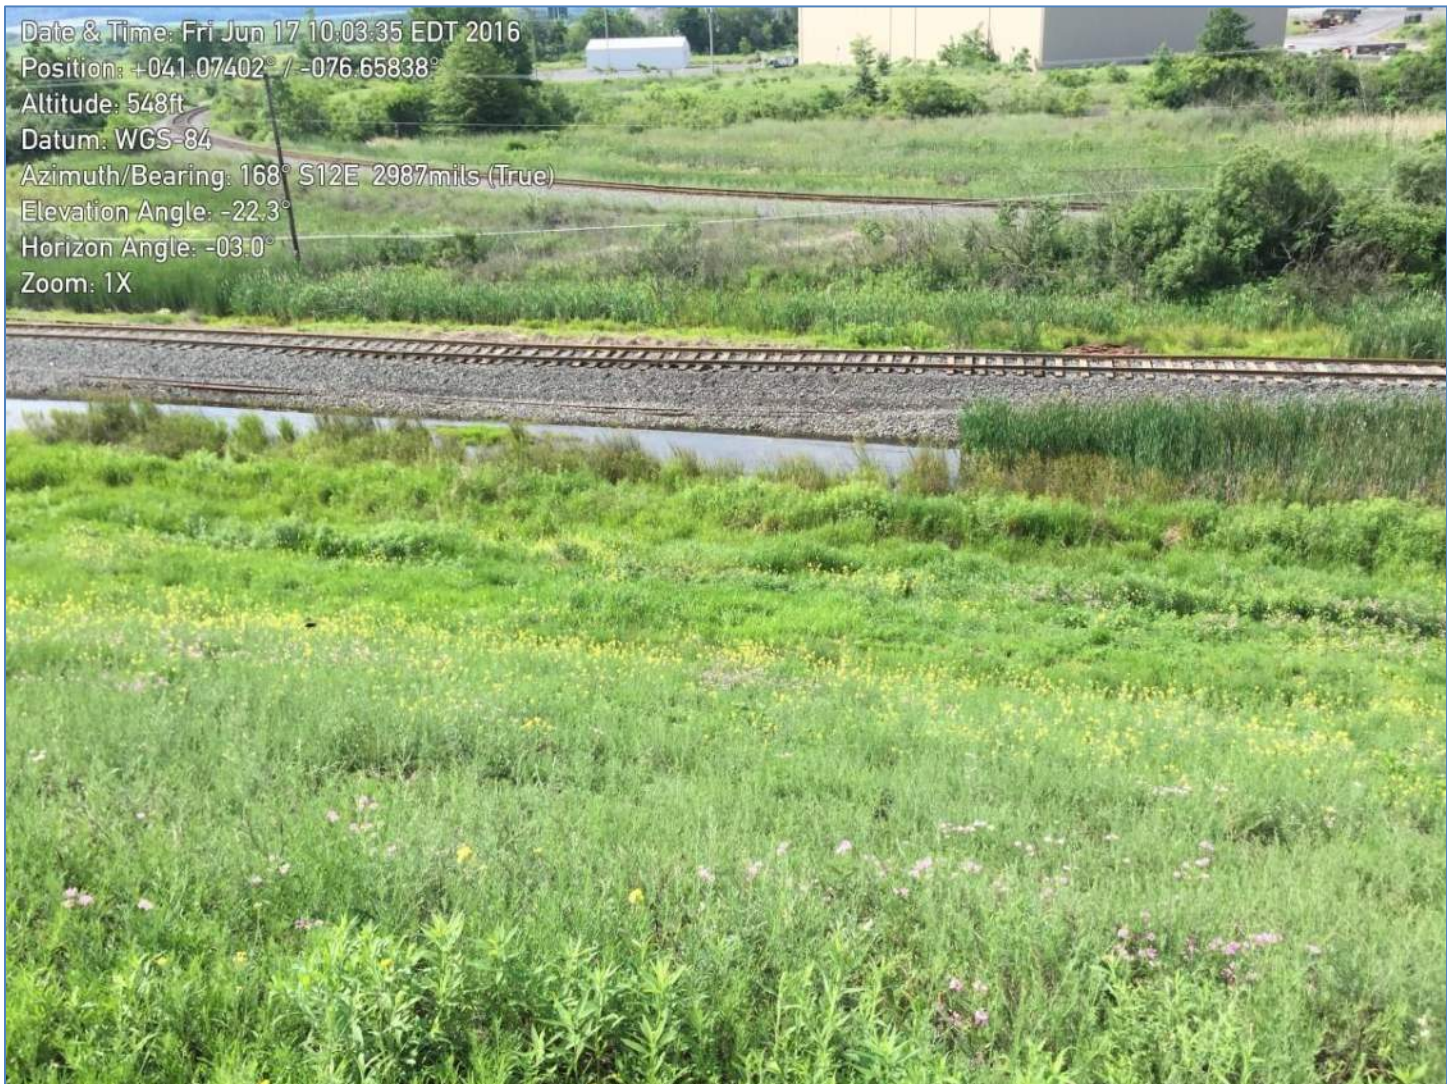
Ponding water was observed between the existing rail line and the toe of the southwestern dike slope, east of the pipe bridge, at the time of our site visit as shown in Photograph 4 in Appendix B. The area between the toe of slope and rail line to the west of the pipe bridge was wet; however, no ponding water was observed in this area. The Initial Annual Inspection indicates that this area is generally wet. No signs of slope instability were observed along the southwestern dike slope. A rock buttress was constructed in 2007 along the southwestern downstream dike slope in the area of the pipe bridge to increase stability.

Photograph 4 – Ponding Water at Toe of Southwestern Dike Slope

Item 39 – Seepage through the foundation is known to occur. Ponding water was observed along the toe of the downstream slope on the south side of the basin. Seepage was also observed entering a stormwater catch basin on the northern side of the basin. A seepage collection system is located along the northwestern toe of slope. This water is collected and pumped back into the basin.

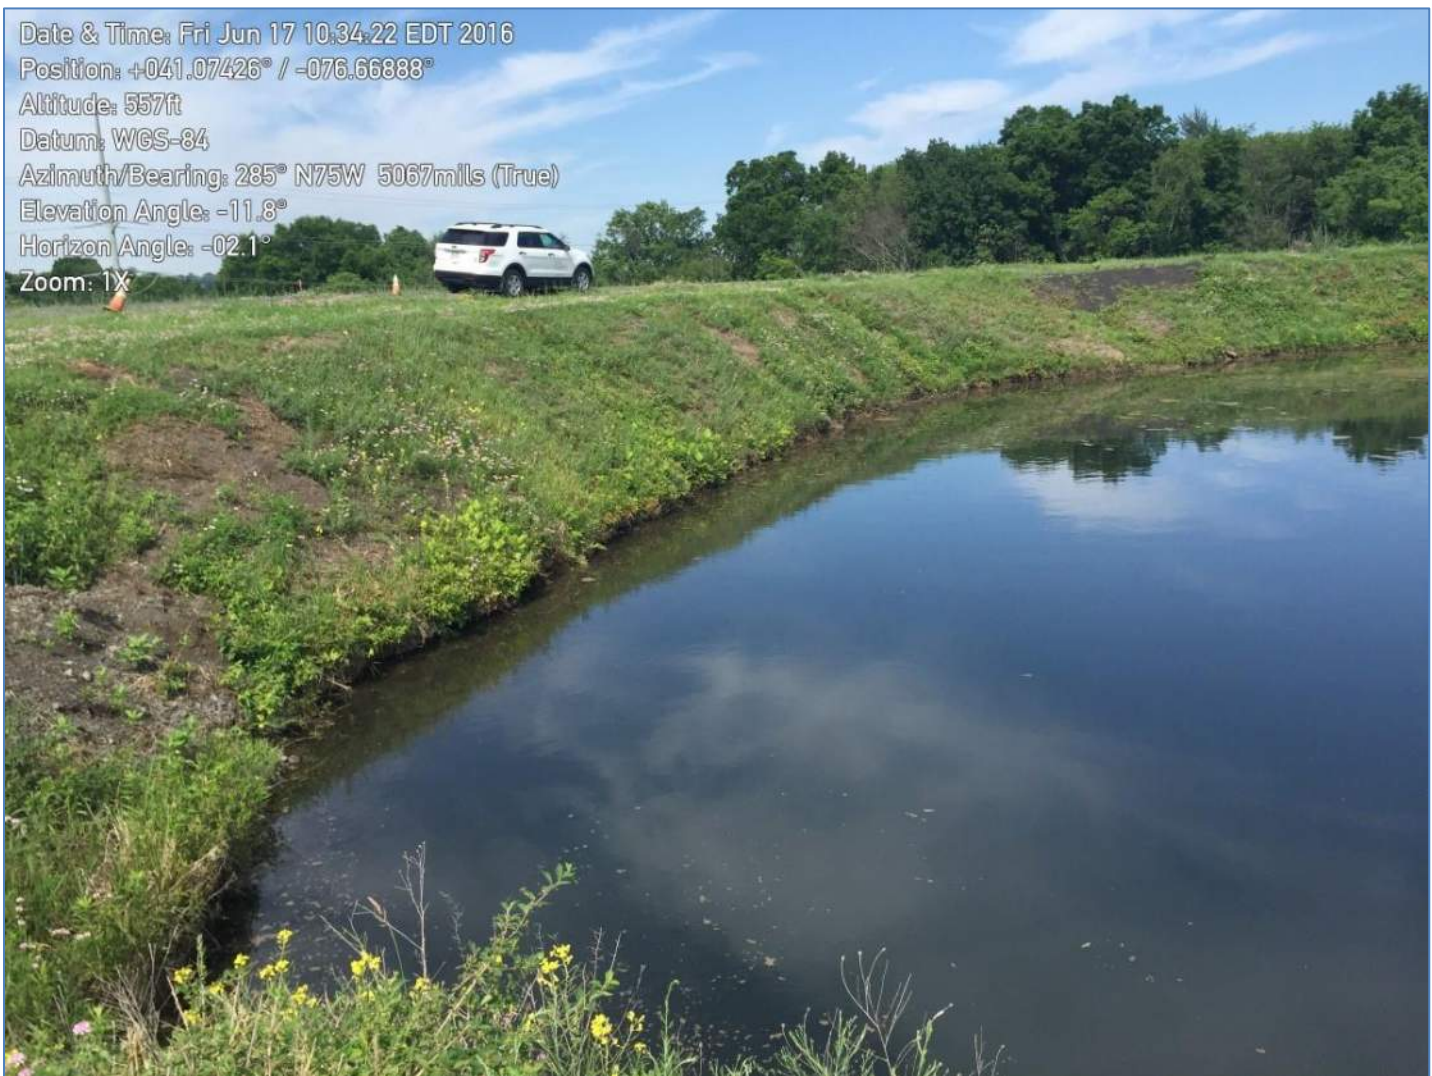
Photograph 5 – Western Upstream Slope of Subbasin C

vegetation and are mowed as needed. Section 3.6.4 of the History of Construction Report states that a berm was constructed along the perimeter dike to protect against erosion from wave action. This document states that the berm was constructed of reclaimed bottom ash and mill rejects. Recent topography indicates that this berm has remained in place. Photographs 5 through 7 in Appendix B show the condition of the vegetation on the upstream dike slopes at the time of our site visit.

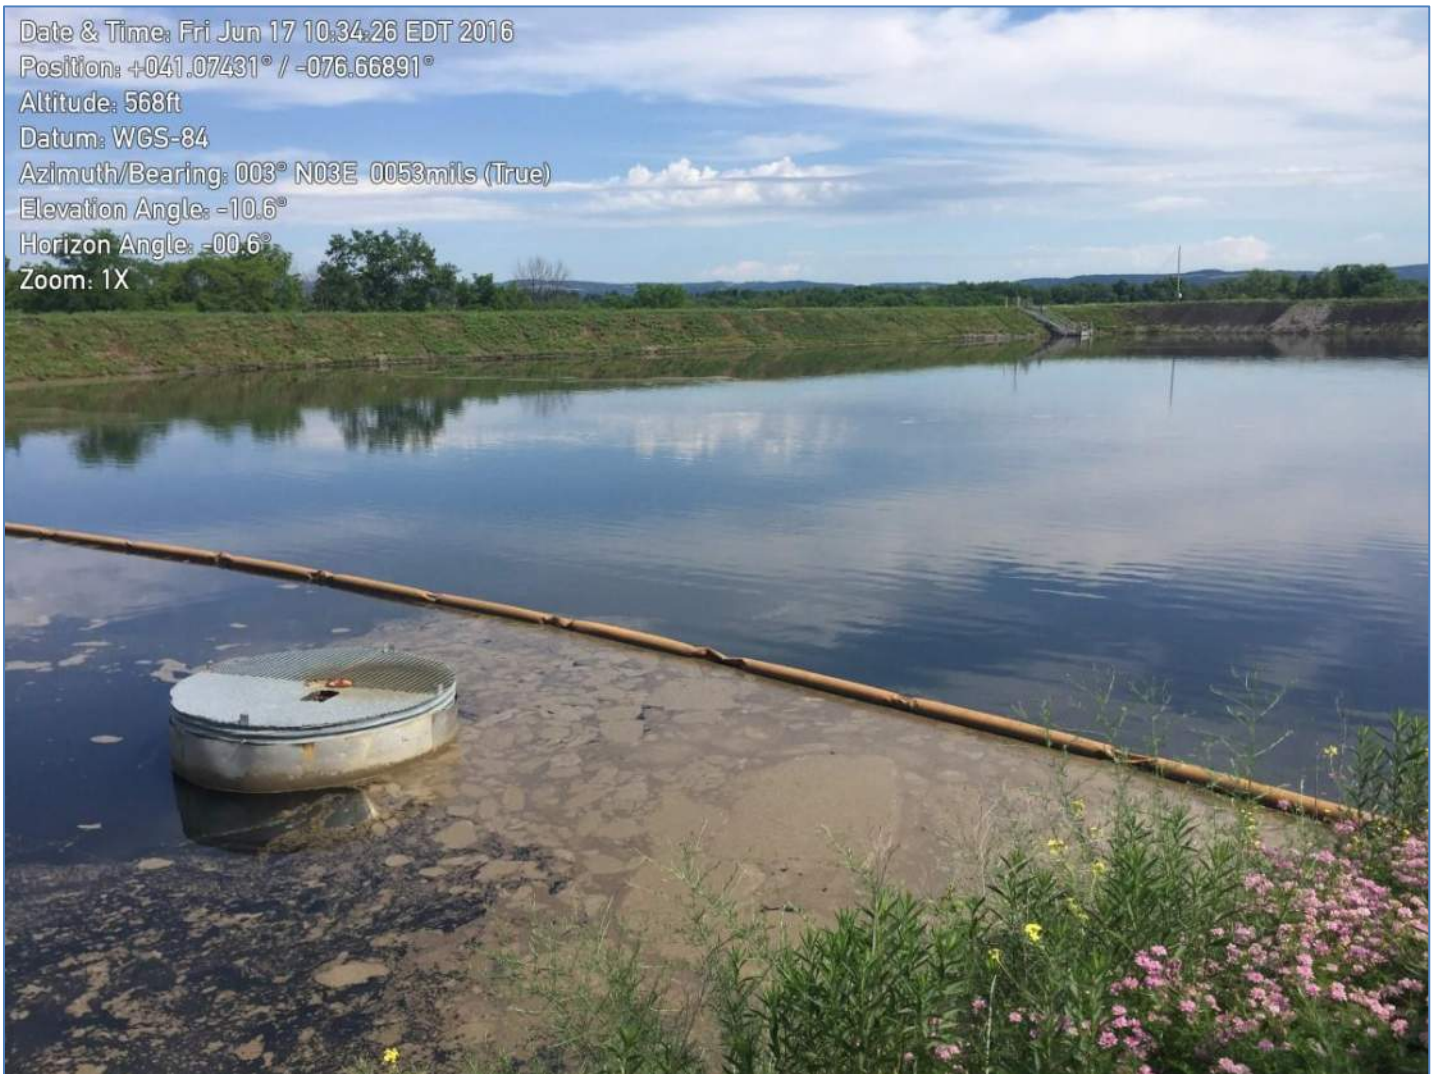
Photograph 8 – Top of Spillway Riser in Subbasin C (looking north)

The current spillway is located in Subbasin C and consists of a 36-inch reinforced concrete riser and culvert pipe. This spillway discharges into the on-site detention basin before discharging to Chillisquaque Creek. The top of the spillway riser is shown in Photograph 8 in Appendix B.

During the Initial Annual Inspection by HDR, the spillway in Subbasin C was inspected with a remotely operated vehicle (ROV). The ROV encountered an obstruction approximately 45 feet downstream of the Subbasin C spillway riser. According to the report, the obstruction appears to be blocking approximately 80 to 90 percent of the spillway culvert opening. Based on the pool level measurements provided by Talen, the normal pool in Subbasin C does not appear to have been affected by the obstruction under normal operating conditions. Talen is currently taking measures to investigate the removal of the obstruction. A detailed inspection of the spillway was not performed as part of this assessment.

- Remove the obstruction in the spillway as soon as possible to increase the flow capacity of the spillway, and investigate the cause of the spillway obstruction and implementing measures to reduce the chances of future obstructions.
- Modify the spillway to increase the capacity to convey the CCR Rule design storm.
- Investigate the seepage collection system at the northern dike slope to address the seep observed during CEC's site visit.
- Inspect the outlet of the plugged western culvert near Chillisquaque Creek as part of the weekly inspections to be performed in accordance with the CCR Rule.

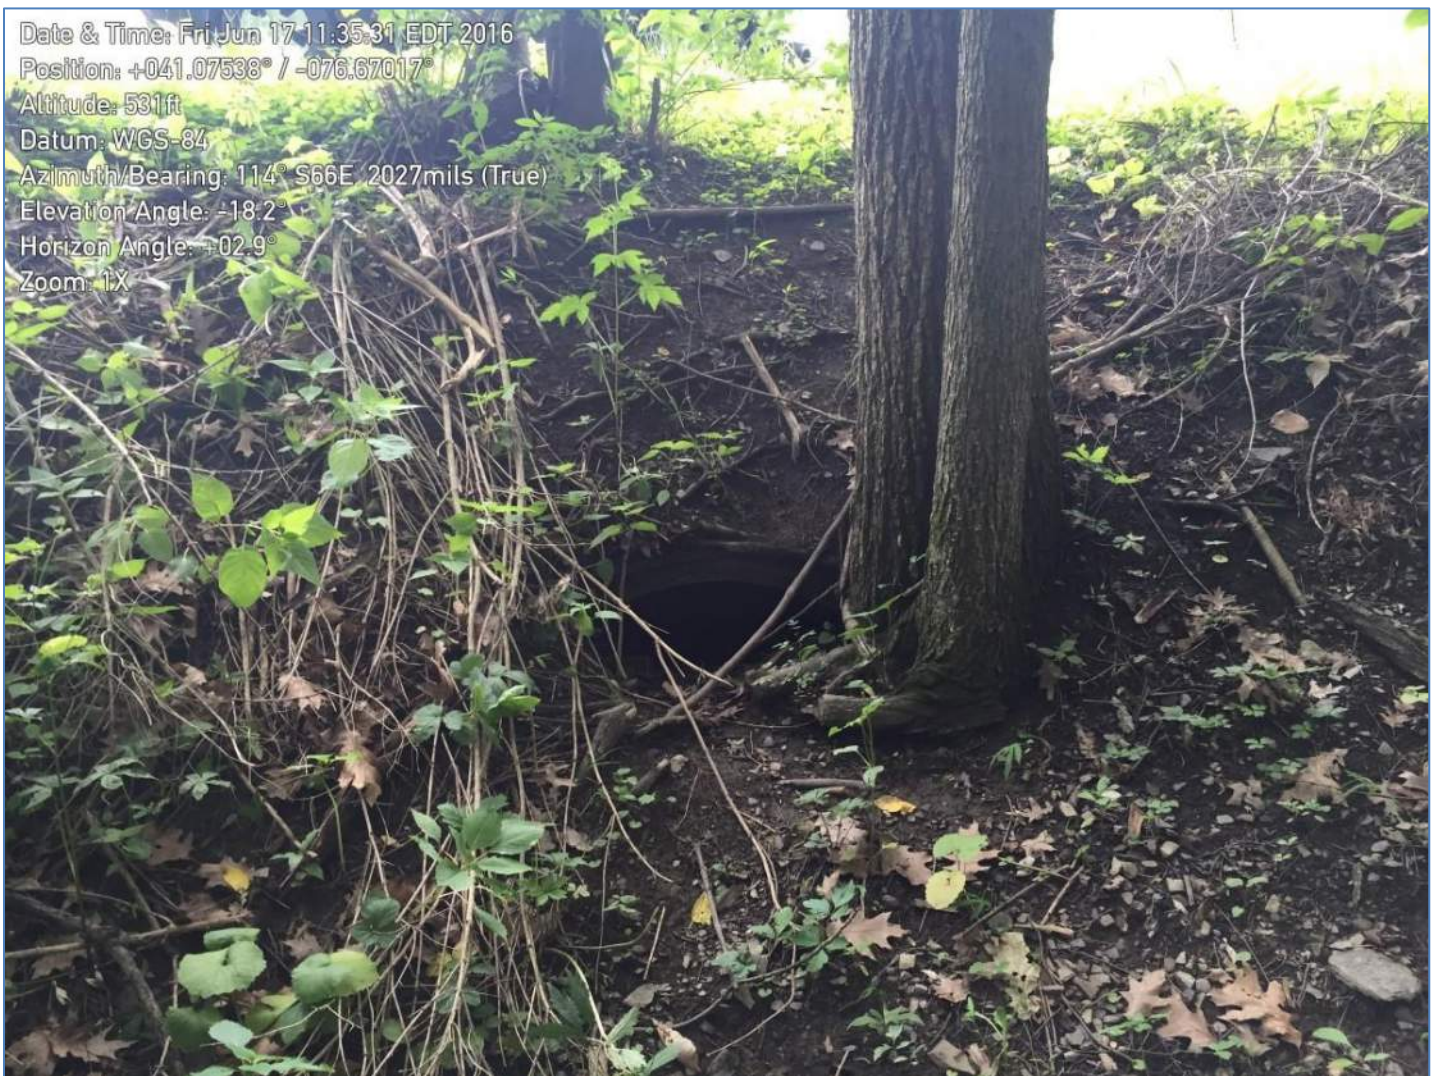
Two abandoned reinforced concrete pipe culverts are present beneath the dike on the north side of Basin 1 as shown on Figure 2. The outlet of the western plugged culvert is exposed and is shown in Photograph 9 in Appendix B. According to the Initial Annual Inspection Report, this pipe was inspected from the downstream end with a ROV by Talen in 2014. A concrete plug was encountered during the inspection approximately 59 feet from the outlet end. Drawing G-199945-13 by Ebasco Services, Inc. dated March 15, 1968 indicates that the eastern plugged culvert was temporarily installed to allow flow of an existing creek through the dike embankment, most likely during construction. The exact location of the eastern plugged culvert is unknown.

Photograph 9 –Abandoned Overflow Culvert Pipe Outlet (plugged)

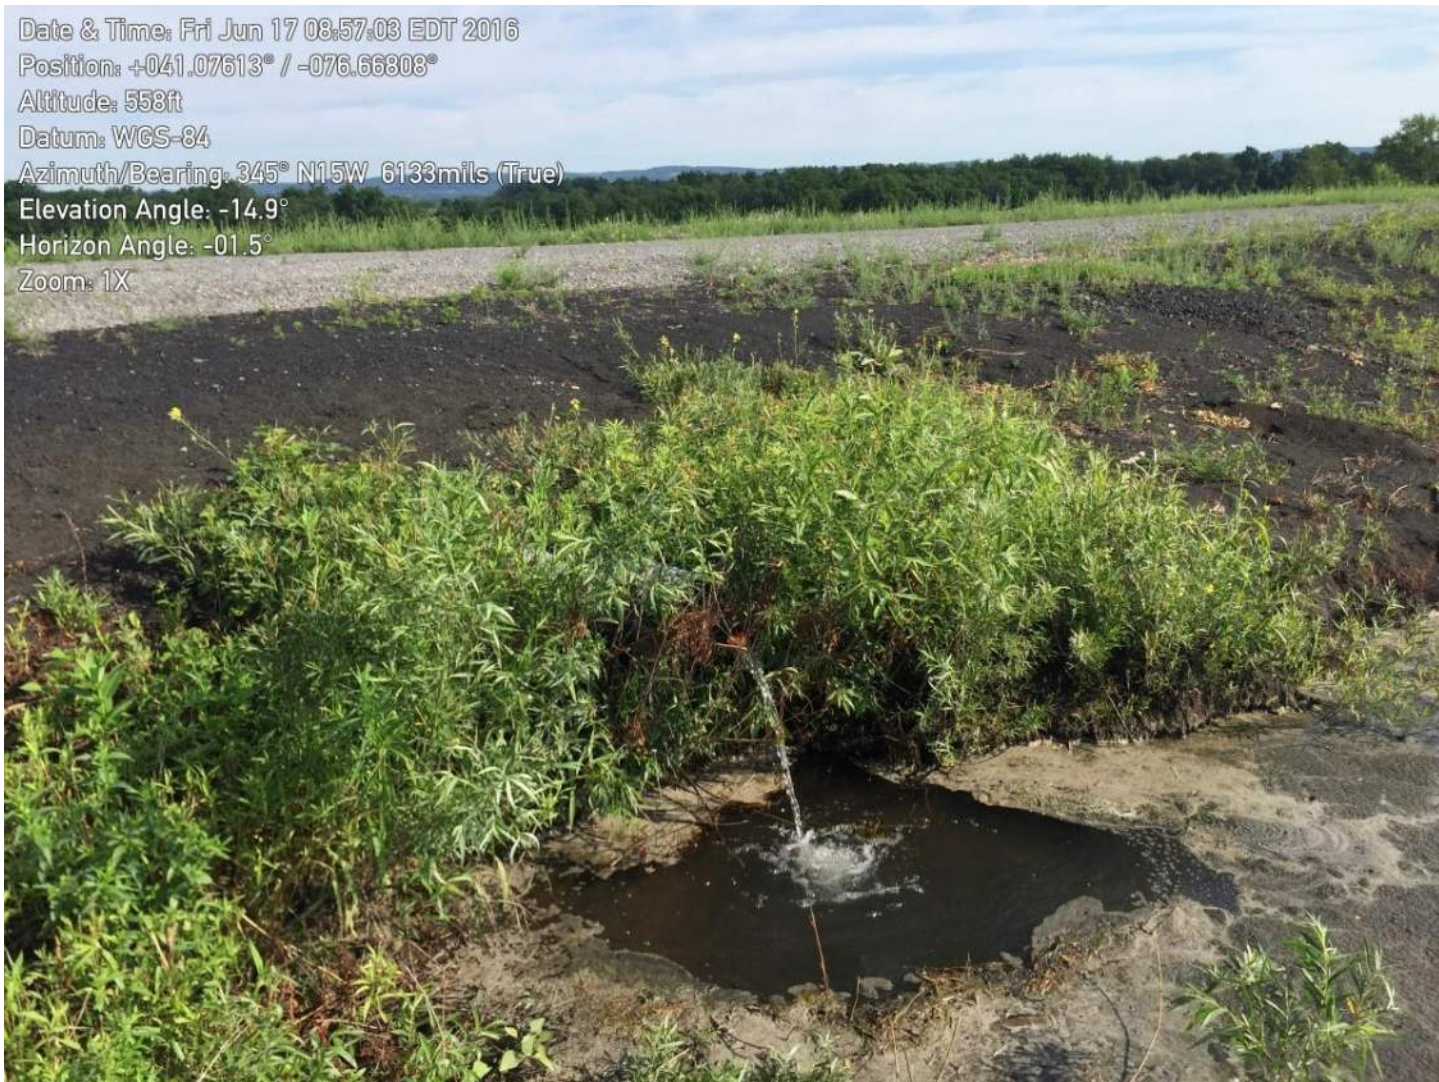
Photograph 10 – Seepage Collection System Outlet Pipe

In 1973, a seepage collection system was installed on the northwestern side of the basin for collecting seepage water and conveying it back to Basin 1. In 1979, the system was extended farther to the northeast and an additional pump station was added to convey the seepage water back to the basin. The collection system consists of a buried interceptor trench at the downstream toe of the northern dike. The trench contains a pipe that is sloped to convey water to four manholes positioned along its length. The manholes are equipped with submersible pumps that operate via level controls to pump the accumulated water back into the basin. Pipes pass through the northern dike to convey pumped water from the seepage collection system to Subbasin B. Some of the pipes were observed to be flowing during our inspection and based on our observations and conversations with Talen, are buried at a relatively shallow depth, just below the crest. One of these pipes is shown in Photograph 10 in Appendix B.

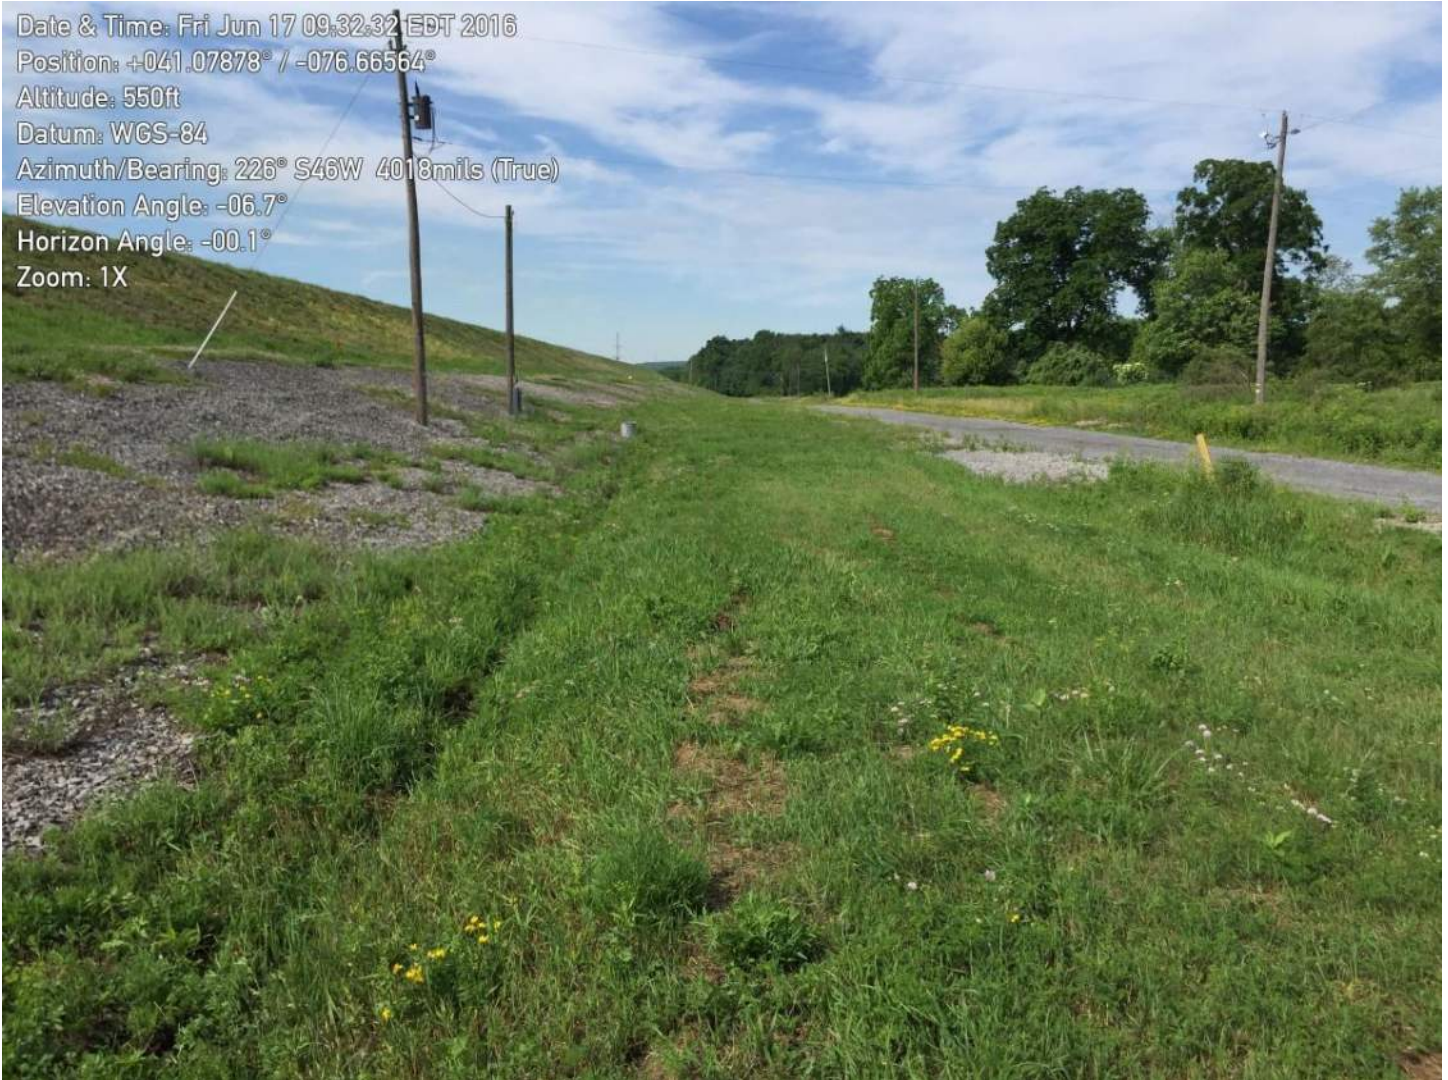
Photograph 11 – Northern Downstream Slope (looking west)

At the time of CEC's inspection, the dike slopes were mostly covered with grassy vegetation. Larger vegetation such as shrubs or trees were not present on the dike slopes. The downstream slopes contain vegetation along the entire dike excluding the areas where riprap has been placed. Photographs 1, 2, 3, 4, 9, 11, 12, and 13 show the condition of the vegetation on the downstream dike slopes at the time of our site visit.
