# 2016 Initial Safety Factor Assessment Report

Brunner Island Ash Basin No. 6

Prepared for:  
Brunner Island, LLC

September 27, 2016

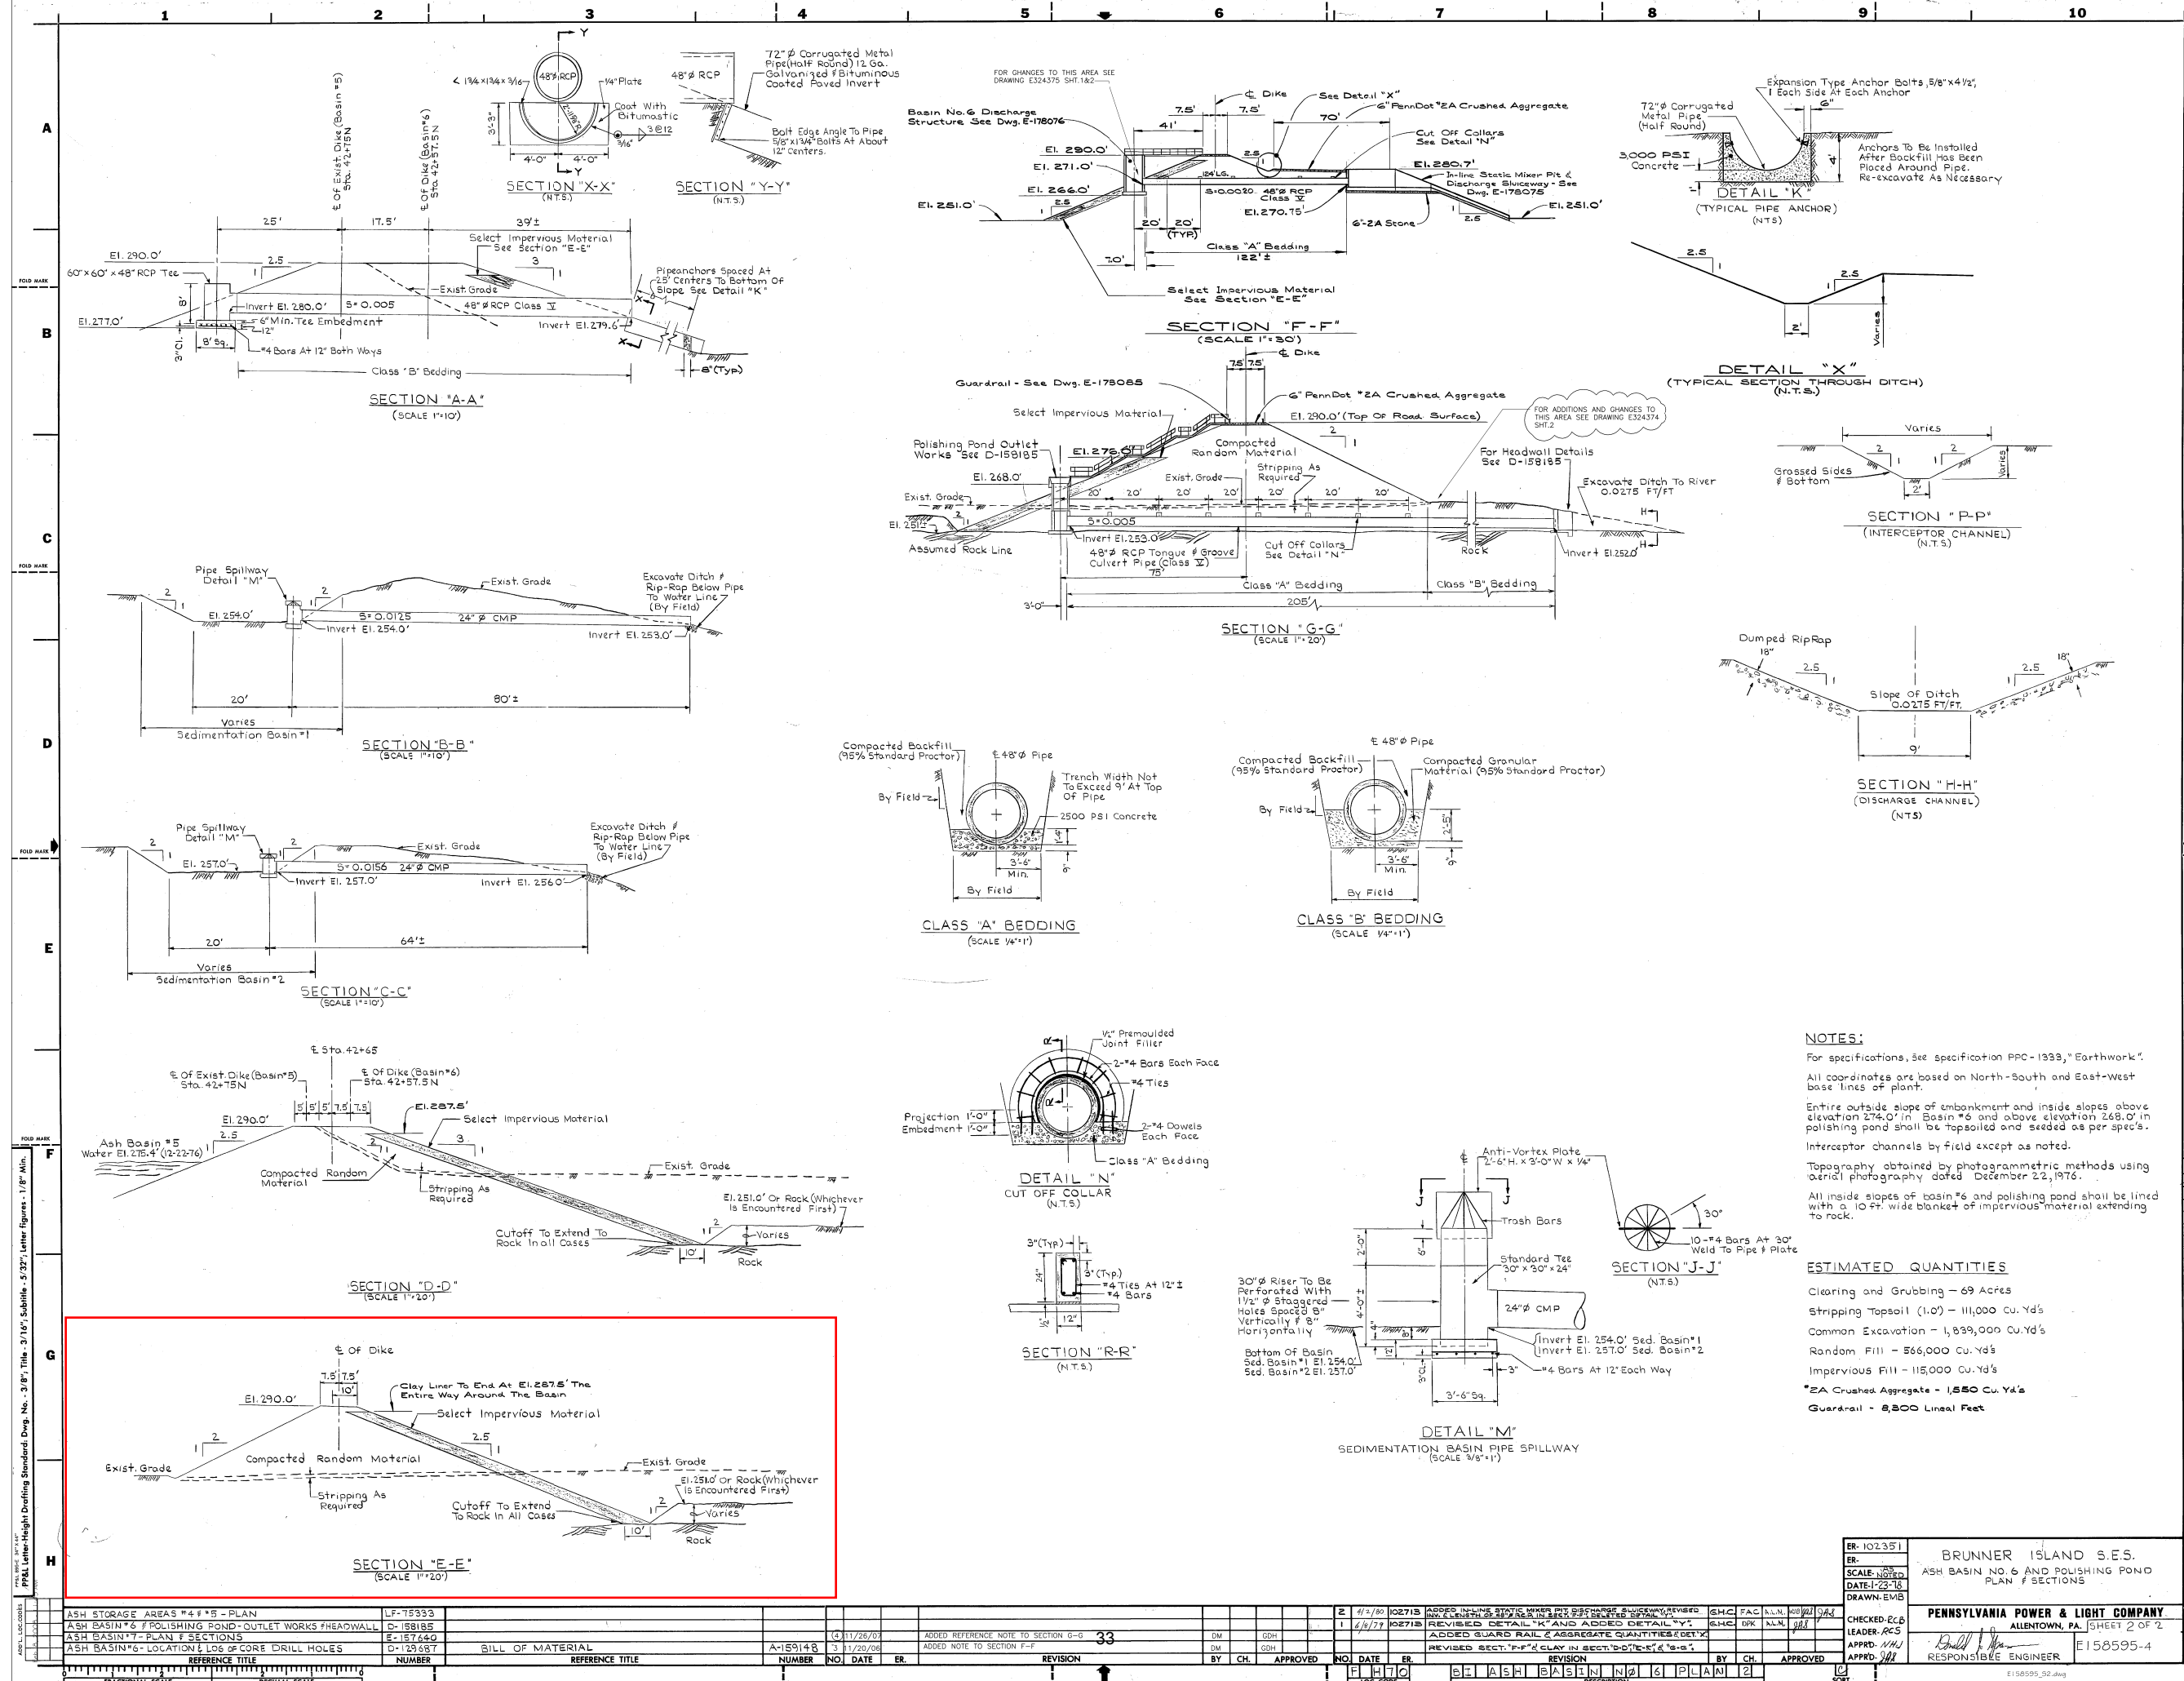
Figure A-4

For specifications, see Specification PPC-1933, "Earthwork".

ER-102351	BRUNNER ISLAND S.E.S.
ER-102351	ASH BASIN NO. 6 AND POLISHING POND
SCALE NOTED	PLAN & SECTIONS
DATE: 12-28-76	
DRAWN: EMB	
CHECKED: RCB	PENNSYLVANIA POWER & LIGHT COMPANY
LEADER: RCS	ALLENTOWN, PA. SHEET 2 OF 2
APPROV: MHS	RESPONSIBLE ENGINEER
APPROV: [Signature]	E158595-4

The Dam Failure Analysis and Initial Hazard Potential Classification (HDR 2016) for the Brunner Island Ash Basin No. 6 classified the ash basin as a significant-hazard-potential dam. A plan of the ash basin, aerial photograph, and original construction drawings are provided in Appendix A.

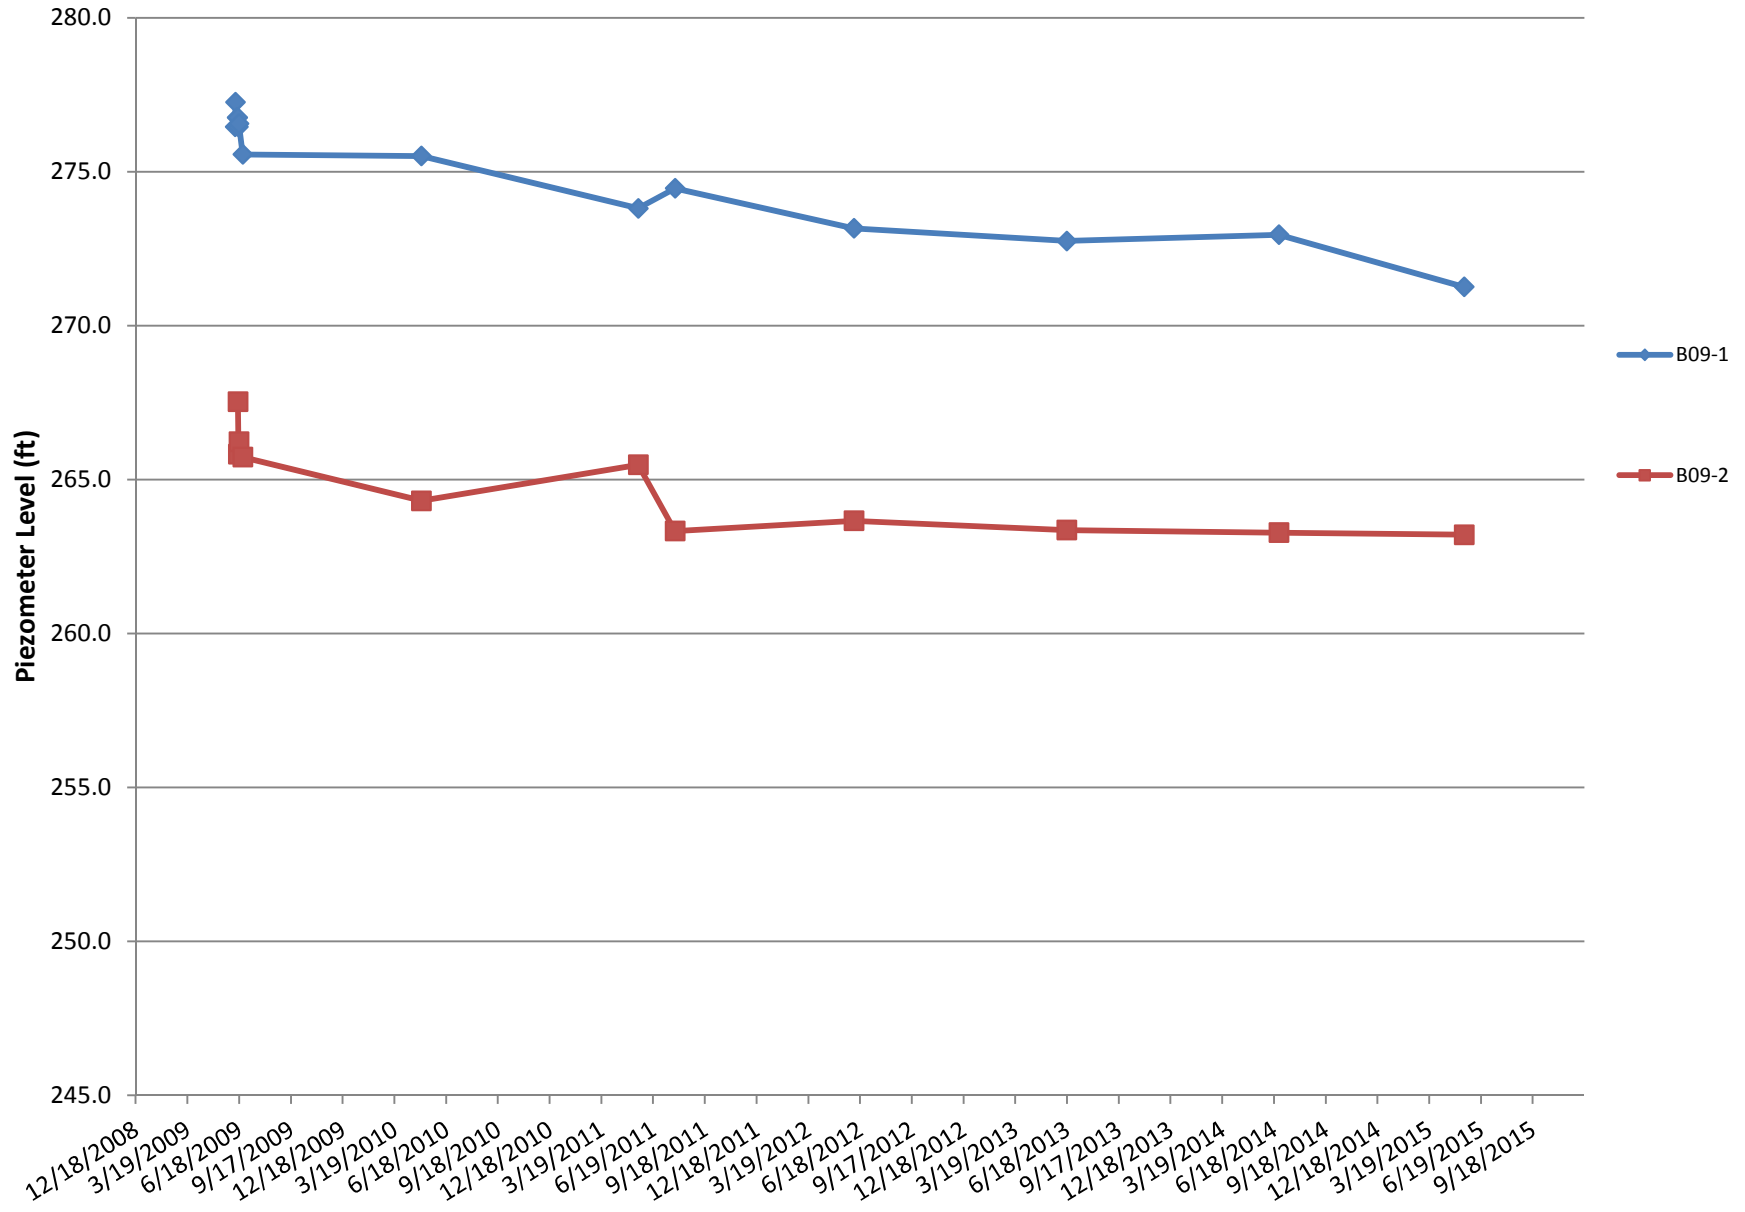
Figure 5. Piezometer Time-History Plot

Reading Date & Time	Water Depth (ft)	Water Elev. (ft NGVD29)	Remarks
	TP		
6/16/09 1:45 PM	6.2	267.5	After piezometer installed
6/17/09 9:15 AM	7.9	265.8	24 - 72 hr reading
6/18/09 7:45 AM	7.5	266.2	24 - 72 hr reading
6/25/09 12:00 AM	8.0	265.7	Extended reading
5/6/10 1:00 PM	9.4	264.3	Extended reading
<b>5/24/11 12:00 AM</b>	<b>8.3</b>	<b>265.5</b>	<b>Measured by PPL emailed to HDR 05/25/11</b>
7/28/11 12:00 AM	10.4	263.3	2011 HDR Inspection
6/7/12 1:00 PM	9.6	263.7	2012 HDR Inspection (stickup = 2.5')
6/18/13 11:00 AM	9.9	263.4	2013 HDR Inspection (stickup = 2.5')
6/27/14 2:00 PM	10.2	263.3	2014 HDR Inspection (stickup = 2.7')
5/20/15	10.5	263.2	Measured by PPL emailed to HDR 05/20/15

The phreatic surface for the normal, seismic, and liquefaction analyses was conservatively based on the highest piezometer readings observed since 2010. At Piezometer B09-1 on the crest, the piezometric level was modeled at EL 275.5, as measured on May 6, 2010. At Piezometer B09-2 on the downstream slope, the piezometric level was modeled at EL 265.5, as measured on May 24, 2011. The piezometric levels can be seen in Figure A-6 in Appendix A and the time-history plot for Piezometers B09-1 and B09-2 can be seen in Appendix D, Figures D-1 through D-4.
