January 15, 2016

390/265831

**Subject: 2015 Annual (Initial) USEPA CCR Surface Impoundment Inspection Report
Montour Ash Basin No. 1**

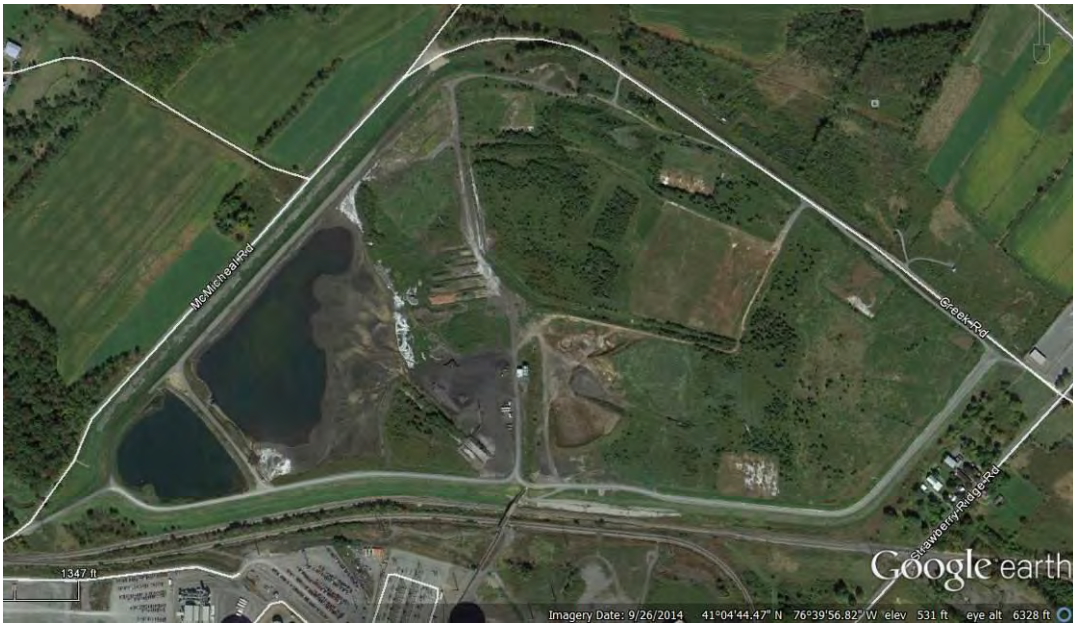
Relevant photographs and a key plan are provided in Appendix A. An aerial view of the Basin can be seen in Photo 1.

Photo 1 – Aerial view of Montour Ash Basin 1.

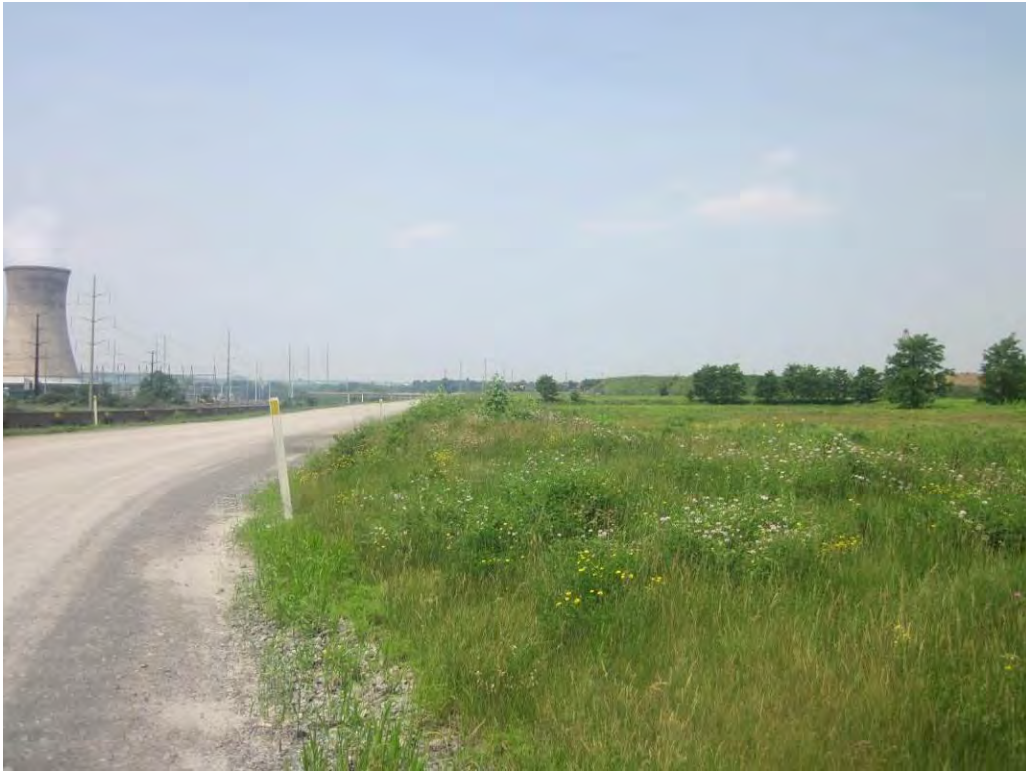
Sub-basin A has been filled with ash and is closed. Sub-basin A can be seen in Photos 11 and 12. As part of the long-term closure plan, the southern part of the basin has been covered with top soil, graded, and stormwater runoff catch basins have been installed at regular intervals. The northern part of Sub-basin A includes the ash processing area and contains stockpiles of material that will be used for the closure of the remainder of the basin.

Photo 11 – Closed area of Sub-basin A, adjacent to the southwest embankment.

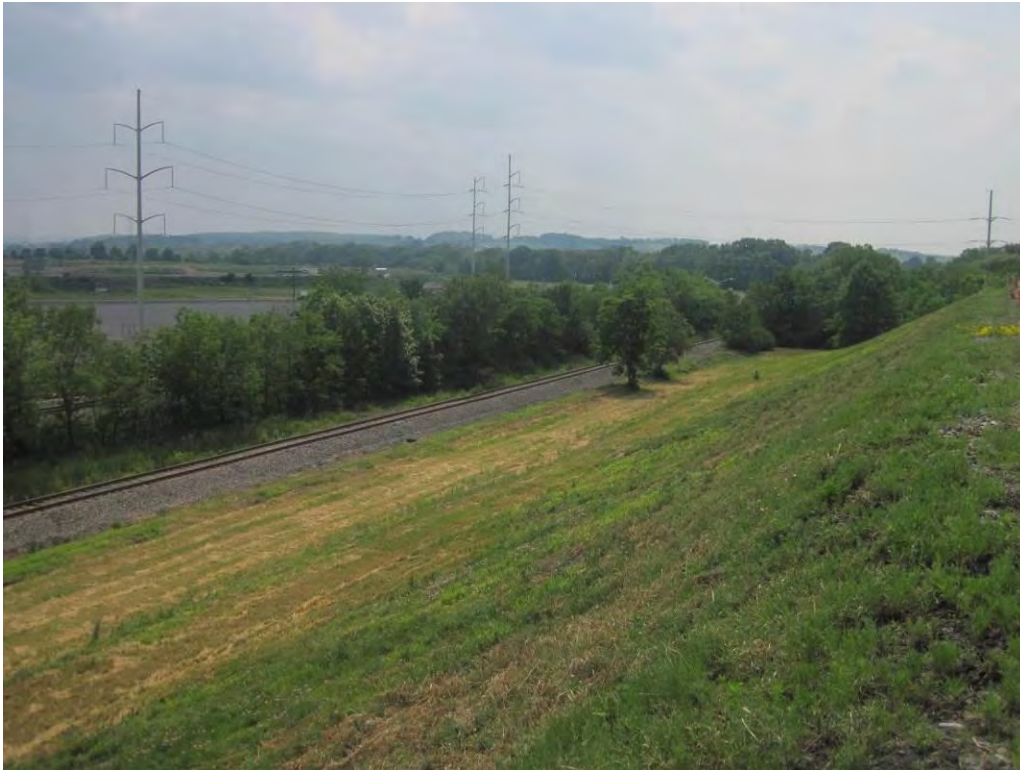
The southwest embankment was generally in good condition and can be seen in Photos 13 through 21. No evidence of active movement was observed. A berm was observed at mid-slope at the north end in an area where slope irregularities had been reported previously, seen in Photos 13 and 15. This area had been obscured by vegetation during earlier inspections. The toe of the embankment was drier than in previous inspections. Wet areas were still observed along the toe of the southwest embankment with standing water at the north end of the embankment at the access ramp, becoming dryer towards the south. The wet areas at the toe of the embankment appeared to be primarily due to lack of drainage along the toe. While there was no evidence of active seepage, wet areas at the toe of a water-retaining dam are a concern that needs to be monitored. The downstream toe of the southwest embankment was dry opposite the splitter dike between Sub-basins B and C. Standing water was present in the majority of the ditch between the toe of the southwest embankment and the railroad tracks, as seen in Photo 17. A wet area, reported as a small seep in previous reports, was observed along the toe of the berm about 80 yards north of the pipe bridge. A wet area previously observed on the downstream slope of the berm further to the south was dry. The wet areas on the embankment slope did not show any evidence of seepage or piping and are not located adjacent to sections of the basin impounding surface water. Wet areas on the slope are a concern and should be monitored.

Photo 14 – Downstream slope of southwest embankment, looking northwest from near the splitter dike between Sub-basins B and C.

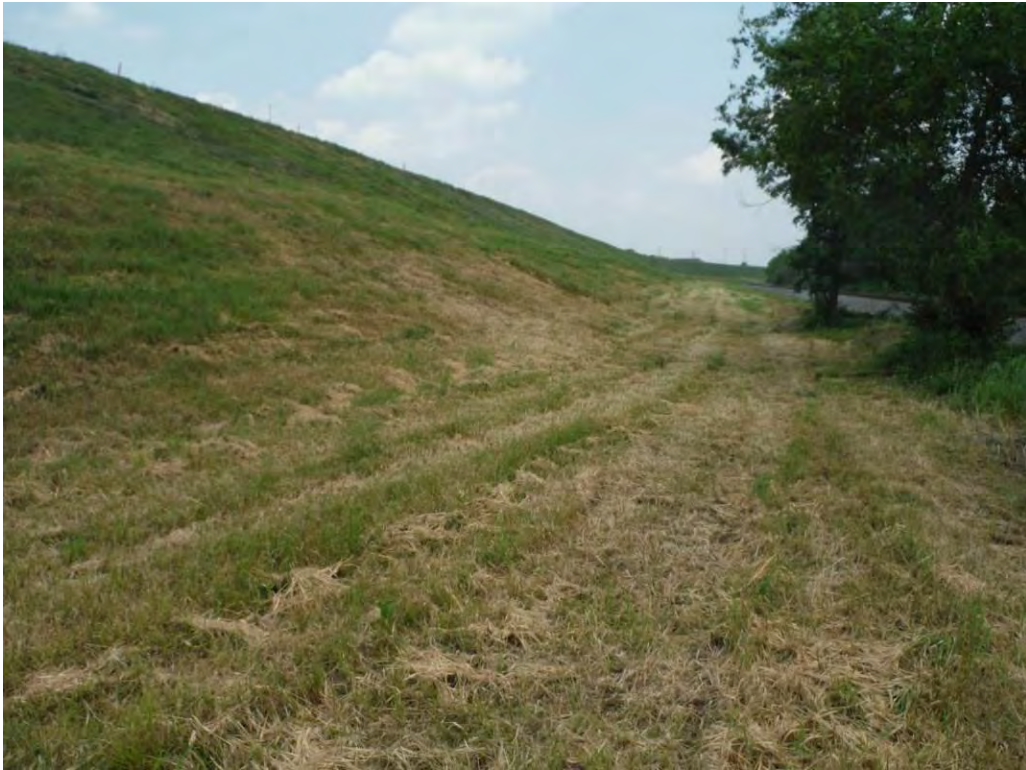
Photo 15 - Stabilization berm along the northwest end of the southwest embankment.

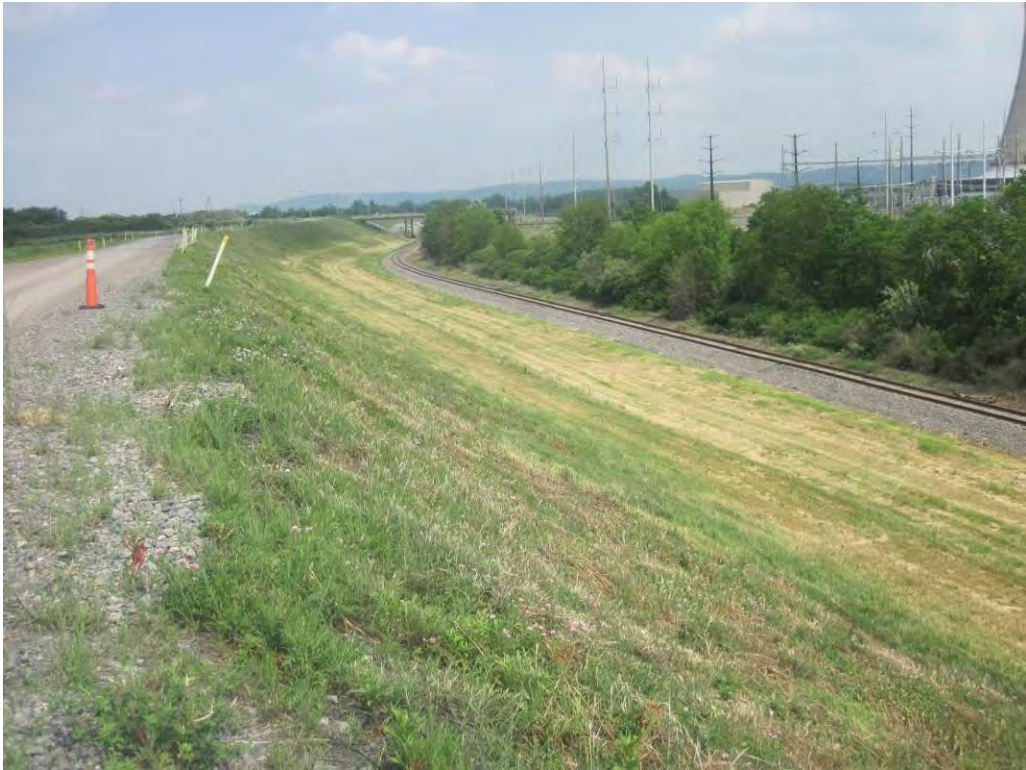
Photo 16 – Downstream slope of southwest embankment, looking southeast from near the splitter dike between Sub-basins B and C. The pipe bridge can be seen in the distance.

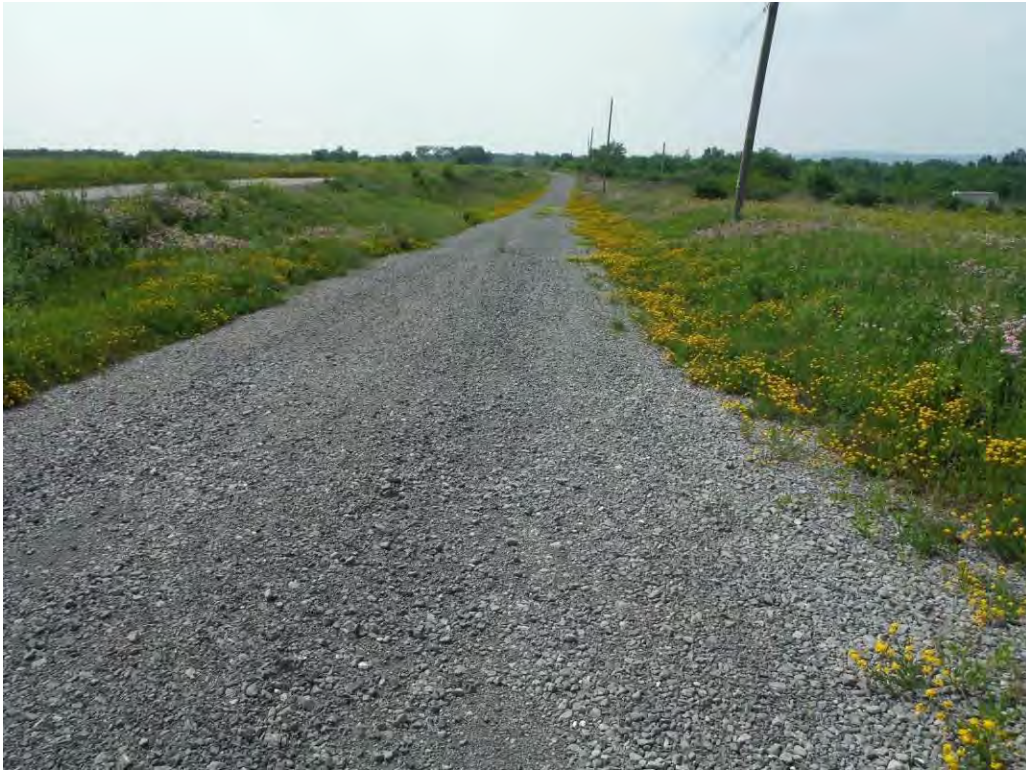
The east embankment is a relatively shallow embankment that does not hold water. The brush along portions of the downstream slope has not been cut in the recent past and is extremely thick. The toe of the embankment is not far below the level of the fill in the adjacent ash basin. The east embankment is shown in Photo 23.

Photo 23 – Crest and downstream slope of Sub-basin A, looking north.

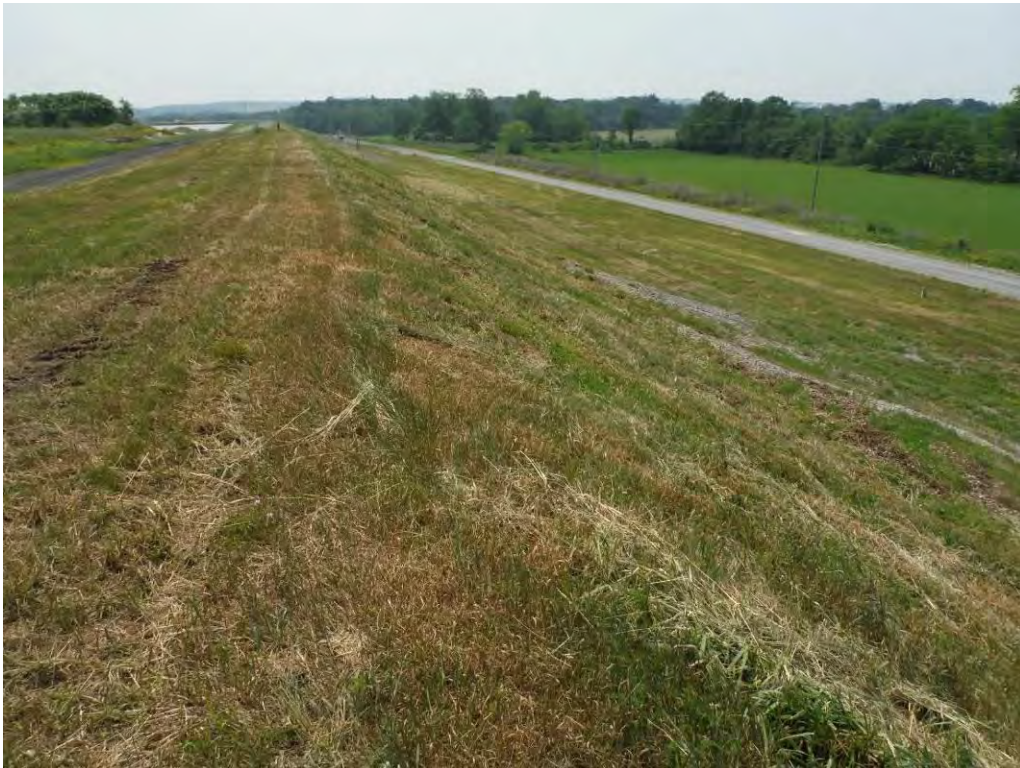
The north embankment was in good condition. The north embankment can be seen in Photos 24 through 29. A gravel stabilization berm is located at the east end of the embankment and extends intermittently to the west end. The vegetation was well trimmed, with the exception of a narrow band at the northeast corner of the embankment, seen in Photo 28. Vegetation in this area should be cut. The wet area in the gravel berm at the east end of the north embankment, initially reported in 2008, was observed in 2013 but not observed in 2014 or 2015. The wet area was previously reported to be about 50 feet long and was located about 50 feet northwest of Well 4. A stormwater runoff drainage system was installed several years ago in the northeast corner of the basin. This system includes a catch basin within Sub-basin B with a drain line extending across the crest of the north embankment, down the downstream slope, and across the toe access road to a discharge structure. Talen reported that the stormwater pipe has since capped at the upstream end. There are two catch basins to the east of Dewatering Well 4 on the downstream slope of the north embankment. Groundwater was observed to be flowing into both catch basins from pipe penetrations that had not been properly sealed. The groundwater inflow into the catch basin is unfiltered and has the potential to wash fine soil into the catch basins, as evidenced by a small depression in the ground surface over the leaking penetration of the catch basin, adjacent to the toe access road that may be the result of piping and subsidence. Although it is unlikely that a significant amount of

Photo 26 – Looking west along the downstream slope of the north embankment.

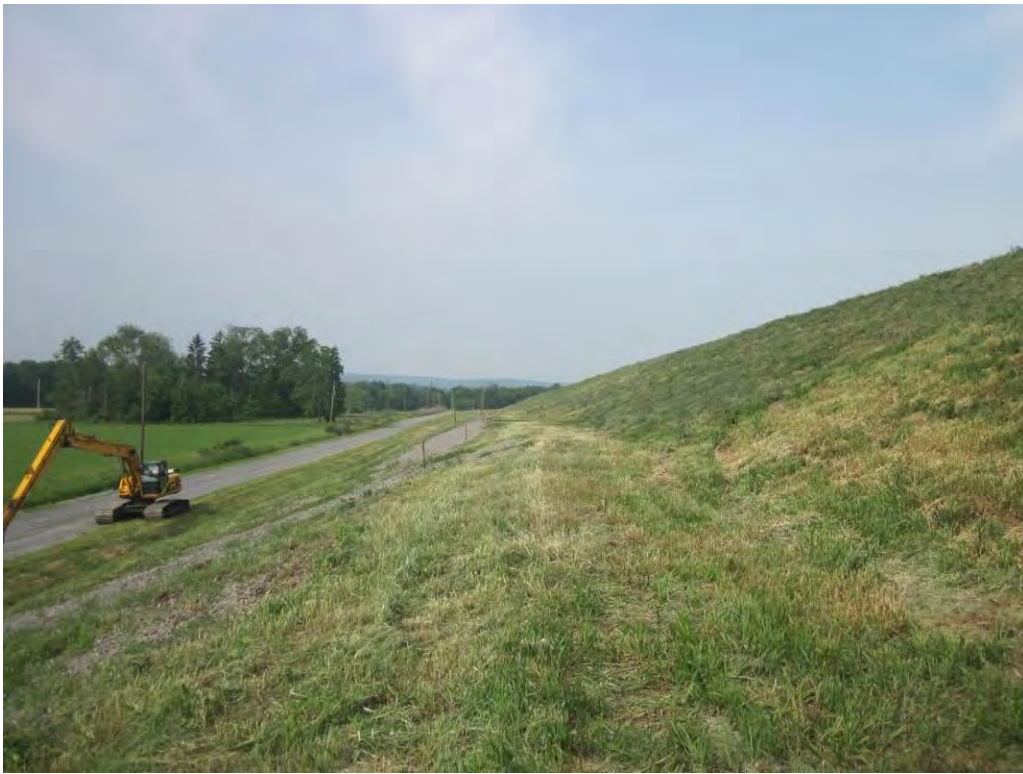
Photo 27 – The downstream slope of the north embankment, looking east.

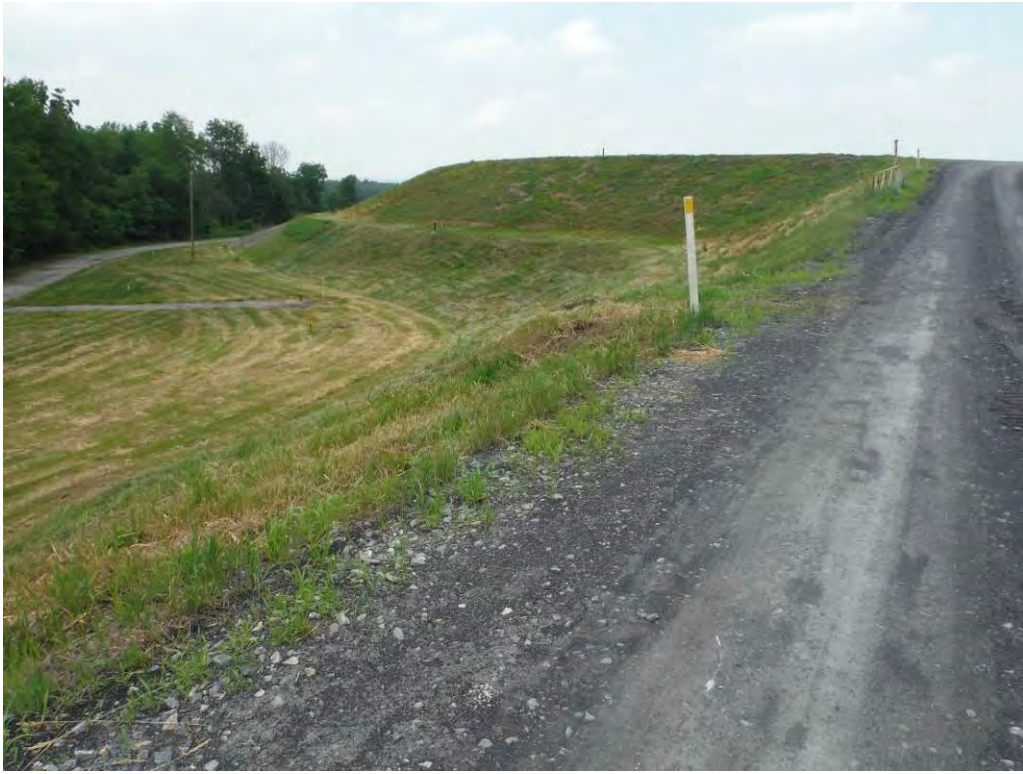
Photo 28 – The downstream slope of the northwest embankment, looking northeast from access road.

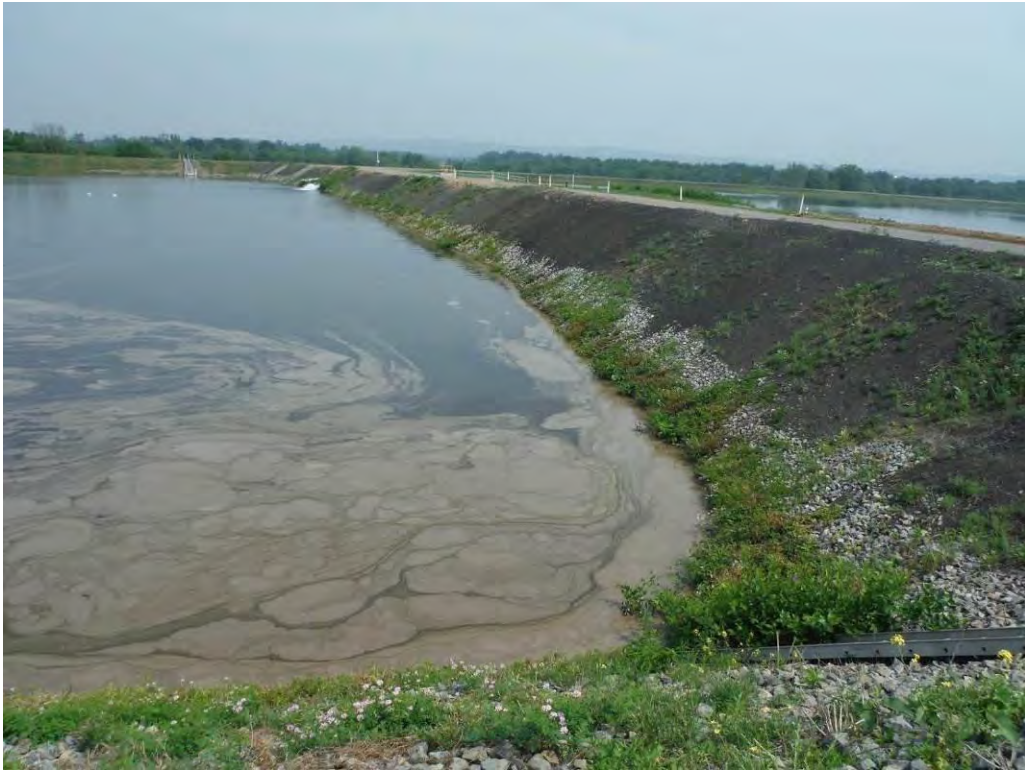
The splitter dike between Sub-basins B and C was in good condition and Talen recently raised the crest and placed new riprap on the steep downstream slope. The dike is broad, so that a shallow failure of the steep downstream slope will not affect the stability of the dike, and, in any event, Sub-basin C should be able to contain any inflow resulting from a failure. It is possible that a slope failure could damage the discharge piping; therefore, continued remote monitoring of the Sub-basin B water level for abnormal increases is important. The downstream face of the dike is shown in Photo 36. The upstream end of the 24-inch CMP inlet to the discharge structure in the splitter dike between Sub-basins B and C was replaced with HDPE pipe in 2014. A debris float was installed surrounding the intake pipe, and the intake was free of debris as seen in Photo 37. Talen installed a trash rack at the upstream end of the intake subsequent to the 2015 inspection, as seen in Photo 37a of Appendix A. The deck of the intake structure had been previously jacked up by over-extension of the gate stem and was no longer plumb after lowering the gate stem. Several of the CMP discharge pipes at the downstream slope of the splitter dike were observed to be corroded and abandoned. These CMP discharge pipes, previously observed with under-seepage, were no longer flowing and it appeared that the upstream ends had been sealed. However, a boil was observed at the downstream end of one of the abandoned pipes, as seen in Photo 38. This boil should be monitored. The origin of these pipes is not clearly documented. There is little differential head acting on the splitter dike, and any discharge, were it to occur, would be contained by the exterior dike around Sub-basin C. If monitoring shows excessive flow or signs of internal erosion, the abandoned pipes should be excavated and removed. The two active 18-inch CMP discharge pipes of the splitter dike discharge structure exhibited signs of corrosion at the downstream end, as seen in Photos 39 and 40. Discharge was observed flowing from

Photo 36 – The downstream face (C side) of splitter dike between Sub-basins B and C.

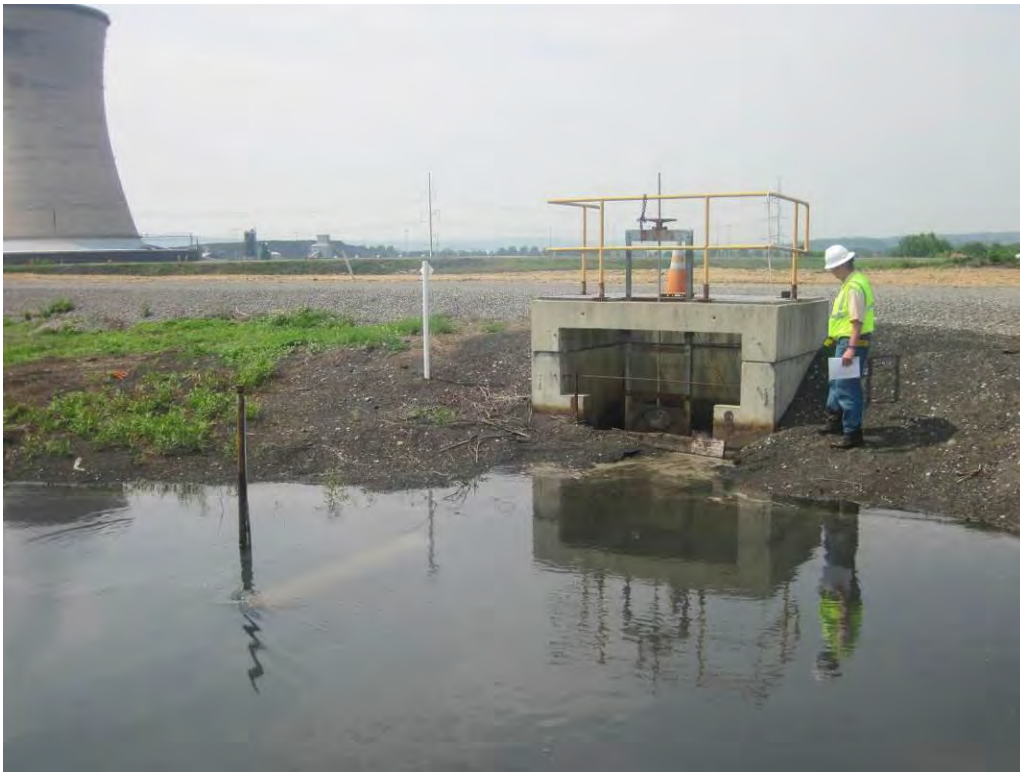
Photo 37 – Intake structure at the splitter dike.

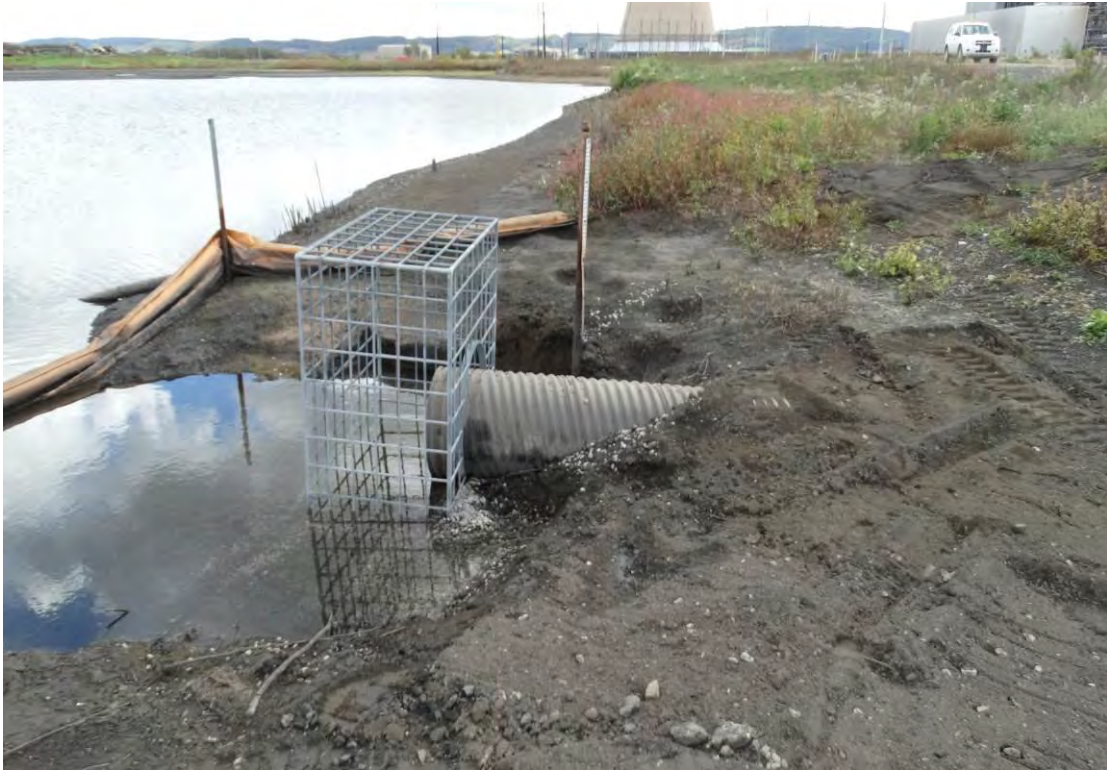
Photo 37a – Trash rack installed at upstream end of intake between sub-basin B and C

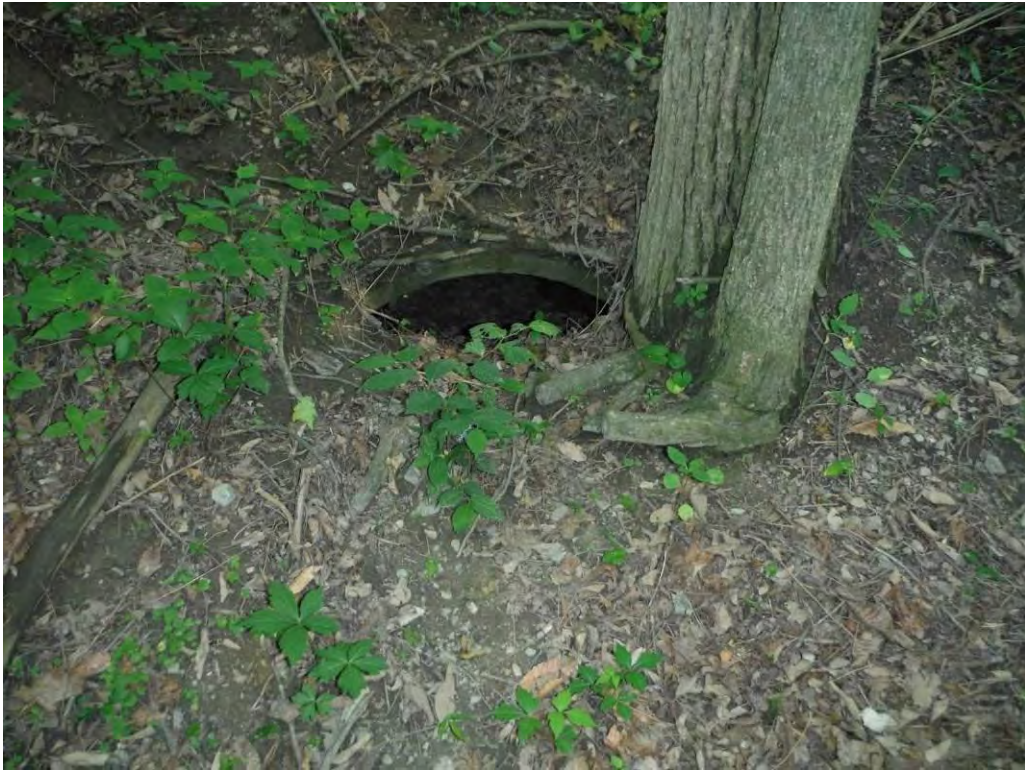
Photo 41 – The outlet pipe of an abandoned outlet structure running from Sub-basin C to Chillisquaque Creek.

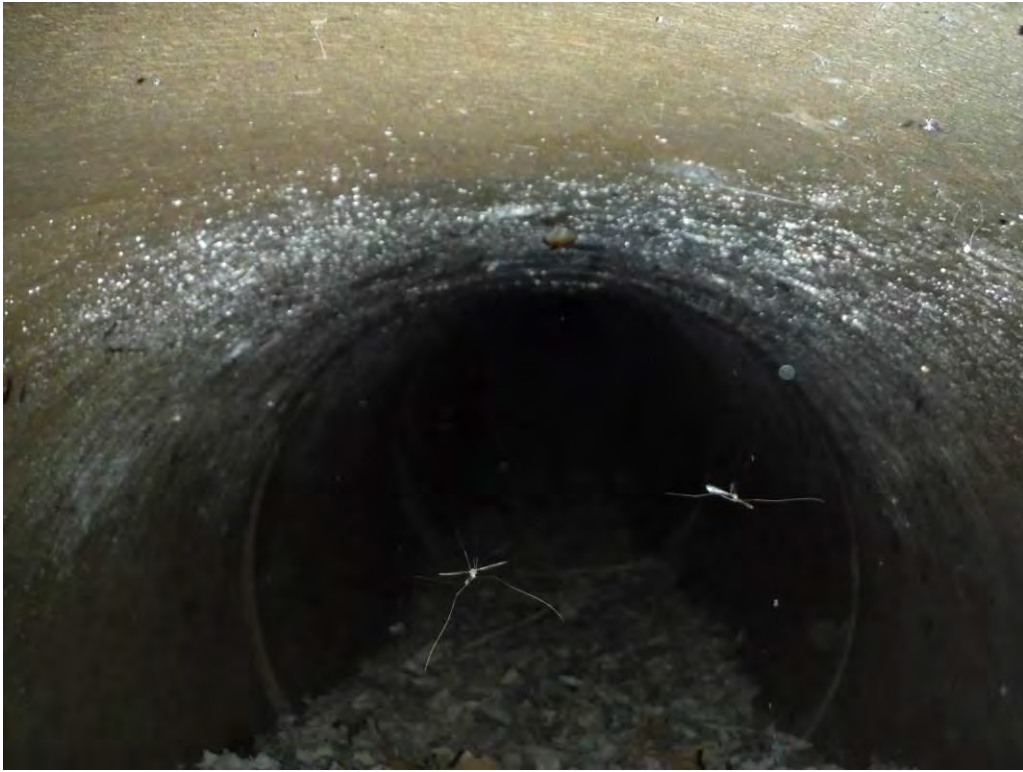
Photo 42 – The outlet pipe of an abandoned outlet structure running from Sub-basin C to Chillisquaque Creek. View inside the RCCP outlet pipe.
